**CONDITION APPRAISAL
(FY 2020)**

**270 STATE STREET PARKING GARAGE
NEW HAVEN, CONNECTICUT**

**NEW HAVEN
PARKING
AUTHORITY**

DESMAN PROJECT No. 20-19171.00-2

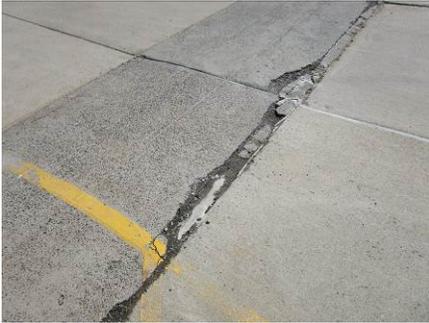
Photo #12

Isolated locations exhibit damage and the initial stages of deterioration due to environmental exposure and normal wearing (**Photos #12, #13, #14, #15, #16 & #17**). In many of these locations, snow removal operations, as typically performed on the roof level, have damaged the concrete aprons. In lower level locations, shallow steel coverage and cracking have resulted in extensive delaminations and spalling.

DESMAN therefore recommends that the cast-in-place concrete all be programmed for full replacement, making certain that appropriate coverage of the steel is accommodated for. This work is currently scheduled to be performed as part of NHPA Project No. 20-005, currently in design.

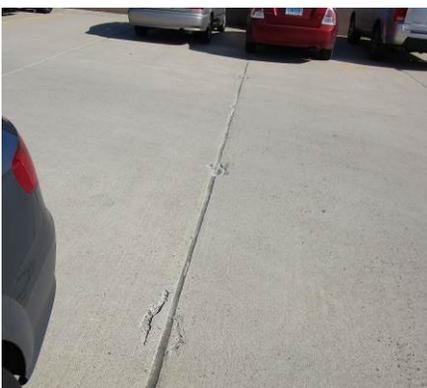
Photo #23

- During erection and placement of the individual precast concrete double tee deck elements, each tee is tied to the adjoining tee with embedded shear connection assemblies spaced periodically along the length of the tee. Depending on the depth of the embedment, and the care utilized during the welding process to connect the adjoining tees, there can be instances where nominal spalling at various connections might occur (**Photo #23**).

If the precast concrete at the shear connections retain sufficient moisture, the heat generated during welding can vaporize the moisture into steam causing tensile failure in the concrete and nominal surface spalling at the connections.

DESMAN recommends the use of an epoxy/aggregate repair mortar to infill the shallow surface spalls. This material can be applied with minimal surface preparation and its material properties and enhanced bonding characteristics allow it to be feathered into the adjoining concrete surface. The recommended repair material is also more flexible than typical concrete/cementitious repair mortars. Similar periodic repairs at the shear connections throughout the garage can be expected throughout the useful life of this facility. The recommended

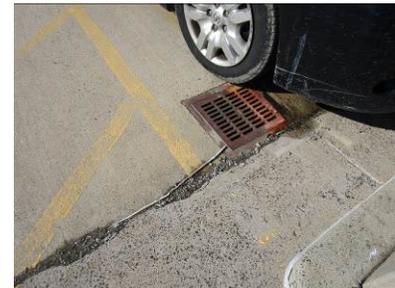
Photo #21

- DESMAN noted minor surface scaling and shallow-depth delamination and/or spalling throughout the garage, particularly in those areas constantly exposed to moisture (i.e. adjacent to vertical surfaces, adjacent to drains (**Photo #20 & #21**), exposed on the roof level, etc.).

Shallow-depth delaminations and spalling can be caused by insufficient coverage above the reinforcing steel, and scaling can be caused by cyclical freeze-thaw, typically exhibited by pitting on the concrete surface and an exposure of the aggregate within the concrete matrix (**Photo #22**). In each case, the reinforcing steel can become exposed, allowing further moisture penetration. DESMAN recommends that the scaling and shallow-depth deterioration be repaired using an appropriate epoxy/aggregate repair mortar. Any recommended concrete repair work should be coordinated with waterproofing/sealant work needed, as described later in this report.

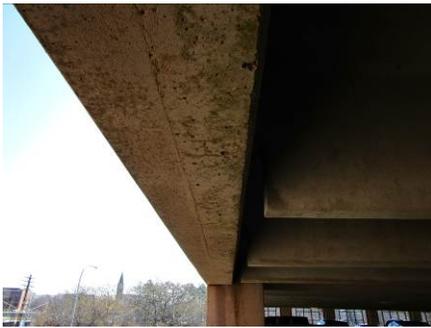
Photo #29

DESMAN recommends that the underside of exterior spandrels specifically be monitored however (**Photo #29 & #30**). When casting the spandrels at the precast plant, the bottom surfaces can be susceptible to insufficient consolidation, thus resulting in voids and cracking, and thus compromising the durability of the concrete, especially the spandrels along the perimeter which are more exposed to the weather. Although the cracking and related deficiencies are not currently compromising the structural integrity of the spandrels, DESMAN suggests that a waterproofing coating may become appropriate at some point, and thus DESMAN recommends that it be programmed accordingly.

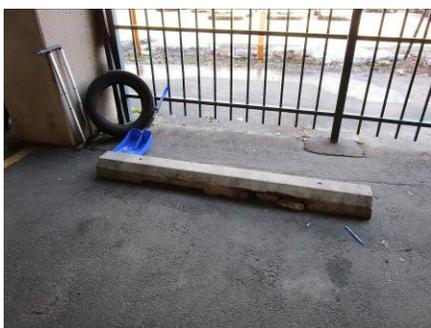
Photo #32

DESMAN observed wheelstops placed on the first level (**Photo #32**); DESMAN typically does not recommend the use of wheelstops since they can become potential trip hazards as well as maintenance concerns. DESMAN recommends that these wheelstops be removed and/or an alternative means of vehicle barrier be employed.

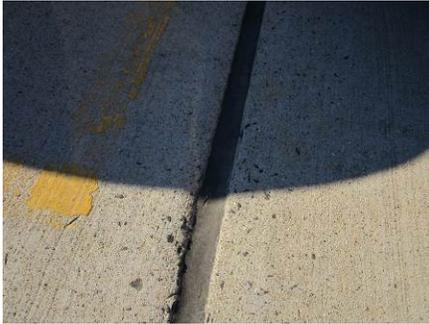
Photo #33

As a general rule, the life expectancy of tee-to-tee joint sealant is between 8 to 12 years depending on exposure and level of usage; joints on a roof level are further susceptible to more aggressive circumstances such as UV-exposure, environmental conditions and snow plow damage (**Photos #33, #34, #35 & #36**).

Repairs to leaking tee-to-tee joints typically requires that old sealant material be entirely removed down to bare concrete, the edges detailed and the substrate properly primed prior to new polyurethane sealant material being installed. Limited "spot" repair of tee-to-tee joints can be problematic as new polyurethane sealant materials do not adhere well to preexisting or previously cured polyurethane sealant. "Spot" repairs can be accomplished, as evident from the recently performed repairs, but the pre-existing sealants must be thoroughly cleaned and wiped down with solvents to soften the surface and enhance the bond between old and new materials. Unless there is only limited tee-to-tee joint failures along a 60 foot wide parking bay, DESMAN typically recommends that the entire length of tee joint be removed and repaired/replaced in its entirety.

For budgeting purposes, DESMAN recommends that all the joint sealant be removed and new sealant installed throughout the deck. While "spot" repair can be considered acceptable along certain joints, full replacement will provide a uniform life expectancy for all the sealant, as well as also avoiding varying and multiple warranties on the new sealant. This work is currently scheduled to be performed as part of NHPA Project No. 20-005, currently in design.

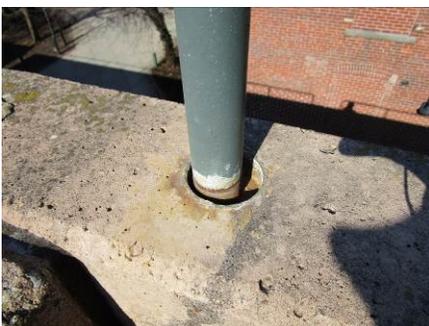
Photo #39

DESMAN further noted the lack of cove joints around various railings, bollards and other metal assemblies (**Photos #39 & #40**); installing new cove joints around the bases of these assemblies would protect them from moisture and related deterioration.

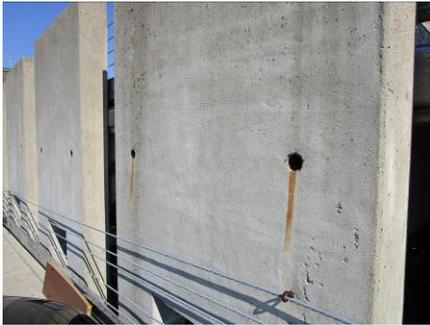
Photo #50

DESMAN did also observe miscellaneous shallow cracking throughout the surfaces of the columns, various spandrels and shear walls as well, most specifically the roof level, especially when wet (**Photos #50 & #51**). Although the cracking is not uncommon and DESMAN does not consider the integrity of the surfaces to have been compromised, DESMAN certainly recommends that the condition be monitored. In the long-term, continued moisture contamination will be detrimental to the surfaces' condition. DESMAN recommends that the condition be monitored and the application of a waterproofing coating be programmed accordingly, inclusive of filling and/or sealing all the voids, to protect the various surfaces and enhance their longevity (**Photos #52 & #53**).

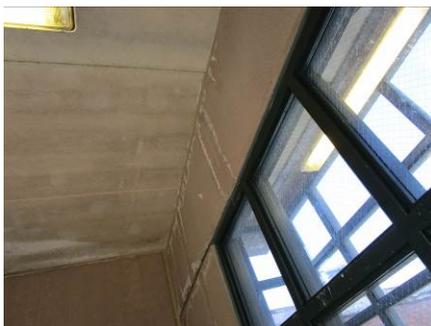
Photo #74

- The stair and elevator tower roofs are all in poor condition (**Photos #74 & #75**); indications of moisture penetration and concrete deterioration appear throughout the stair towers and throughout the roof slabs. Considering the age of the roofing systems and the indications of system failures, DESMAN recommends that the roofing systems be programmed for replacement. This work is currently scheduled to be performed as part of NHPA Project No. 20-005, currently in design.

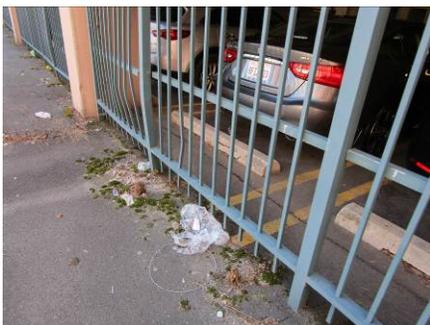
Photo #80

- Decorative metal fencing has been installed along the perimeter of the garage. Although generally in good condition, certain portions of the fencing has been damaged, and the various mountings have been exposed to moisture and are exhibiting corrosion. DESMAN recommends that the fencing system be monitored for repair and re-painted on regular intervals; a cove joint can be installed around the base of the posts to protect the metal (**Photos #80, #81 & #82**).

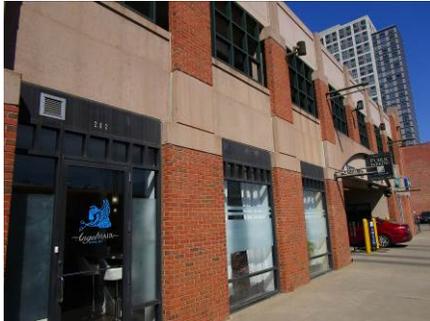
Photo #83

The storefront systems, of the tenant spaces, are aged and showing indications of leaking and water penetration (**Photos #83, #84, #85 & #86**); moisture damage to the flooring was observed. DESMAN recommends that these systems be replaced with new storefront systems.

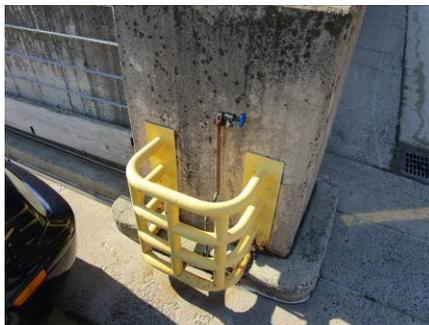
Photo #128

Hose bibbs are located on each level for washdown of the facility (**Photos #128, #129, #130, #131 & #132**). The hose bibbs appear to be in serviceable condition, however there appears to be damage by freezing of the cold water distribution piping. The full extent of the damage is uncertain due to insulation wrapping the piping. DESMAN recommends that the system receive a full-pressure test to confirm its condition and serviceability. However, it is unlikely that the pressure available from the domestic water system is adequate for effective washdown of the parking decks, to fully remove all dirt, oil, residual ice-melt materials, etc.

DESMAN emphasizes it is important that accumulated sand and other contaminants be removed from the garage decks each spring as they hold concentration of chloride (road salt) and moisture in direct contact with the concrete deck; causing an increase in the amount of deterioration which could take place.

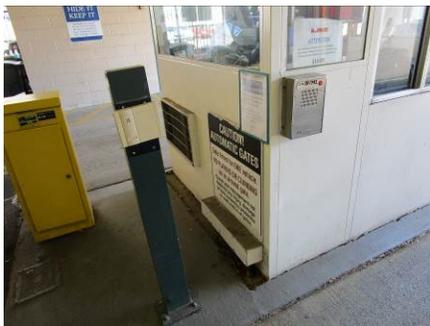
Photo #138

Cashier Booth Ventilation/AC: There is currently no provision for ventilation of the cashier booth (**Photo #138**). DESMAN recommends supplying outside air directly to the booth by installation of a supply fan, duct heater and ductwork to draw outside air from a location on the face of the facility, above the sidewalk, the intention being to ventilate the booth with fresh air, creating a slight pressurization which would help to prevent infiltration of auto exhaust. Air conditioning for the cashier booth, however, is provided by a thru-wall air conditioning unit. The unit appears to be in poor condition, and DESMAN therefore recommends that the unit be replaced.

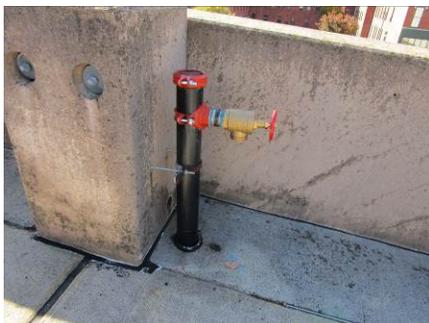
Photo #142

Fire Standpipe Maintenance: The dry-manual standpipe system was recently replaced (**Photos #142 & #143**); however, it has not yet been painted. DESMAN recommends that the piping be painted to further protect and enhance its durability.

The State Fire Safety Code requires periodic maintenance and testing of Fire Protection Systems in accordance with the provisions of NFPA 25 – “Standard for the Inspection, Testing and Maintenance of Water Based Fire Protection Systems”. At a minimum, owners’ maintenance personnel should conduct a quarterly visual inspection of piping, fire department connections and hose valves to ensure that systems have not been damaged. A more thorough detailed inspection should be conducted annually to verify that all system piping and components are in proper working order which should include testing and inspection of all valves and components. Flow tests should be conducted every five years at a minimum. Additional requirements for inspection testing and maintenance of Standpipe Systems are outlined in NFPA 25.

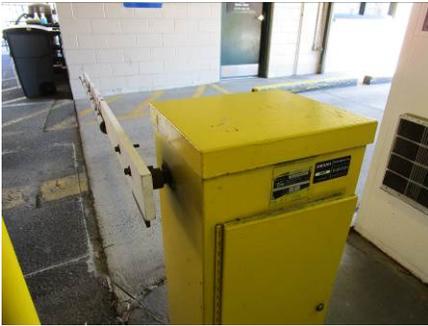
Photo #150

Due to age, improved technology and compatibility with PNH's operations, DESMAN recommends that PNH review the current system for potential enhancements and/or replacement, and plan accordingly (**Photos #150, #151, #152 & #153**).

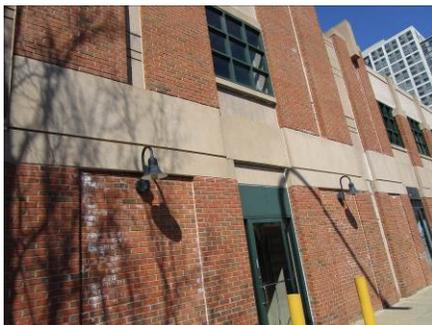
Photo #154

Facade Repairs: The exterior surfaces of the garage appear to be in good condition, however, miscellaneous damage should be repaired, as required; DESMAN recommends that the facade be monitored and the repairs performed on an as-needed basis, including a comprehensive cleaning, replacement of all sealant materials and flashing, removal of excess vegetation (**Photos #154, #155, #156 & #157**).
