**CONDITION APPRAISAL
(FY 2020)**

**AIR RIGHTS PARKING GARAGE
NEW HAVEN, CONNECTICUT**

**NEW HAVEN
PARKING
AUTHORITY**

NHPA PROJECT NO. 20-001
DESMAN PROJECT NO. 20-19171.00-2

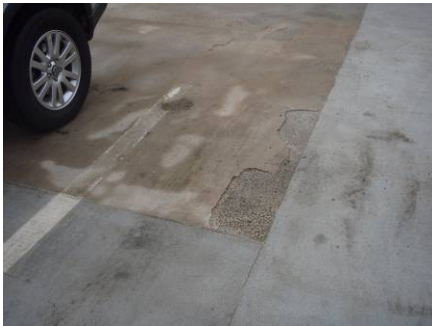
**Photo #4**

While partial depth concrete deck repairs have been performed historically (**Photos #3 & #4**), a designated amount of deck repair was addressed as part of the comprehensive repair program of 2011/2012, with additional work in 2015/2016 and continued again in 2016/2017 as well as season (2017/2018) and (2018/2019), a process which should continue to be expected in the future to keep this structure in good condition. As we have indicated previously, this facility's lack of concrete cover and the extent of chloride contamination will continue to result in ongoing corrosion and concrete deck deterioration, so a program to keep it in check is necessary. NHPA should continue to plan to perform repairs at approximate two year intervals, and monitor the performance of the corrosion inhibitor. The projected five year repair costs have been adjusted accordingly.

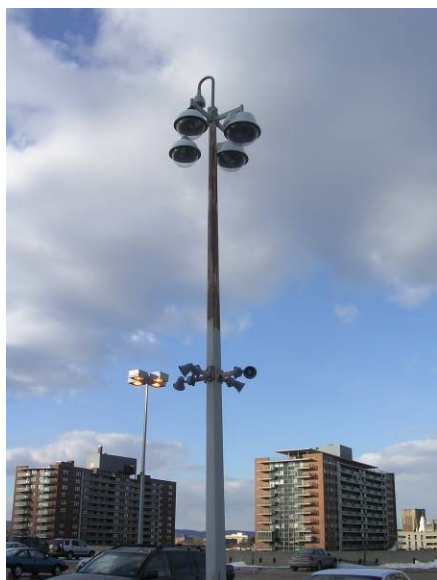
Photo #13

2004 Based upon the security system audit performed in 2001, the facility's entire security system was upgraded starting in the Fall of 2004 (**Photo #13**).

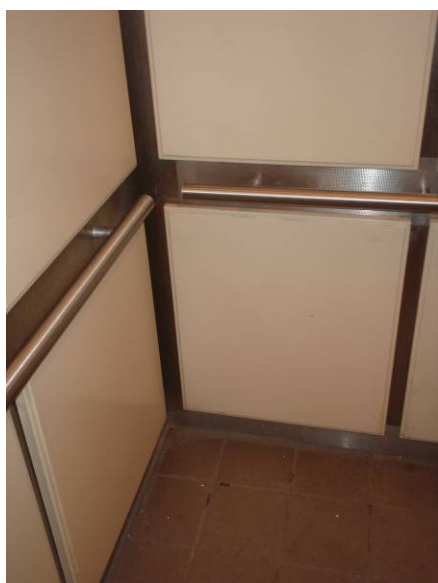
Photo #16

- 2007 The four (4) elevators were completely modernized. These improvements include a complete upgrade of elevator mechanical and electrical equipment, and improvements to the interior of the elevator cabs with new stainless steel and Corian™ paneling, new flooring tile and new lighting (**Photo #16**).

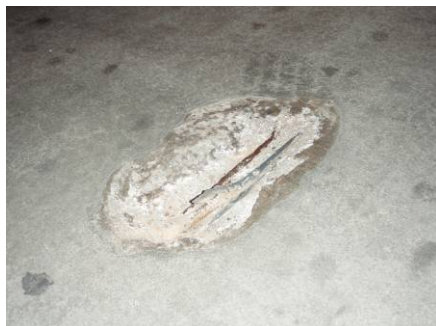
Photo #21

In limited locations, post-tension tendons have been exposed and damaged (**Photo #21**). While the locations are infrequent, and DESMAN does not consider them to have compromised the structural integrity of the garage at this time, DESMAN does recommend that designated locations be monitored and be budgeted for repair. Interim short-term repairs may be required, as NHPA Maintenance has already performed in certain locations.

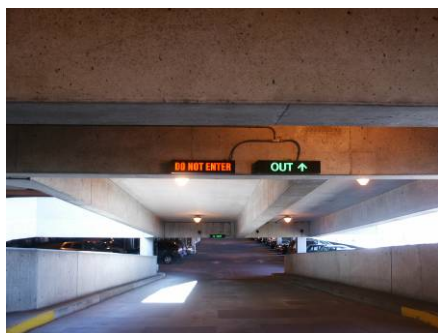
Photo #52

Miscellaneous Signage Repairs and Improvements: This garage has a multitude of traffic and pedestrian way-finding signage installed throughout the facility (**Photo #52**). Additionally, a graphic signage program was implemented historically which identifies individual parking levels by various health and fitness activities. Over time, depending on environmental exposure, vandalism and abuse, and normal wear, this signage will require repair and update.

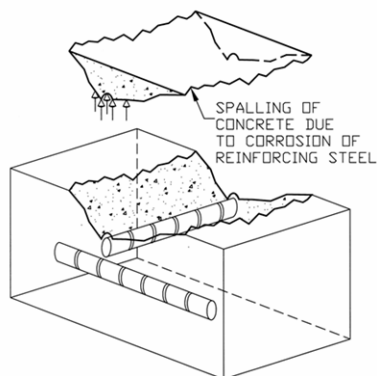
Fig. A

The primary cause of the majority of reinforced concrete deterioration within parking structures is directly related to the penetration of water into the concrete. Reinforcing corrosion, concrete scaling, water leakage, leaching, and concrete delamination are all caused at least partially by water penetration.

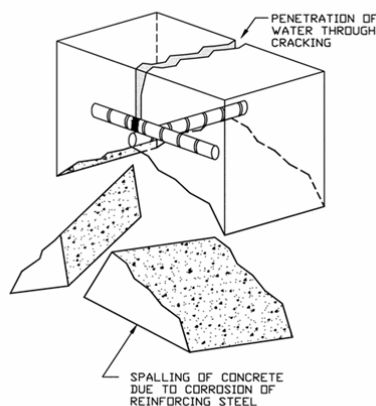
Fig. B

Water penetration can also cause delamination of concrete along subsurface fractures through pressures generated during freeze-thaw cycling.

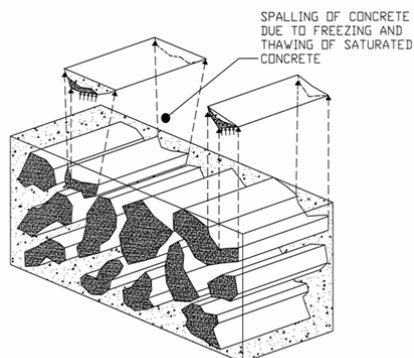
Fig. C

Because concrete has poor tensile strength properties, cracking occurs within the concrete matrix allowing additional moisture and chlorides to reach the reinforcing causing acceleration of the corrosion process. The deterioration caused by this corrosion includes the reduction of cross sectional area of the reinforcing, and the delamination of concrete surrounding the reinforcement.

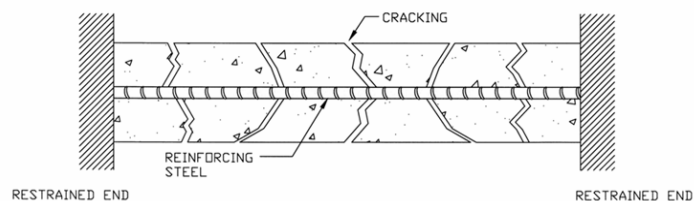
Fig. D

Volume changes due to thermal movement, shrinkage, creep, and loading can also contribute to the deterioration of reinforced concrete. These volume changes will produce stress in restrained members, often resulting in cracking of the member (*Fig. D*). These cracks also provide access to water and other deterioration mechanisms to attack the member.
