**CONDITION APPRAISAL
(FY 2020)**

**CROWN STREET PARKING GARAGE
NEW HAVEN, CONNECTICUT**

**NEW HAVEN
PARKING
AUTHORITY**

APRIL 2020

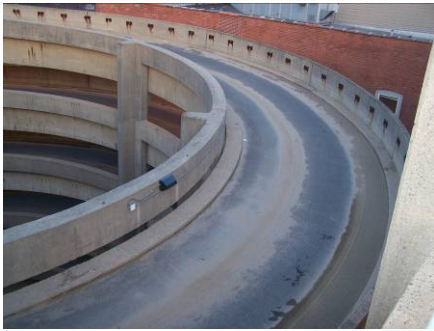
Photo #2

The facility's seven-story exit silo was repaired in its entirety. Now only minor repairs are required to correct overhead concrete spalling, weathered concrete curbing on the roof level and to remove metal shoring brackets left in place by the previous contractor. Part of repairs performed was the installation of a protected waterproofing membrane (**Photo #2**); this installation continues to perform in acceptable condition.

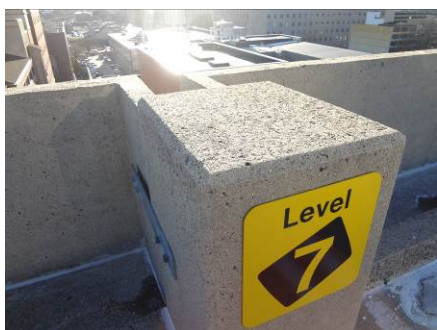
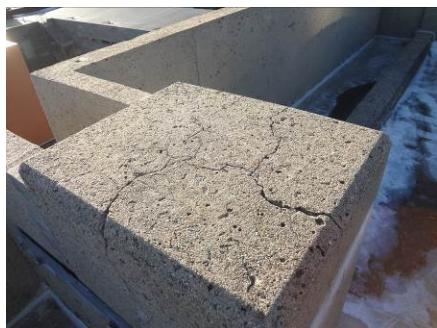
However, the top surfaces of the columns, the portions that protrude from the roof level and are most exposed to the elements, exhibit more significant wear-and-tear such as exposed aggregate and cracking (**Photos #6 & #7**). DESMAN recommends that these column portions be repaired as needed, either with a polymer-modified repair mortar or epoxy injected, as well as coated with a waterproofing material.

This work is currently scheduled to be performed as part of NHPA Project No. 17-006, currently in design.

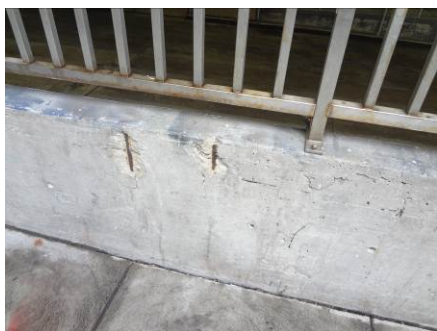
Photo #8

In addition, specific deterioration has become evident at the concrete wall facing the Shubert Theater, at the exit to College Street (**Photo #8**); DESMAN recommends that this deterioration be repaired accordingly.

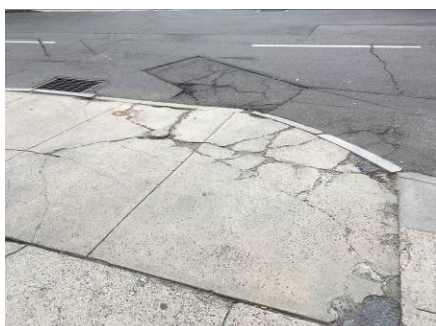
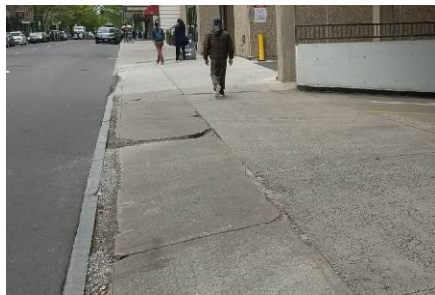
Sidewalk Repairs: the sidewalks surrounding the garage on Crown Street and College Street are exhibiting various stages of deterioration (**Photo #12 & #13**). DESMAN recommends that a comprehensive replacement be planned for the sidewalks accordingly.

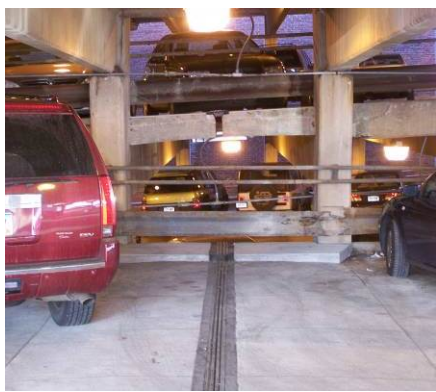
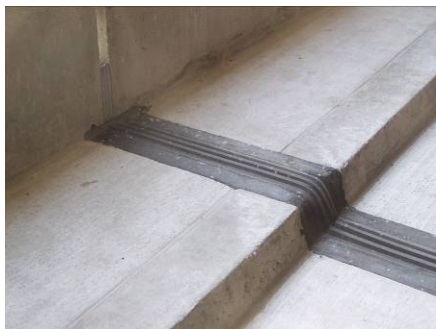
Miscellaneous Expansion Joint Repair: New expansion joint glands were installed in selected locations in 2008, and the remaining joints were repaired as part of the 2013 capital repair project (**Photo #14 & #15**). Although visual examination of the expansion joint seals and expansion joint nosings indicates a variety of conditions, some being in good condition while others are exhibiting wear-and-tear, Desman recommends that the joint glands be monitored and considered for miscellaneous repair, if not full replacement, in conjunction with the anticipated imminent waterproofing repairs recommended; a comprehensive approach would result in a uniformly aged expansion joint system throughout the garage in lieu of multiple warranties and gland systems. This work is currently scheduled to be performed as part of NHPA Project No. 17-006, currently in design.

DESMAN reiterates that expansion joint glands are adversely impacted by accumulated sand and debris within the joint; sand, grit and debris which is not being swept clear periodically will cause premature deterioration/failure of the joint. As vehicles traverse the joints, accumulated material is ground into the rubber expansion joint glands wearing them prematurely. The accumulated debris also restricts the elongation and compression of the joint material also causing premature wear.

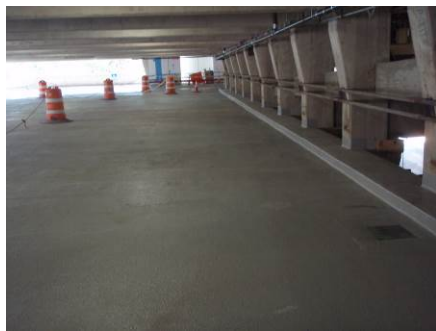
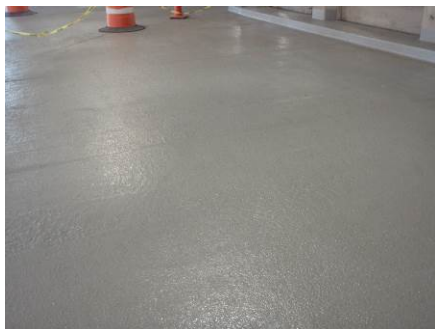
Repair/Installation: A full elastomeric traffic bearing waterproofing membrane system was installed on the first supported level of the garage, specifically the portion located above the facility's commercial space (**Photos #16 & #17**); previously, only the caulked joints had been protected by the application of 2-foot wide strips of membrane along the length of the individual tee joints. DESMAN recommends that the membrane be monitored and repaired as required.

Traffic bearing membranes are approximately 85%-90% effective as moisture and chloride screens inhibiting future chloride-ion migration into the deck; an elastomeric membrane will also traverse cracks that may form and joints that may be tooled. However, upon completion of the membrane installation, DESMAN suggests developing a yearly service contract with a qualified waterproofing contractor to assure that damaged portions of the membrane are successfully repaired each spring and autumn. It is important that all damage to waterproofing membranes be repaired, as continued and progressive de-bonding of the membrane will result if left unattended.

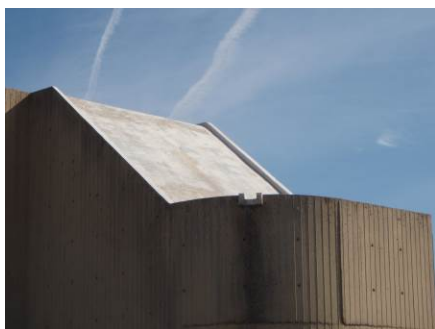
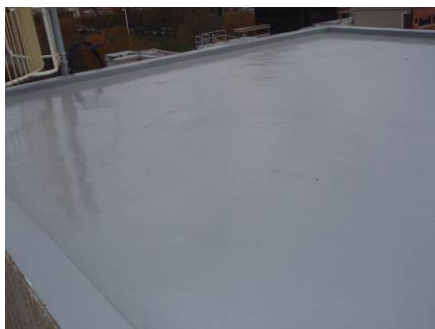
Roofing Repairs at Stairs and Elevator Cores: The facility's roofing materials were replaced (**Photos #18 & #19**) as part of the 2013 comprehensive capital repair project; an elastomeric membrane was installed on both tower roofs. DESMAN recommends that the membrane be monitored and repaired as required.

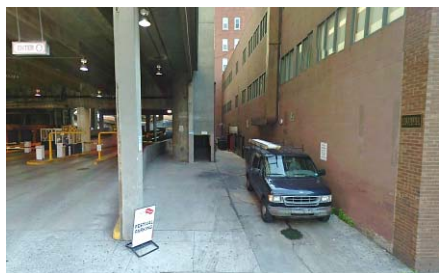
Photo #23

DESMAN recommends that the pedestrian corridor leading to the stair and elevators on Crown Street be enhanced (**Photo #23**); the close proximity of the adjacent property has provided a challenge to separate this space and make it unique and welcoming. In conjunction with the installation of decorative accent lighting, the existing concrete may be removed and/or resurfaced with a decorative stamped/stenciled concrete, providing an aesthetically enhanced pathway highlighting the route to the stair and elevators.

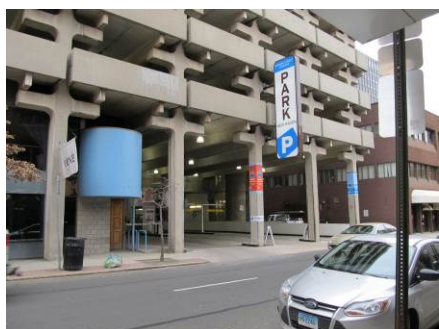
Photo #24

The façade of the Crown Street Garage along Crown Street has become aged (**Photo #24**). Although architecturally unique, the recent and ongoing development in the immediate area continues to provide a challenge for the garage to stay current.

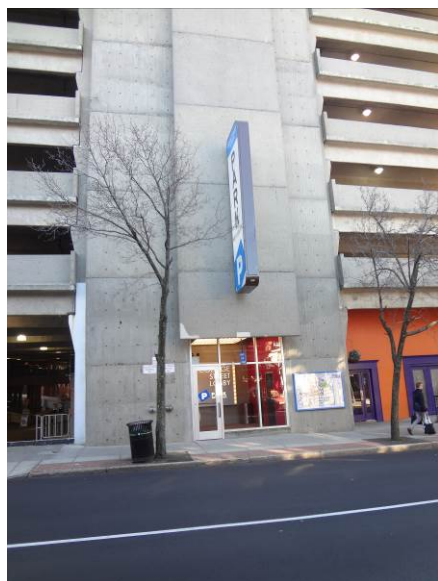
Photo #25

As an effort to enhance the lobby at the College Street stair/elevator tower, a major contributing factor to the pedestrian experience at the garage due to the adjacent Shubert Theater, an enhancement project was undertaken consisting of accenting the rear wall of the lobby with an architectural signage box (i.e. entertainment theme) along with installation of an illuminated ceiling element, and painting the walls with theater-themed coloring (**Photo #25**).

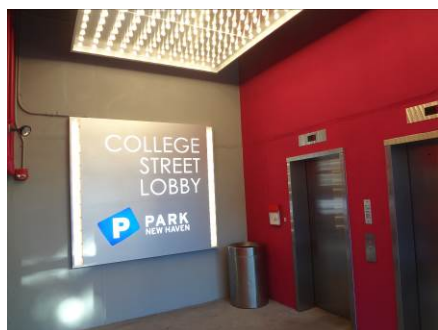
Photo #27

Due to the valuable aesthetic experience now provided by this lobby, DESMAN recommends that the various materials be monitored and repaired or touched-up as required (i.e. the vibrant colors now provided by the walls (**Photo #27**) will inevitably fade over time, and thus should be re-coated upon exhibiting wear).

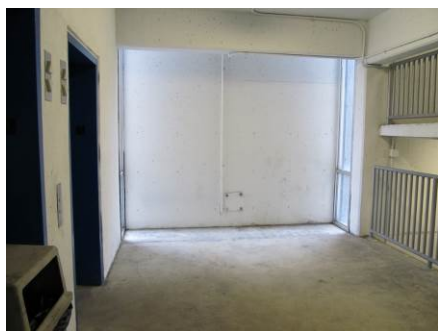
Photo #29

The interior lobbies of the stair/elevator tower on College Street provide opportunities for significant enhancements (**Photo #29**); the solid rear wall has provided a challenge to make this space unique and welcoming. In conjunction with the recent color-coding of the levels [completed as part of the recent comprehensive repair program (2013)], enhancements could include accenting the rear

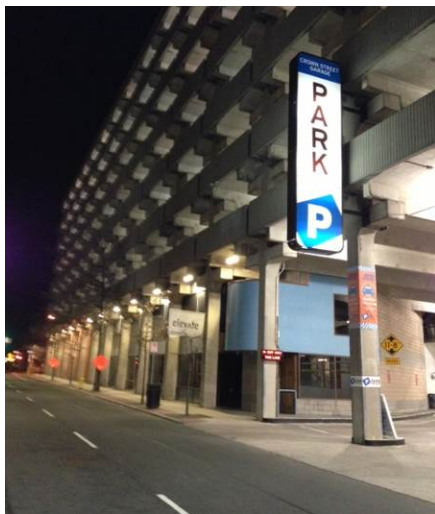
Photo #34

In conjunction with the monitoring of the lighting throughout the interior of the garage, review of the light fixtures along the sidewalk should be performed as well and monitored as required. Although the City of New Haven is typically responsible for maintaining and addressing concerns regarding the surrounding sidewalks, NHPA addressed certain minimal improvements to enhance the lighting along the sidewalk and limited to within the garage footprint (**Photo #34**).

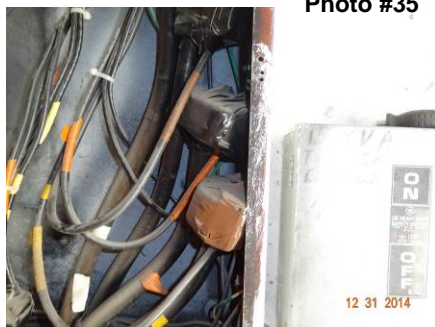
Photo #36

Miscellaneous Electrical Repairs: Although the recent 2013 comprehensive capital repair project included extensive electrical improvements, certain miscellaneous "clean-up" will remain due to a history of materials installed at various times but now abandoned, as well as organization of new materials in a more efficient manner, such as provision of new 120V branch circuits to the stairwells as well as replacement of the feeder and associated unused taps in the stair risers (**Photos #36**). All electrical equipment, including fixtures,

As miscellaneous repair may be performed, DESMAN recommends that PNH be cognizant of new conduit passing through the floor slab; since the slab tends to be exposed to significant moisture, the metal conduit is then also exposed, thus corroding and deteriorating over time. To help extend the longevity of the conduit, DESMAN recommends that sleeves be used to protect the conduit from direct, sitting water, followed by a polyurethane cove joint as well.

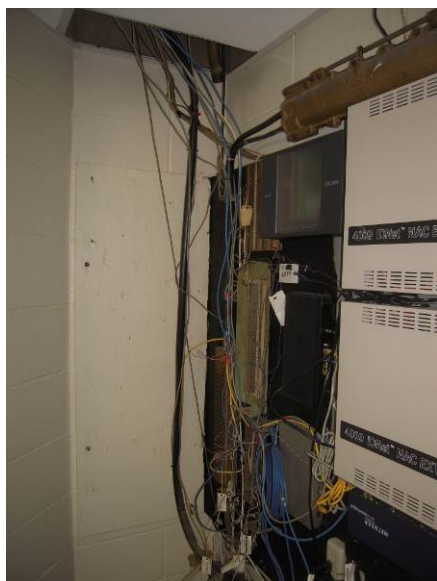
Photo #38

Telephone Block Clean-up: Over time, various modifications have resulted in a web of cabling that is unsightly as well as simply difficult to manage (**Photo #38**). DESMAN therefore recommends that PNH consider testing the cables to confirm activity with subsequent coordination with the phone company along with replacement with shorter lines, proper support and a new block. This work is currently scheduled to be performed as part of NHPA Project No. 19-006, currently in design.

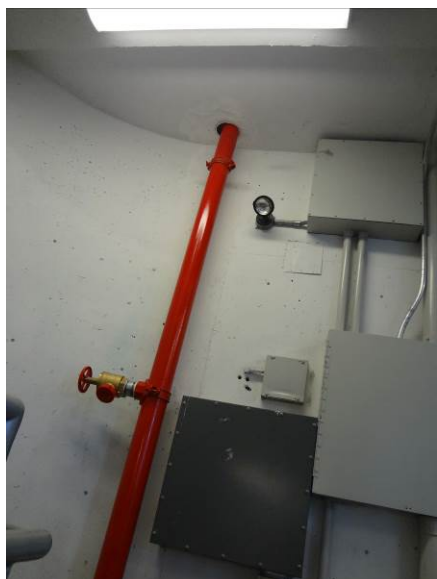
Photo #40

Fire Standpipe Repair: The facility's fire standpipe system has been replaced as part of the 2013 comprehensive capital repair program (**Photo #40**).

The State Fire Safety Code requires periodic maintenance and testing of Fire Protection Systems in accordance with the provisions of NFPA 25 – “Standard for the Inspection, Testing and Maintenance of Water Based Fire Protection Systems”. At a minimum, owners’ maintenance

personnel should conduct a quarterly visual inspection of piping, fire department connections and hose valves to ensure that systems have not been damaged. A more thorough detailed inspection should be conducted annually to verify that all system piping and components are in proper working order which should include testing and inspection of all valves and components. Flow tests should be conducted every five years at a minimum. Additional requirements for inspection testing and maintenance of Standpipe Systems are outlined in NFPA 25.

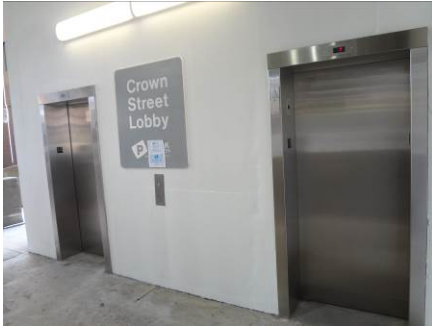
Photo #47

A new elevator No. 4 was also installed in the blanked out hoist-way (**Photo #47**) which is located on the east end of the facility, in order to provide additional elevator service to this busy garage.
