**CONDITION APPRAISAL
(FY 2020)**

**TEMPLE MEDICAL PARKING GARAGE
NEW HAVEN, CONNECTICUT**

**NEW HAVEN
PARKING
AUTHORITY**

**NHPA PROJECT No. 20-001
DESMAN PROJECT No. 20-19171.00-2**

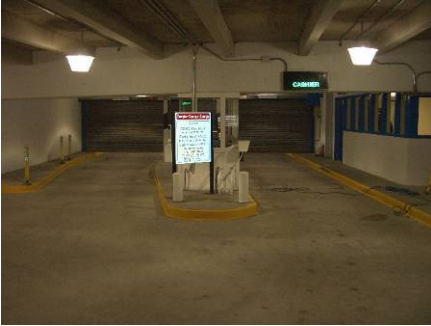
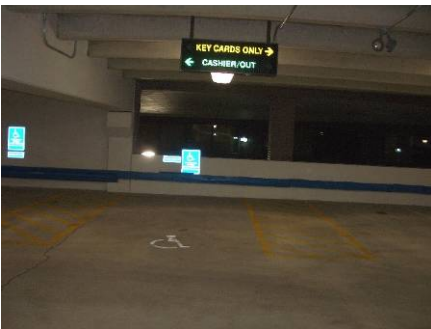
Photo #1

An extensive restoration of this facility was completed in 2007 and a subsequent project completed in 2013 addressing the remaining items not included in the previous project (2007) (**Photos #1 & #2**). This restoration project included extensive concrete repair to the supported decks, as well as significant waterproofing improvements, inclusive of expansion joint replacement, crack chasing and caulking, detailing of control/construction joints and cove joints, and replacement of the facility's interior guardrail/handrail system.

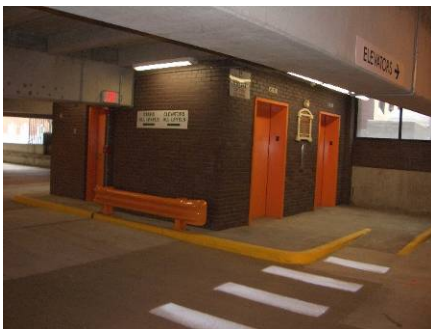
Photo #7

The Temple Medical Parking Garage is rectangular in plan with a north-south dimension of approximately 308 feet and an east-west dimension of approximately 124 feet. Each corner of the facility, except the northwest corner, has an enclosed stair-tower with metal pan stairs (**Photo #6**). The facility is equipped with a combination elevator/stair-tower core with two elevators centrally located on the east side of the garage (**Photo #7**).

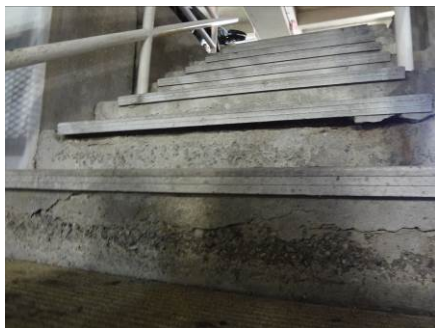
Photo #16

Concrete Stair Repair: This work is currently scheduled to be performed as part of NHPA Project No. 18-008, currently in design. Additional stair repair work should be anticipated in the future and therefore DESMAN recommends that the curbing be monitored and NHPA budget accordingly. (**Photo #16**).

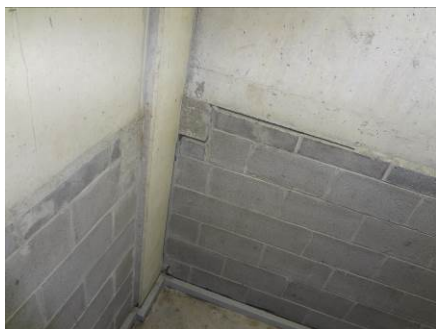
Photo #19

Masonry Unit Repair: This work is currently scheduled to be performed as part of NHPA Project No. 18-008, currently in design. Additional brick repair as well as exterior repair and re-pointing work should be anticipated in the future and therefore DESMAN recommends that the masonry be monitored and NHPA budget accordingly (**Photo #19**).

Subsequent to the miscellaneous repair of the masonry, DESMAN recommends that PNH program a comprehensive cleaning of the exterior as well.

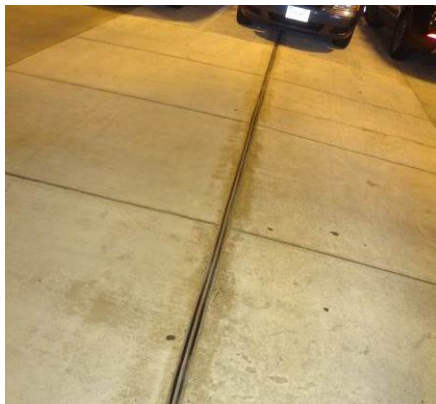
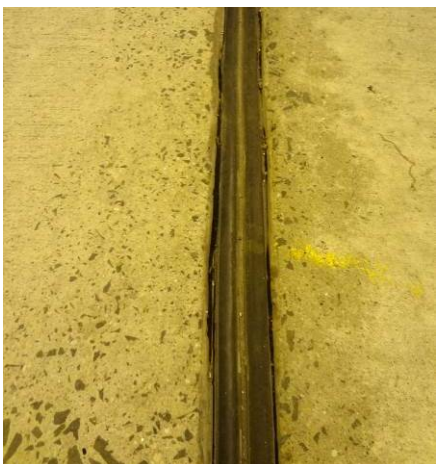
Expansion Joint Repair: DESMAN suggests that repair and replacement of the expansion joints be anticipated in the near future. Any repairs required would be expected to be due to normal wear and tear (**Photos #20 & #21**). This work is currently scheduled to be performed as part of NHPA Project No. 18-008, currently in design.

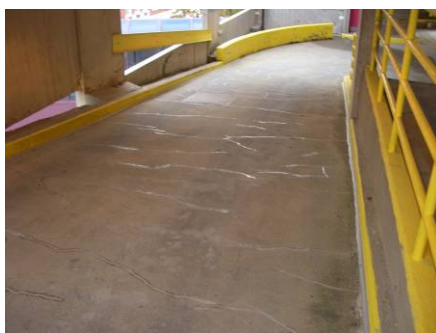
Photo #22

Crack Repair: Miscellaneous crack repair was addressed as part of the (2013) repair program (**Photo #22**). Additional crack repair work is currently scheduled to be performed as part of NHPA Project No. 18-008, currently in design.

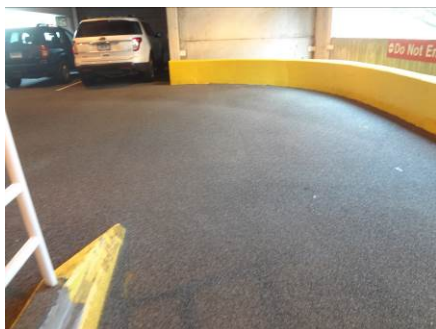
Photo #23

Membrane Maintenance & Repair: A new traffic bearing membrane has recently been installed on Level 2, directly over the tenant space (and PNH Main Office) (**Photo #23**). DESMAN recommends that this membrane system be monitored and repaired as may be required.

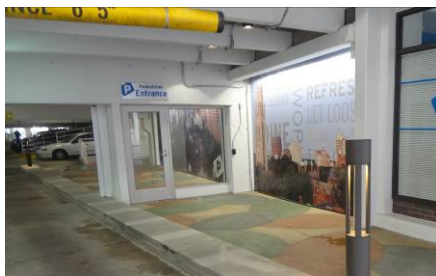
Photo #24

Miscellaneous Door Repair & Replacement: As part of PNH Project No. 16-010, certain new doors were installed and other doors, related to the storage area and office space, were replaced with new ones as well. Certain of these doors have sensitive hardware, such as electric strikes, and should be maintained accordingly (**Photo #24**).

Other doors, such as related to the stair towers, were not addressed, and so should be monitored and repaired as required. While various adjustments and repairs were made to doors, doorframes, and door hardware during the most recent repair project (2013), miscellaneous repairs should be anticipated in the near future due to normal wear and tear, although DESMAN now considers it more appropriate to recommend that the door systems be replaced in their entirety, and planned accordingly.

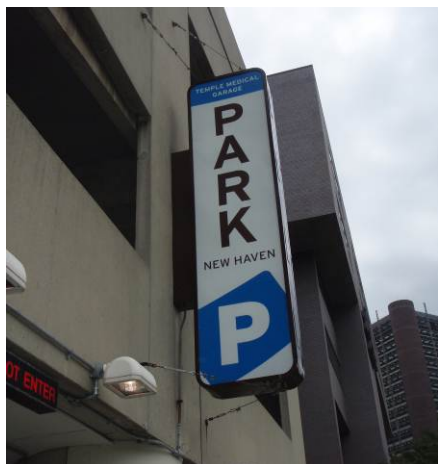
Photo #27

Update of Garage Signage: NHPA requested that there be updates made to this facility's exterior signage, designating the facility as a parking garage (**Photo #27**) and directing patrons to park in this facility, as well as to a limited number of interior signs. In conjunction with NHPA's current re-branding program, the exterior signage was refurbished and updated with new sign box materials and new graphic faces to be more in keeping with NHPA's new logo and graphic standards. This work was addressed in the (2013) comprehensive capital project.

In conjunction with NHPA's current re-branding program, the interior and/or pedestrian signage should be programmed for replacement. The signage can updated with new graphic faces to be more in keeping with NHPA's new logo and graphic standards. This work is currently being programmed for implementation.

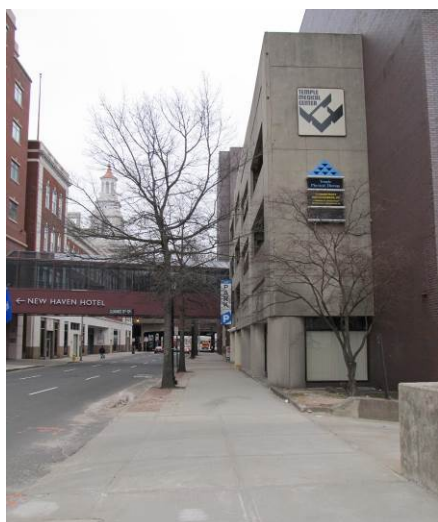
Photo #28

The façade of the Temple Medical Garage has become aged (**Photo #28**). The recent and ongoing development in the immediate area continues to provide a challenge for the garage to stay current.

Recently, with NHPA's re-branding efforts fully underway, additional opportunities have developed that could assist in revitalizing the garage. Enhancements, such as installation of a super-graphic to the blank concrete side of the garage, re-finishing of the columns on the ground level to contrast the floors above, providing an architectural screen element on the brick wall, as well as updating the landscaping with new local plantings an grasses, could assist in transforming the garage (various concepts as follows).

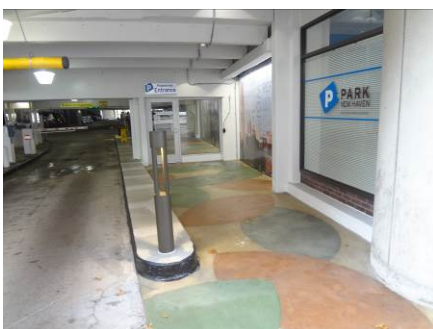
Photo #32

Previously, pedestrian access into the garage from George Street required the patrons to walk along a curb adjacent to the vehicular drive lanes, simultaneously being cautious of beams and other garage elements (**Photos #29, #30 & #31**). As an effort to enhance the visitor's experience upon entering the garage, PNH Project #16-010 was initiated and various improvements were implemented. The adjacent storage areas were removed, glass storefront systems installed for security, a decorative overlay/flooring and murals were installed, and the walls painted, all with improved signage and accent lighting (**Photo #32**).

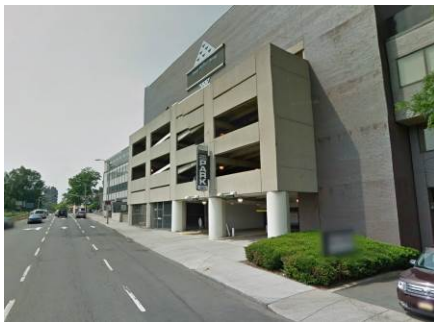
Photo #35

The façade of the Temple Medical Garage has become aged (**Photo #35**). The recent and ongoing development in the immediate area continues to provide a challenge for the garage to stay current.

Recently, with NHPA's re-branding efforts fully underway, additional opportunities have developed that could assist in revitalizing the garage. Unlike the façade on George Street, though, the M. L. K. Boulevard façade directly faces the highway and the Downtown Crossing development currently in progress, and thus this façade has a more immediate opportunity to create an updated impact on the surrounding environment. Enhancements, such as installation of a super-graphic to the blank concrete side of the garage, re-finishing of the columns on the ground level to contrast the floors above, providing an architectural screen element on the brick wall, as well as re-clad and brand the parking deck portion of the garage that is directly visible from the highway, could assist in transforming the garage (various concepts as follows).

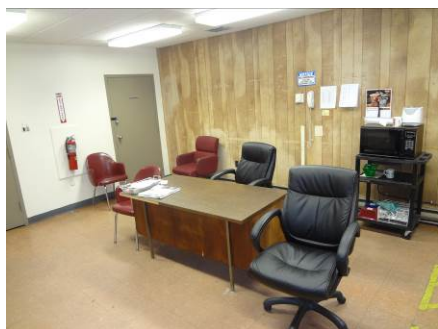
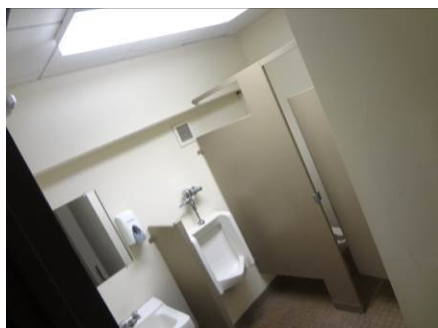
Manager's Office: In conjunction with the recent creation of a dedicated manager's role at the Temple-Medical Garage, the existing space being used as a Manager's Office would benefit from certain aesthetic improvements. Enhancements, such as new flooring, ceiling with lighting, painting, as well as renovations of the bathrooms, could be programmed accordingly. **(Photos #36 & #37)**

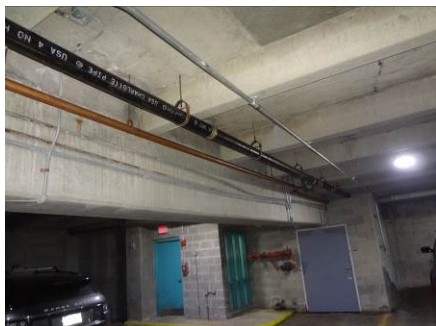
Photo #43

Repair of Office Bathroom Sanitary Line: It had been reported by the garage security staff that the sanitary line had not been working properly (**Photo #43**). Although certain repair work was addressed as part of NHPA Project #16-022, additional repairs appear to be warranted to improve flow; this work is currently in progress as part of NHPA Project #16-009.

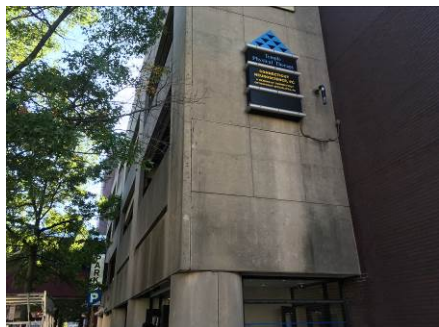
Photo #48

While the typical preventative maintenance cost associated with this work is not included within our projected five-year construction costs, subsequent to the miscellaneous masonry repairs programmed, DESMAN recommends that the exterior be comprehensively pressure-washed and cleaned accordingly as well (**Photo #48**), and has programmed this work accordingly.
