**CONDITION APPRAISAL
(FY 2020)**

**TEMPLE STREET PARKING GARAGE
NEW HAVEN, CONNECTICUT**

**NEW HAVEN
PARKING
AUTHORITY**

NHPA PROJECT No. 20-001
DESMAN PROJECT No. 20-19171.00-2

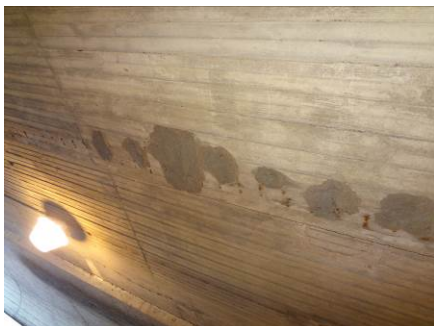
Photo #3

As previously reported in past Condition Assessment Reports, this facility's overhead concrete surfaces are exhibiting increases in overhead deterioration. Continued overhead concrete repairs are anticipated for the future. **(Photo #3 & #4)**

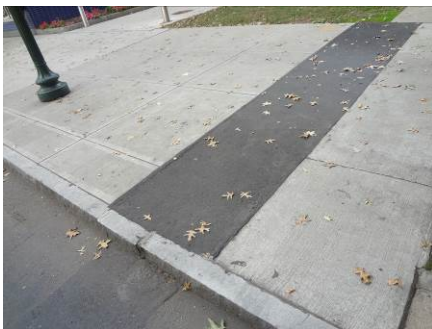
Photo #9

We understand the City Engineering Office had been pursuing a capital program for this work and certain repair work has now been completed, particularly with regard to the tunnel structure to the east and the street expansion joint on the east side of the garage(**Photos #8 & #9**).

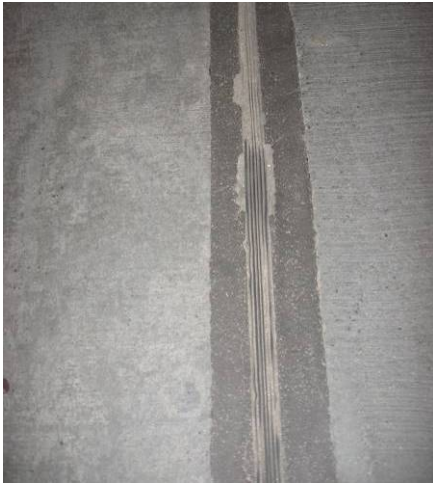
Photo #14

Expansion joints have been provided between column lines 6 & 7, 14 & 15, and 26 & 27 to allow for thermal movements within the structure (**Photo #14**).

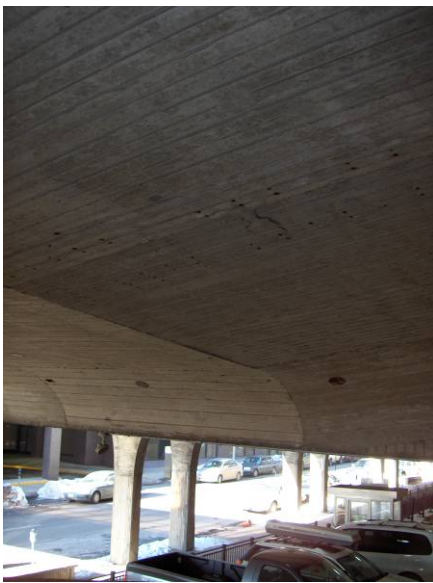
Photo #15

The supported slabs of the parking garage vary in thickness from 6 to 12 inches and are arch shaped (**Photo #15**). Slabs typically span 10 to 28 feet and frame into 24-inch deep floor beams. The slab is cantilevered along the perimeter of the structure and at the expansion joints. The majority of the 1st, 2nd, 3rd and 4th levels above the commercial space (retail area) and former tire center consist of structural concrete slabs with an intermediate waterproofing membrane and a cast-in-place concrete topping/overlay. It should be noted that the floating slabs within the overlay areas described above still retain the double expansion joint configuration. No modifications were made here as the structure has been performing well, and extensive repairs in these locations has not been necessary or recommended. Similarly the same deck configuration, with the double expansion joints and floating slab still exists on the facility's two roof decks (Levels 9 and 10).

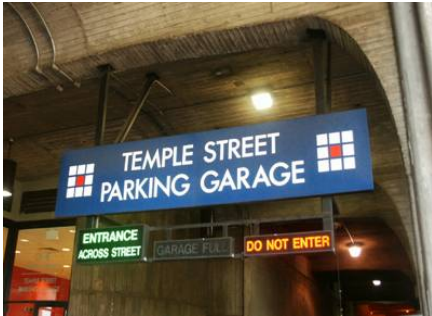
Photo #23

- Electrical repairs and improvements were performed which included the replacement of the facility's entire electrical distribution system, installation of new garage lighting and a new lighting and signage control system, installation of a new fire alarm system, installation of a new emergency callbox system, installation of new exit signs, and installation of a new emergency lighting system.
- Signage improvements included the installation of pedestrian signage and graphics (level designation signage, elevator bank identification signage, pedestrian information/directional signage, and vehicle directional signage, etc.). The installation of vehicular signage included both non-illuminated, changeable (computer controlled) illuminated vehicular signage and vehicle entry clearance bars (**Photos #23 & 24**).

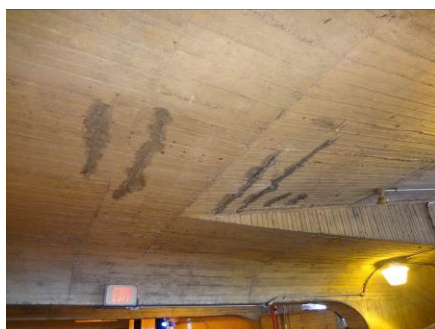
Photo #31

Vertical & Overhead Concrete Repair: The quantity of vertical and overhead concrete spalling observed throughout the facility has continued to increase (**Photos #31 & #32**). While a significant amount of vertical and overhead concrete repairs were addressed in the (2013) comprehensive capital project, additional square footage remains.

The overall age of this parking structure, the lack of adequate concrete cover utilized in the original construction, increased concrete carbonation due to age and environment which allows greater corrosion in the embedded steel (increased concrete porosity and a decrease in alkalinity) and because the facility's original concrete is known to now contain a build-up of chlorides all contributes to the increased overhead deterioration. Environmental exposure, and depending on ambient humidity levels, can cause moisture to condense onto the underside of the deck creating an environment conducive to active and progressive corrosion.

DESMAN recommends that NHPA continue to implement a periodic maintenance program to inspect all overhead and vertical surfaces (Spring and Fall) and to knock loose or remove all deteriorated concrete in a controlled fashion. Even if overhead and vertical concrete repairs were to be implemented on a yearly basis, it is likely that additional deterioration will occur.

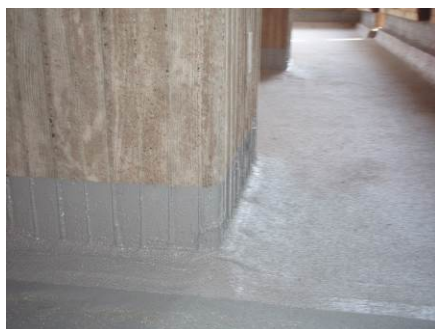
Photo #37

Cantilever Deck Membrane Repair: The waterproofing membrane installed on the cantilevered sections of the garage in 1989 has all been repaired and recoated as part of the (2013) comprehensive capital project (**Photos #37 & #38**). DESMAN recommends that the membrane be monitored and repaired as required. This work is currently scheduled to be performed as part of NHPA Project No. 17-006, currently in design.

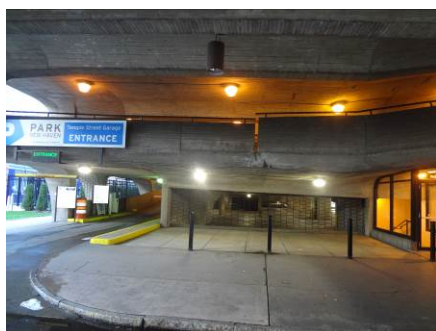
Photo #39

Although PNH continues to repair deteriorated concrete throughout the garage, PNH has observed leaking through the end of the ramp from Level 2 down to Level 1 (**Photos #39 & #40**). Since this deck area consists of a slab with an intermediate waterproofing [(as well as various other areas of the garage (Levels 1, 2, 3 & 4)], no single origin can be designated as the source since the surface has miscellaneous cracking throughout and subsequently, penetrating moisture may travel through the intermediate layer to an alternate location.

DESMAN recommends that this ramp be monitored further, and all apparent cracking be routed and sealed, as well as deteriorated concrete be repaired along with replacement of the intermediate waterproofing as it becomes exposed. Should the leaking continue, DESMAN suggests that installation of waterproofing membrane may need to be programmed for installation throughout this area.

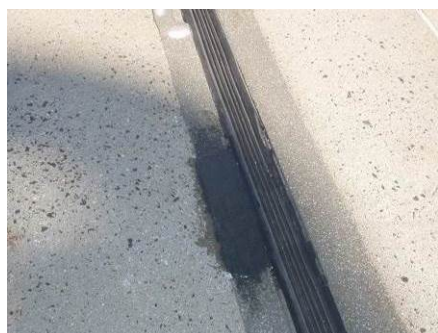
Photo #41

Expansion Joint Repairs: Miscellaneous repairs were performed as part of the (2013) repair program (**Photo #41**); however, more comprehensive repairs and/or replacement are recommended. Although new joints were installed on designated ramps that were not addressed as part of the comprehensive renovation program of (2000) (**Photo #42 & #43**), the joint glands on the supported levels are all almost 20 years of age now, including the joint glands surrounding Elevator C (**Photo #44**). DESMAN recommends that miscellaneous repairs continue to be performed as required, but a more comprehensive replacement program be planned for accordingly. This work is currently scheduled to be performed as part of NHPA Project No. 17-006, currently in design.

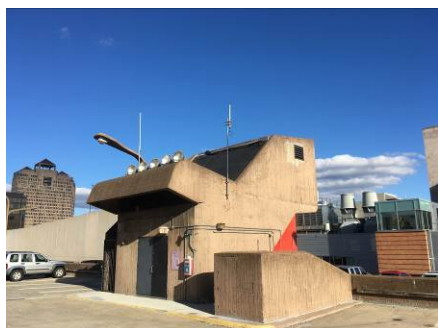
Photo #46

Elevator Machine Room Roofing: the existing roof systems of the elevator machine and fan rooms are exhibiting their age and wear-and-tear (**Photo #46**). DESMAN recommends that the roofing systems be removed in their entirety and replaced with new systems.

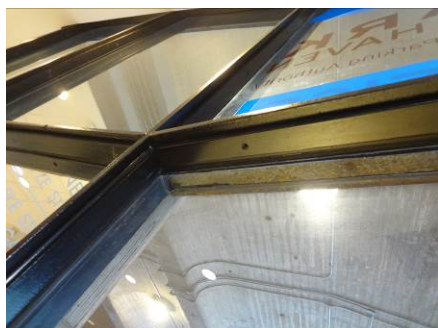
Photo #49

Miscellaneous Storefront Repair: DESMAN noted miscellaneous screws and seals missing from the storefront system of the George Street Lobby (**Photo #49**). DESMAN recommends that PNH monitor the condition of this storefront system and repair the system on an as-needed basis, so that the envelope (and related patron comfort) of the lobby is maintained.

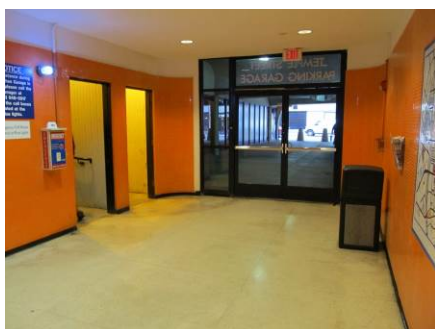
Photo #56

Although the stair/elevator lobby by Crown Street has been well-maintained (**Photo #56**), DESMAN recommends that the lobby could be energized and refreshed to be made more current. Enhancements could include cleaning and refinishing the floor and walls, installing an accent material to the walls of the lobby to be coordinated with the exterior space design, relocating the trash receptacle and incorporating it into an architectural bench seating, as well as updating the signage and graphics to be more consistent with the updated signage visible from the street (various concepts as follows).

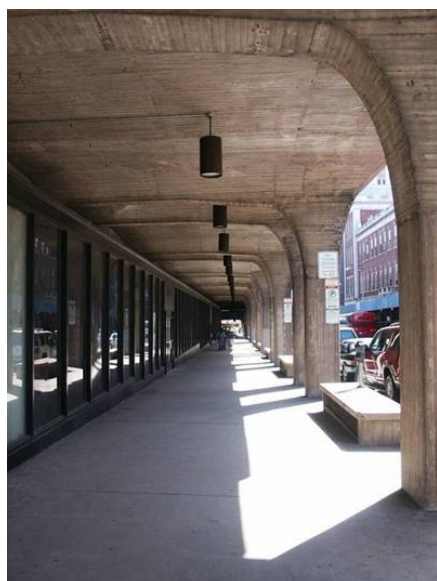
Photo #63

Sidewalk Lighting Improvements: NHPA had expressed the desire to replace the pendant mounted cylinder lights that were serving the sidewalks (**Photo #63**). This replacement would be for aesthetic, maintenance and energy savings considerations. New LED lights were installed in 2019 to decrease energy use and enhance illumination, as part of NHPA Project No. 16-009.
