**CONDITION APPRAISAL  
(FY 2020)**

**UNION STATION BUILDING  
NEW HAVEN, CONNECTICUT**

**NEW HAVEN  
PARKING  
AUTHORITY**

**APRIL 2020**

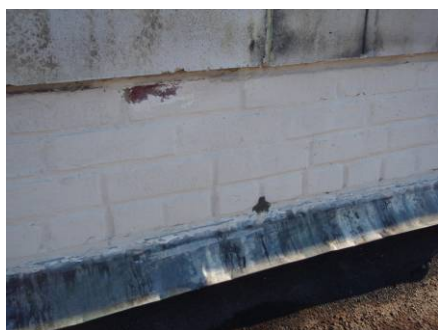
**Photo #8**

- Reworking of the facility's roof level parapet coping stones to eliminate water infiltration into the exterior masonry wall construction. This work was coordinated with the application of an architectural waterproof coating on interior surfaces of the parapet following miscellaneous brick removal/replacement and re-pointing of brick mortar (**Photo #8**).

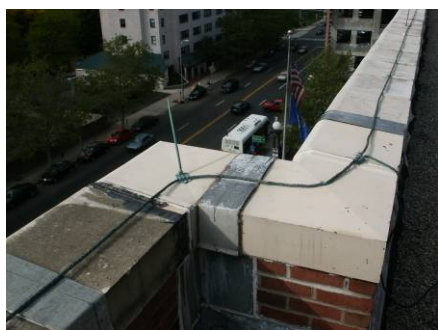
Photo #10

- Addressing various concerns to the facility's southwest stairwell, inclusive of the application of an architectural waterproof coating on the exterior surfaces of the penthouse, repair to the plaster finishes of the upper reaches of the interior of the stairwell, the replacement of the access door and its associated framing.
- Installation of rubber treads, risers, and landings on the stairs leading to the train platforms (**Photo #9**).
- Repair of the lightning arrestor system (**Photo #10**).

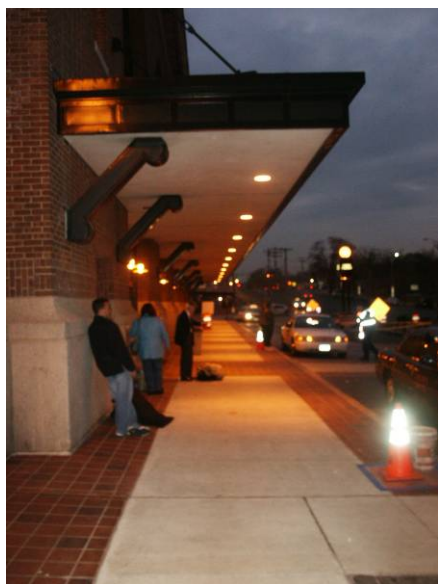
**Photo #13**

- Various exterior lighting fixtures were replaced or otherwise added around the perimeter of the station building to increase lighting levels as an enhancement to security (**Photo #13**).

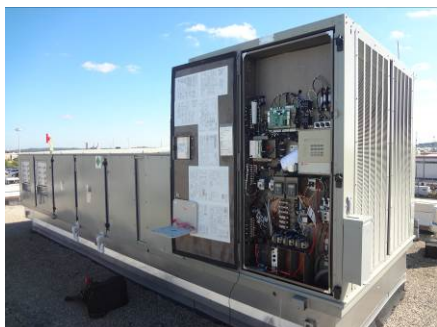
Photo #25

1. Replace Pneumatic HVAC Controls w/ Electronic Controls (**Photo #24**)
2. Replace 3 Packaged Rooftop Units (**Photo #25**)
3. Replace Eight (8) Gate Valves @ Control Valves
4. Replace two (2) Existing Recessed Wall Heaters in Main Entry

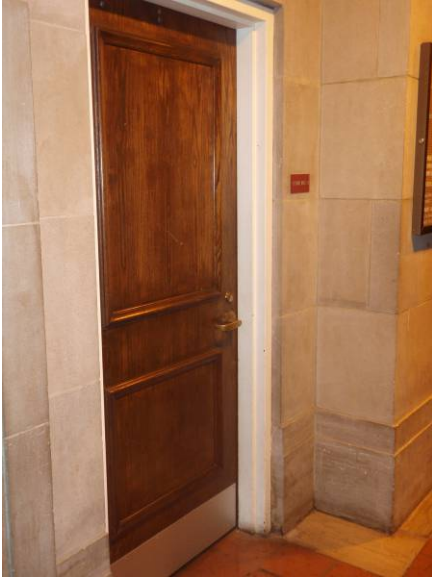
Photo #28

A review of the Station's stairwells indicates that each stair well access door on all levels would benefit from being refinished (**Photo #28**), as well as the handrails throughout the stairwells (**Photo #29**). In combination with this work, each stairwell has been identified as requiring a limited amount of plaster/sheetrock repair in combination with a fresh coat of paint (**Photo #30**).

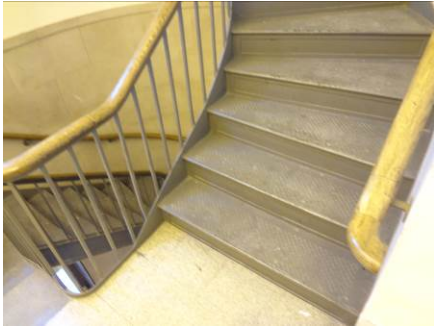
Photo #31

In addition to repainting the stairwell walls, it was noted that the stair treads and risers need to be properly prepped, primed, and repainted (**Photo #31**) along with associated balusters, railings and handrails.

Although this work is currently included as part of NHPA Project no. 15-003 A, now in design, DESMAN recommends that a nominal extent of repair continue to be programmed to address preventative maintenance needs accordingly as they arise.

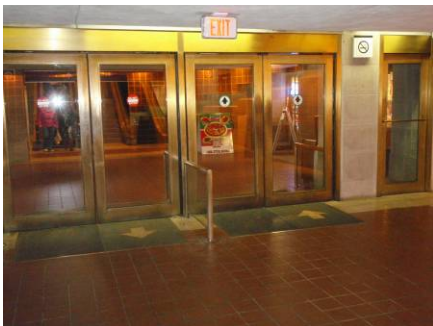
**Photo #36**

The brass doors located at the base of the escalators, leading to the pedestrian tunnel to the train platforms, are in need of repair (**Photo #36**). While the doors themselves are in acceptable condition to remain but be cleaned and refinished, all hardware and automatic controls should be replaced.

The brass doors located at the base of the escalators are included for repair as part of NHPA Project no. 15-003 A, now in design

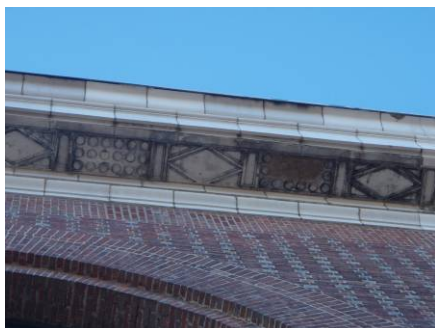
Photo #40

The entire building exterior was cleaned as part of NHPA Project no. 08-016 B. Stains, dirt and other contaminants were noted throughout the exterior. The terra cotta accents along the roof edge appear to be specifically stained, perhaps

with the staining embedded in the terra cotta due to exposure over time (**Photo #40**). Not all stains are removable and may need to remain as a natural element of this historic building's age.

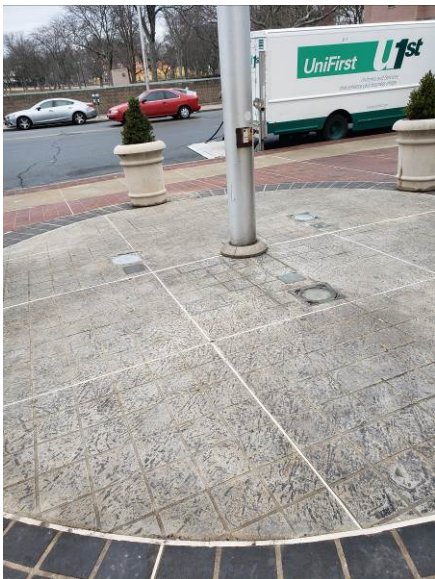
Photo #90

14. Lights around Flagpole: the embedded light fixtures surrounding the flagpole in the front of the Station are aged and damaged due to water (**Photo #90**). DESMAN recommends that these fixtures be replaced.

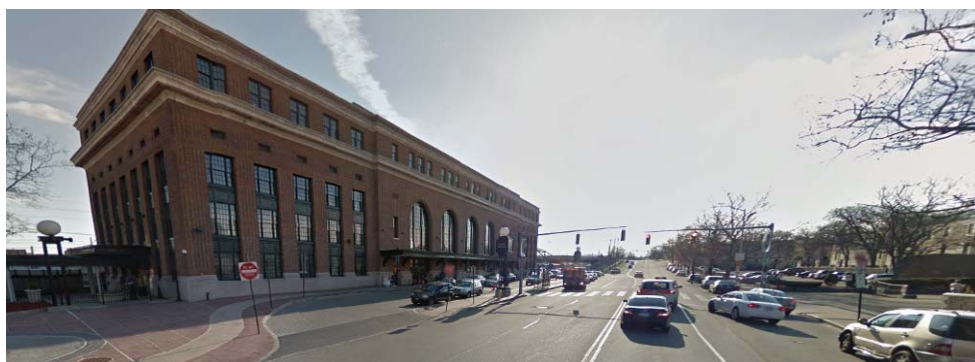
Photo #99

PNH has determined the need to modify the existing traffic and transit operations along Union Avenue and in front of New Haven Union Station (**Photo #99**) to better organize and delineate the various functions for all types of travel including shuttle bus, city bus, taxi, Uber, limo, pickup/drop off by car, bicycling and walking. Improvements include, but are not limited to, installing new vehicular signage and pedestrian wayfinding signage, installing new bus shelters, installing a new bicycle parking area, and other streetscape and site improvements at New Haven Union Station (the "Project"). Although this work is currently being considered as part of Project no. 15-023, progress is on hold per discussion with the City of New Haven and State of Connecticut.
