**CONDITION APPRAISAL
(FY 2020)**

**270 STATE STREET PARKING GARAGE
NEW HAVEN, CONNECTICUT**

**NEW HAVEN
PARKING
AUTHORITY**

DESMAN PROJECT No. 20-19171.00-2

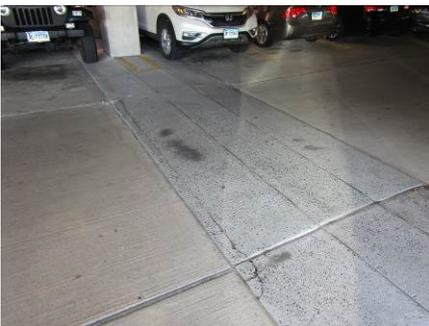
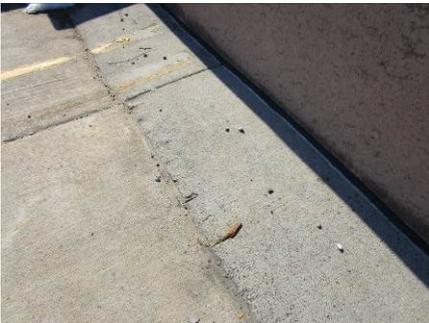
Isolated locations exhibit damage and the initial stages of deterioration due to environmental exposure and normal wearing (**Photos #12, #13, #14, #15, #16 & #17**). In many of these locations, snow removal operations, as typically performed on the roof level, have damaged the concrete aprons. In lower level locations, shallow steel coverage and cracking have resulted in extensive delaminations and spalling.

DESMAN therefore recommends that the cast-in-place concrete all be programmed for full replacement, making certain that appropriate coverage of the steel is accommodated for. This work is currently scheduled to be performed as part of NHPA Project No. 20-005, currently in design.

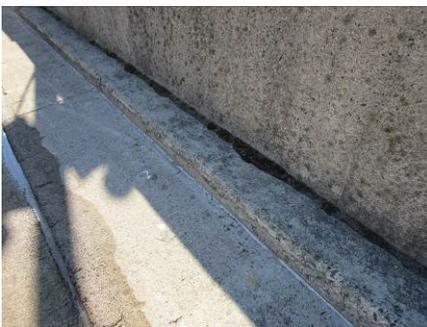
Photo #19

Similar to the washes and aprons, spalling was observed in a number of areas of raised cast-in-place concrete curbs as well, located around the parking facility. The damage appears to be a combination of shallow coverage of the steel, corrosion of embedded reinforcing steel and due to vehicular damage, especially on the roof level where the curbs are exposed to snow removal operations (**Photo #18 & #19**). Along with the concrete washes and aprons, DESMAN recommends that the curbs be replaced as well.

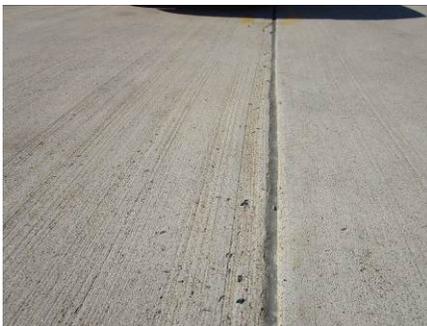
Photo #22

Shallow-depth delaminations and spalling can be caused by insufficient coverage above the reinforcing steel, and scaling can be caused by cyclical freeze-thaw, typically exhibited by pitting on the concrete surface and an exposure of the aggregate within the concrete matrix (**Photo #22**). In each case, the reinforcing steel can become exposed, allowing further moisture penetration. DESMAN recommends that the scaling and shallow-depth deterioration be repaired using an appropriate epoxy/aggregate repair mortar. Any recommended concrete repair work should be coordinated with waterproofing/sealant work needed, as described later in this report.

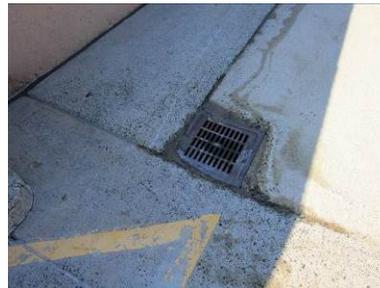
Photo #20

- DESMAN noted minor surface scaling and shallow-depth delamination and/or spalling throughout the garage, particularly in those areas constantly exposed to moisture (i.e. adjacent to vertical surfaces, adjacent to drains (**Photo #20 & #21**), exposed on the roof level, etc.).

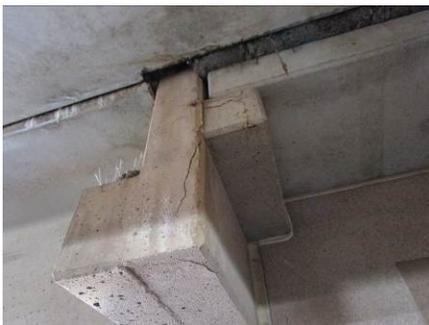
Photo #28

- Miscellaneous vertical and overhead concrete spalling was observed throughout the garage (**Photo #28**). Insufficient coverage of reinforcing steel, insufficient drainage and failed waterproofing above can allow moisture to access the steel, thus causing the spalling. Although cosmetic in nature, DESMAN recommends that these locations be repaired with a high-quality polymer modified repair mortar.

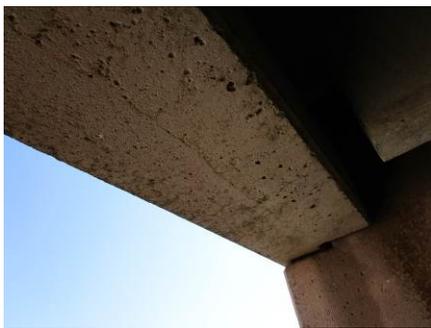
Photo #30

DESMAN recommends that the underside of exterior spandrels specifically be monitored however (**Photo #29 & #30**). When casting the spandrels at the precast plant, the bottom surfaces can be susceptible to insufficient consolidation, thus resulting in voids and cracking, and thus compromising the durability of the concrete, especially the spandrels along the perimeter which are more exposed to the weather. Although the cracking and related deficiencies are not currently compromising the structural integrity of the spandrels, DESMAN suggests that a waterproofing coating may become appropriate at some point, and thus DESMAN recommends that it be programmed accordingly.

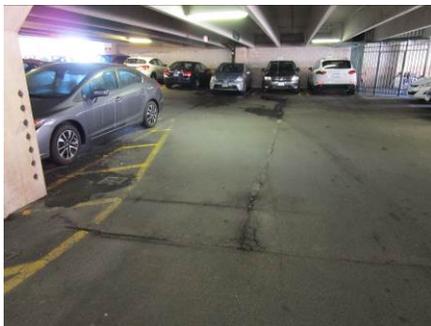
Photo #31

- Minor cracking and other deterioration mechanisms exist throughout the bituminous concrete (asphalt) slab-on-grade (basement level) (**Photo #31**). Since the slab-on-grade is typically considered a lesser priority than a supported deck, DESMAN recommends that the slab-on-grade be monitored to make certain no trip-and-fall hazards present themselves and the deterioration mechanisms don't expand or become exacerbated.

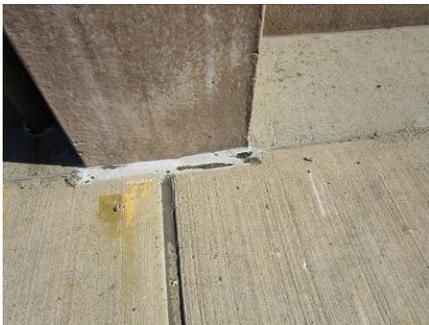
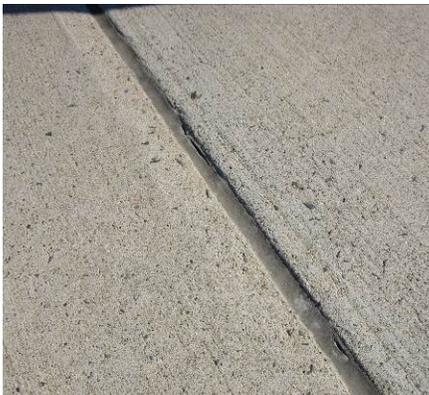
As a general rule, the life expectancy of tee-to-tee joint sealant is between 8 to 12 years depending on exposure and level of usage; joints on a roof level are further susceptible to more aggressive circumstances such as UV-exposure, environmental conditions and snow plow damage (**Photos #33, #34, #35 & #36**).

Repairs to leaking tee-to-tee joints typically requires that old sealant material be entirely removed down to bare concrete, the edges detailed and the substrate properly primed prior to new polyurethane sealant material being installed. Limited "spot" repair of tee-to-tee joints can be problematic as new polyurethane sealant materials do not adhere well to preexisting or previously cured polyurethane sealant. "Spot" repairs can be accomplished, as evident from the recently performed repairs, but the pre-existing sealants must be thoroughly cleaned and wiped down with solvents to soften the surface and enhance the bond between old and new materials. Unless there is only limited tee-to-tee joint failures along a 60 foot wide parking bay, DESMAN typically recommends that the entire length of tee joint be removed and repaired/replaced in its entirety.

For budgeting purposes, DESMAN recommends that all the joint sealant be removed and new sealant installed throughout the deck. While "spot" repair can be considered acceptable along certain joints, full replacement will provide a uniform life expectancy for all the sealant, as well as also avoiding varying and multiple warranties on the new sealant. This work is currently scheduled to be performed as part of NHPA Project No. 20-005, currently in design.

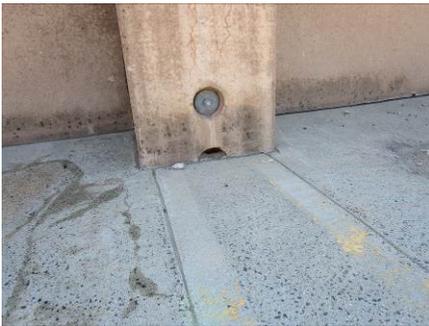
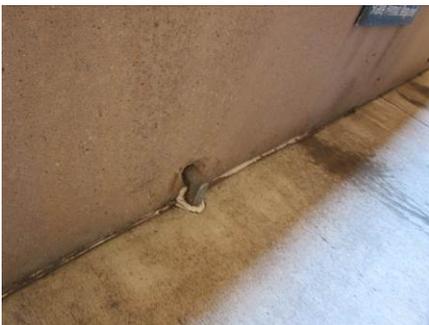
DESMAN observed that various spandrel connections were installed recessed within the concrete, as well as various electrical components installed, penetrating the sealant (**Photos #37 & #38**). When replacing the cove joint sealant, we recommend that the recessed connections be cleaned, cold-galvanized and fully coated/filed with the sealant for further protection.

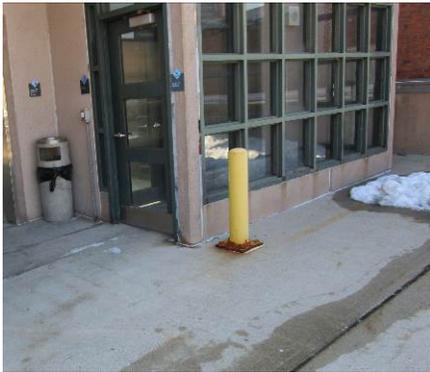
Photo #40

DESMAN further noted the lack of cove joints around various railings, bollards and other metal assemblies (**Photos #39 & #40**); installing new cove joints around the bases of these assemblies would protect them from moisture and related deterioration.

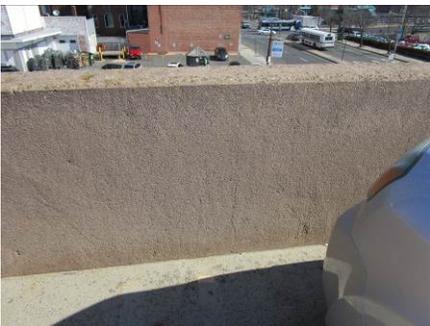
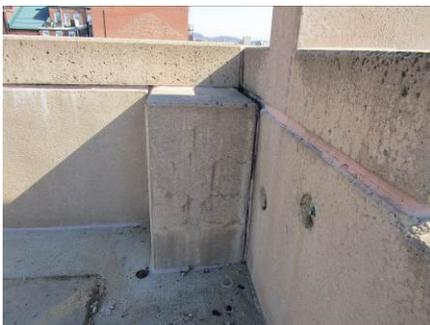
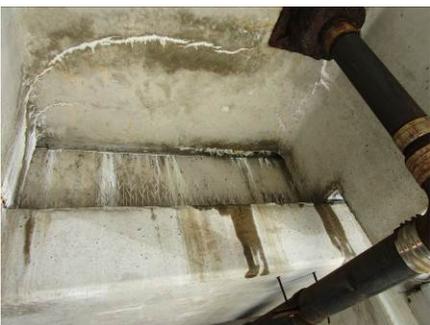
- Miscellaneous cracking (**Photos #47, #48 & #49**) was visually identified throughout the parking garage, some of which was previously routed and sealed. The cracking observed within the precast concrete tees is similar to cracking observed in most precast concrete tee construction, and is usually related to restrained concrete shrinkage. This cracking can also occur when the tees are pulled from their forms if minimum concrete strengths have not been achieved. Since this parking deck is fully exposed to the winter weather, the cracking may also be a result of wear-and-tear from snow removal operations during the winter, due to the heavier vehicles that may be utilized. None of the cracking identified is an immediate structural concern, although continued water infiltration into and through these cracks should be eliminated to prevent the egress of deicing chemicals and road salt, and thus the deck should continue to be monitored for potential distress.

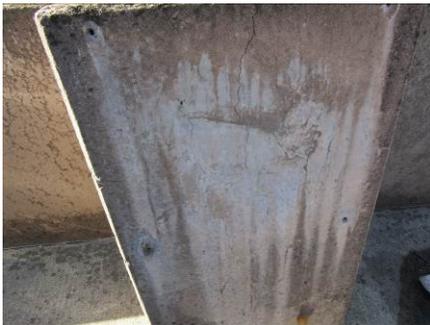
Photo #51

DESMAN did also observe miscellaneous shallow cracking throughout the surfaces of the columns, various spandrels and shear walls as well, most specifically the roof level, especially when wet (**Photos #50 & #51**). Although the cracking is not uncommon and DESMAN does not consider the integrity of the surfaces to have been compromised, DESMAN certainly recommends that the condition be monitored. In the long-term, continued moisture contamination will be detrimental to the surfaces' condition. DESMAN recommends that the condition be monitored and the application of a waterproofing coating be programmed accordingly, inclusive of filling and/or sealing all the voids, to protect the various surfaces and enhance their longevity (**Photos #52 & #53**).

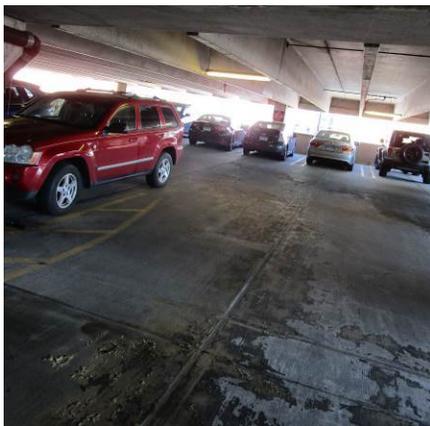
Photo #54

DESMAN recommends that the areas currently protected with a membrane system, such as floor areas above the tenant spaces, be monitored and re-coated as required to maintain their waterproofing integrity (**Photos #54 & #55**); at the time of re-

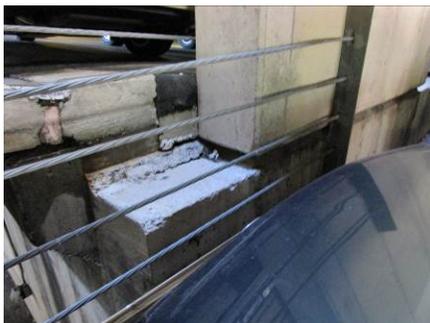
Photo #56

- Various joints in the walls, not unusual due to the nature of connecting the many precast elements, were grouted with a cementitious mortar (**Photos #56 & #57**); although considered common practice, the mortar isn't a flexible material, and therefore is now exhibiting moisture penetration and leaking; similar with various retaining wall surfaces. DESMAN recommends that the grout be removed and a non-sag polyurethane sealant be installed within the exposed walls.

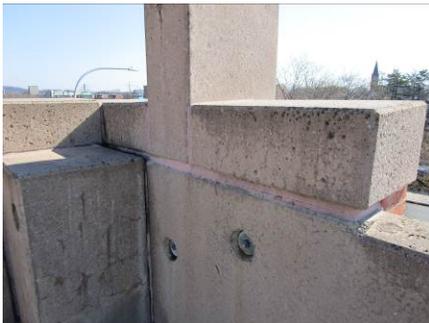
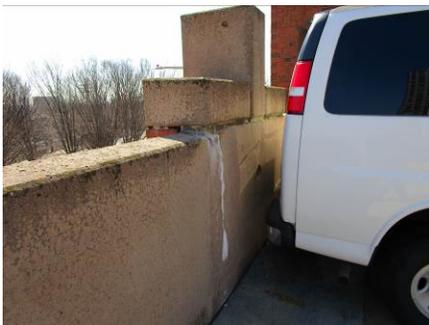
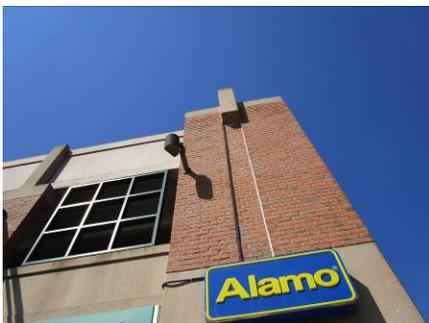
Similar to the many wall joints, DESMAN recommends that all horizontal and vertical joints throughout the facade be sealed as well with a non-sag polyurethane sealant to maintain the waterproofing integrity of the building envelop (**Photos #58, #59 & #60**).

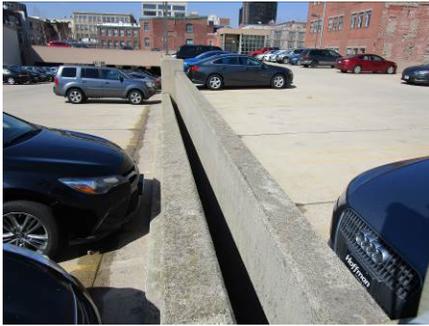
Photo #61

DESMAN observed that, between a certain section of column-line, the slopes of the parking decks are such that a significant opening is provided between the ramp to the roof level and the adjacent bay that allows rain water to intrude onto the lower levels (**Photo #61**); this rain water will corrode the various mechanical and electrical systems that are routed through this space, and the falling rain water can provide a nuisance for the patrons of the garage. **DESMAN** recommends that a flashing system or barrier be installed to close the gap between the two bays; this can be accomplished on the roof level which could address the multiple levels below.

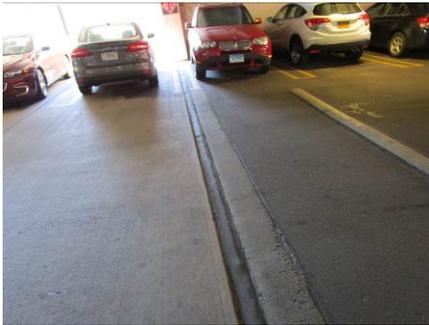
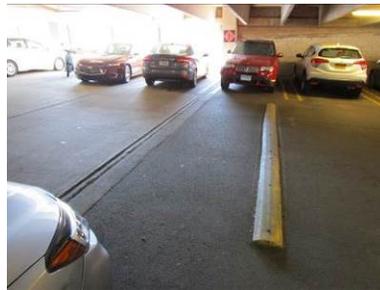
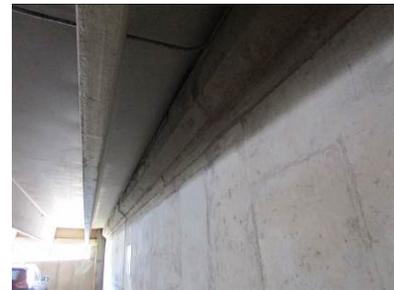
- An expansion joint is currently installed on the first level, where the asphalt meets the supported deck (**Photos #62, #63 & #64**). Expansion joints are typically created within a structure to allow for thermal movements within the structure in response to ambient temperature variation and are also sometimes necessary to separate structural elements which are anticipated to move contrary to one another due to differential settlement or potential seismic activity. These expansion joints need to be closed off to prevent water infiltration through the joint opening or to allow for a smooth transition between adjoining

structural elements; typically, a flexible material or gland is designed to handle the extent of movements experienced. These glands can be comprised of any number of materials and need to be tough enough to handle vehicular and/or pedestrian traffic as may be required and still allow for unimpeded pedestrian access. DESMAN recommends that this joint be replaced with a new heavy-duty expansion joint gland.

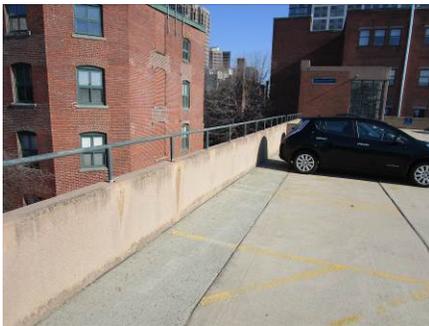
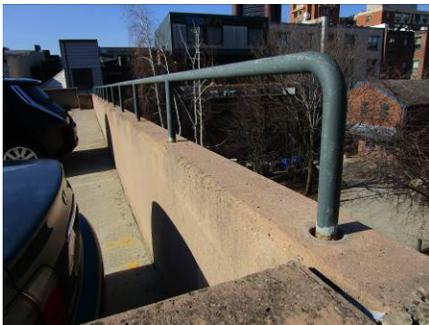
- The existing perimeter railing system currently does not provide appropriate pedestrian protection systems (**Photos #65 & #66**). While DESMAN assumes that the existing systems was installed per Code at the time of construction, and therefore exempt from current requirements and updates, DESMAN recommends that the existing railing system be removed and replaced with a new railing system per current code requirements, with no gaps or openings greater than 4 inches.
- Although the handrail/guardrail systems throughout the stairs generally remain in good condition, DESMAN observed miscellaneous, minor corrosion throughout the stairs (**Photos #67, #70 & #71**); DESMAN recommends that the deterioration be monitored and repaired as required, programming priming and re-painting the stairs on a regular basis.

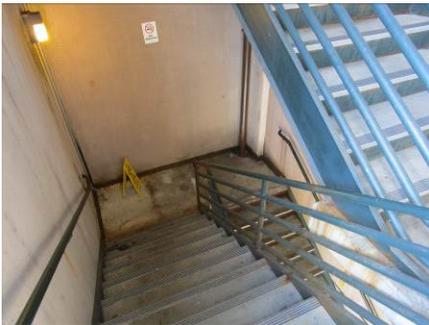
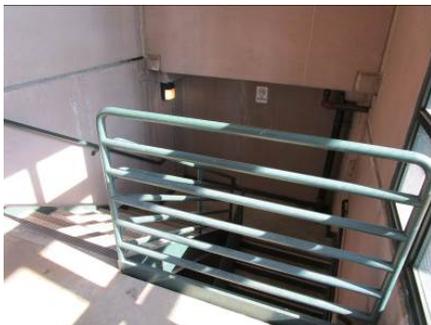
DESMAN also observed, however, that the railings do not appear to be in compliance with current Code (**Photos #68 & #69**); as DESMAN understands, the applicable Code specifies that handrails are to be provided at 2'-10" from the surface of the floor with guardrails at 3'-6", as well as no openings be greater than that which would allow a 4" diameter sphere to

pass through. Although DESMAN assumes that the railing systems were installed in compliance with the applicable Code at time of construction (and thus may be exempt from current requirements), DESMAN recommends that the railing systems be considered for modification and/or replacement to comply with current Code requirements.

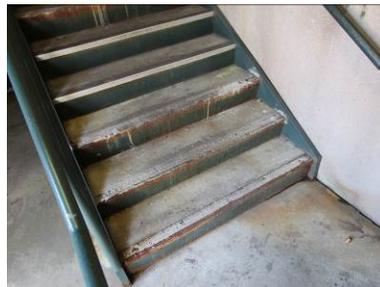
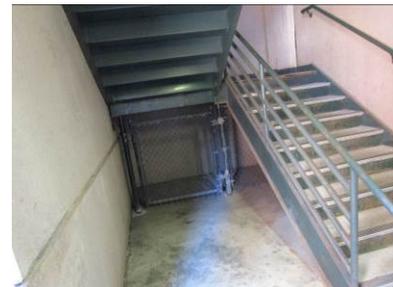
DESMAN also recommends that the railing/guardrail system be extended to terminate at the lower level's wall (**Photos #72 & #73**). The configuration of the stairs results in a space below the last flight of steps, which, due to the lack of visibility may be difficult to maintain. DESMAN recommends that a locked gate be installed within the guardrail to allow access to the space as required.

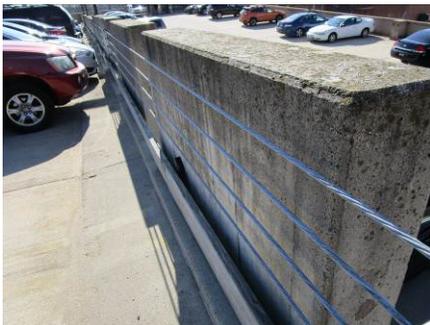
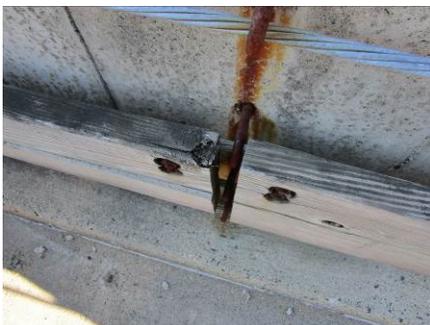
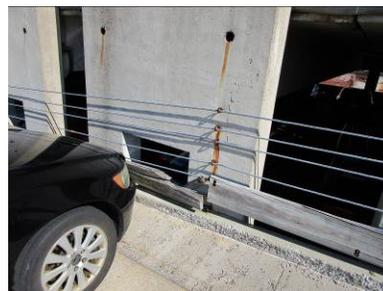
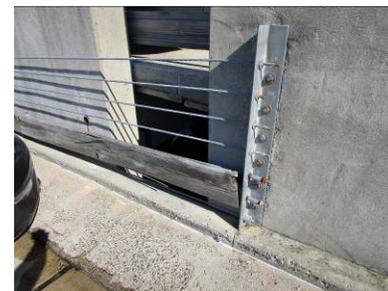
- The cable systems are in dis-repair and no longer properly tensioned, and the wood boards installed throughout the garage, acting as vehicle protection, are in various states of disrepair as well (**Photos #76, #77, #78 & #79**). In order to continue to provide appropriate vehicle protection, the cables should be re-tensioned and wood boards should all be replaced. As an alternative, however, to avoid the future need to maintain the tensioning of the cables and replacing cracked wood boards, another option could be to install a more traditional highway-type guardrail with metal screen-infill for pedestrian protection (PNH has installed similar types guardrail systems elsewhere, that have proven to be appropriate and durable long-term).

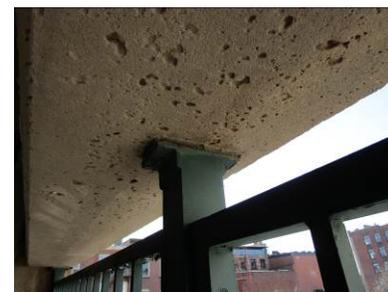
Photo #82

- Decorative metal fencing has been installed along the perimeter of the garage. Although generally in good condition, certain portions of the fencing has been damaged, and the various mountings have been exposed to moisture and are exhibiting corrosion. DESMAN recommends that the fencing system be monitored for repair and re-painted on regular intervals; a cove joint can be installed around the base of the posts to protect the metal (**Photos #80, #81 & #82**).

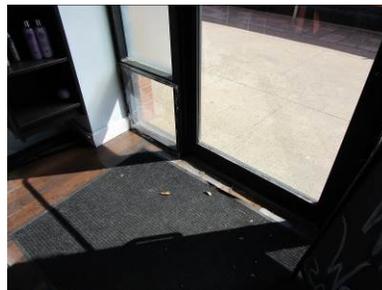
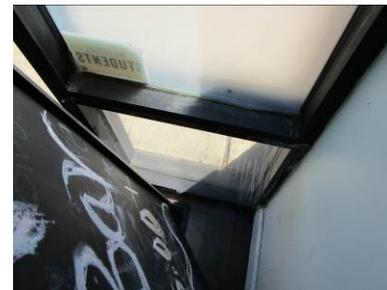
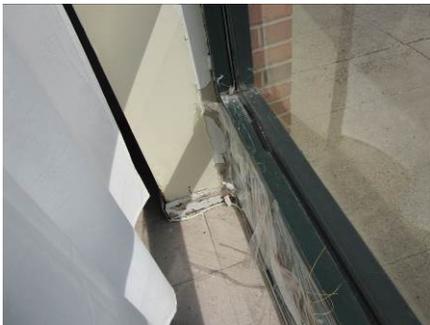
The storefront systems, of the tenant spaces, are aged and showing indications of leaking and water penetration (**Photos #83, #84, #85 & #86**); moisture damage to the flooring was observed. DESMAN recommends that these systems be replaced with new storefront systems.

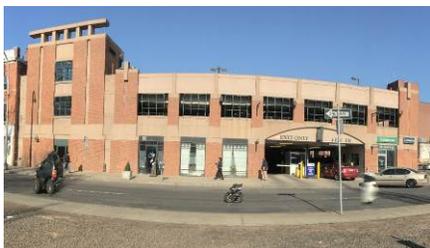
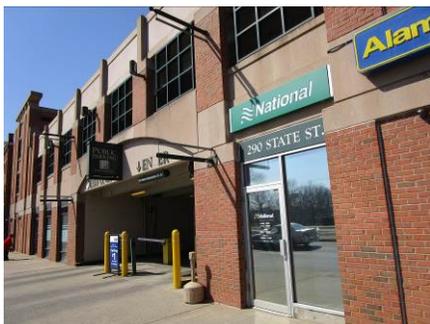
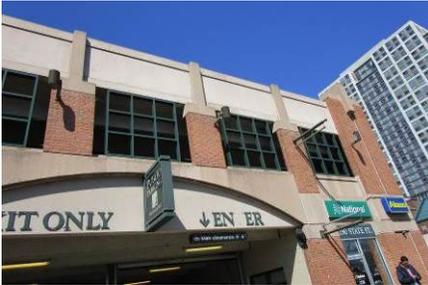
The entrance and façade of the 270 State Street Garage along State Street has become aged (**Photos #87, #88, & #89**). Although architecturally unique in conjunction with its twin on George Street, recent and ongoing changes in the immediate area continues to provide a challenge for the garage to stay current.

In conjunction with ongoing development in the area, additional opportunities have developed that could assist in revitalizing the garage. Enhancements, such as incorporating signage and lighting into a unifying architectural element, additional lighting to accent and identify the tenant spaces as well as the pedestrian entrance from the street, creation of new tree planting zones along the sidewalk as well as new planting locations across the façade with metal trellis to accommodate vegetation growth, could assist in transforming the garage (various concepts as follows).

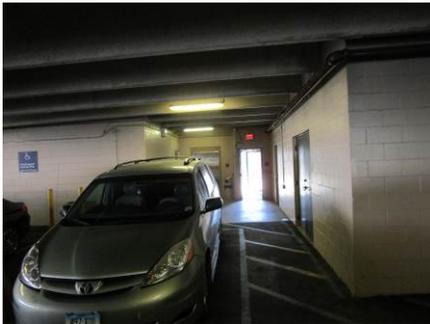
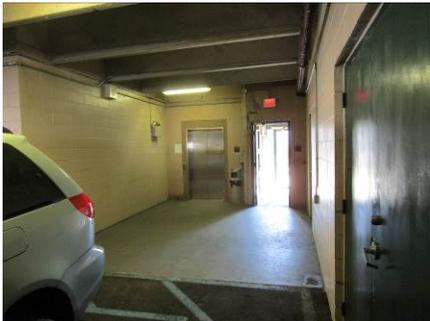
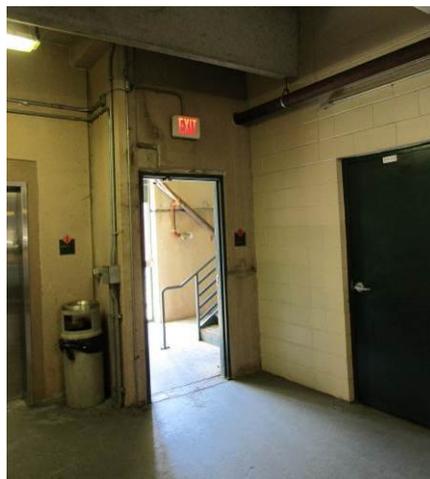
The ground level stair & elevator lobby serves as the primary first impression as patrons enter the garage from State Street, but this portal has become aged and is in need of a modern update (**Photos #90, #91, & #92**).

Enhancements, such as incorporating decorative accent lighting, installation of a new decorative but durable flooring system, utilization of identification colors and/or graphics along with cove-mounted wash lighting, installation of a mural (or decorative mosaic or illuminated panels, to integrate the history of Ninth Square, could assist in transforming this area and the patron experience (various concepts as follows).

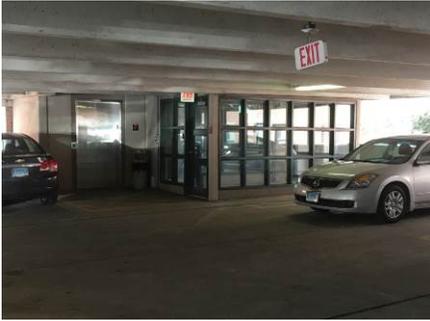
Photo #93

The lobbies on the typical levels are also aged and would benefit from updating (**Photo #93**), but, considering the existing outdated storefront configuration, provide opportunities for significant enhancements.

Enhancements could include decorative and accent lighting incorporating a ceiling element to conceal the conduit and integrating wall wash lighting, installation of a new decorative but durable flooring system, modification and/or replacement and/or limited removal of the storefront systems (since doors/storefront enclosure systems are no longer required for stairs in an open parking structure) with new systems but incorporating local and/or historic artwork related to Ninth Square (various concepts as follows). DESMAN understands that this work would be subject to funding, and so DESMAN recommends that NHPA program this work accordingly.

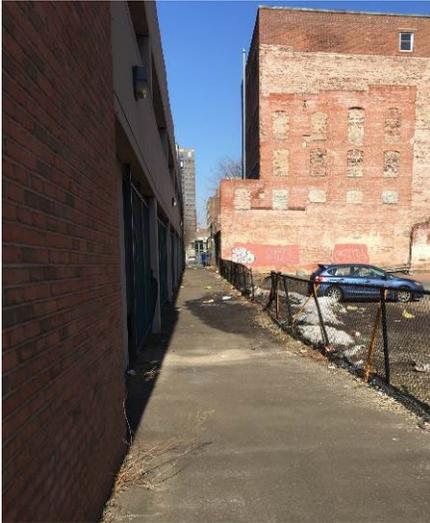
Photo #94

The existing pedestrian walkway adjacent to the garage is currently under-utilized, due to aged fencing, deteriorated asphalt and a gate preventing access to the courtyard (**Photos #94, #95 & #96**).

DESMAN recommends that this pedestrian corridor (leading to the adjacent Courtyard) be enhanced and coordinated to provide a continuous experience. In conjunction with potential improvements to the Courtyard, enhancements could include replacing the asphalt with a decorative concrete, installation of decorative fencing incorporating new plantings, a screen, or a structural lighting element integrating the Ninth Square history along with intermittent translucent illuminated history and/or art panels, all highlighting this pedestrian corridor (various concepts as follows).

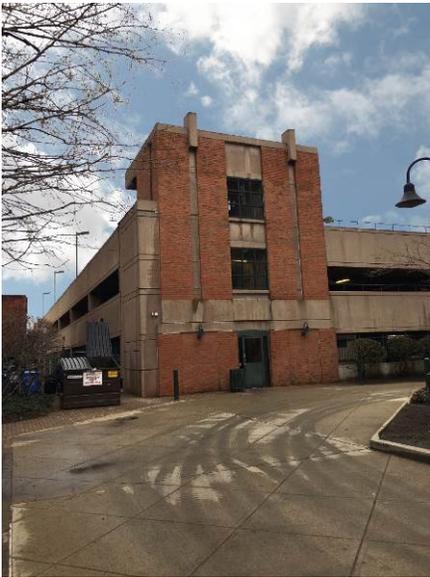
Photo #100

The rear stair & elevator tower serves as a secondary but can be a first impression as patrons enter the garage from the rear Courtyard (**Photos #100 & #101**), but this portal has become aged and is in need of a modern update as well.

Enhancements, such as relocating the dumpster, removal of the gate to allow a continuous pedestrian connection, incorporating decorative accent lighting and signage to emphasize the pedestrian entry, could assist in transforming this area and modernizing this portal and patron experience (various concepts as follows).

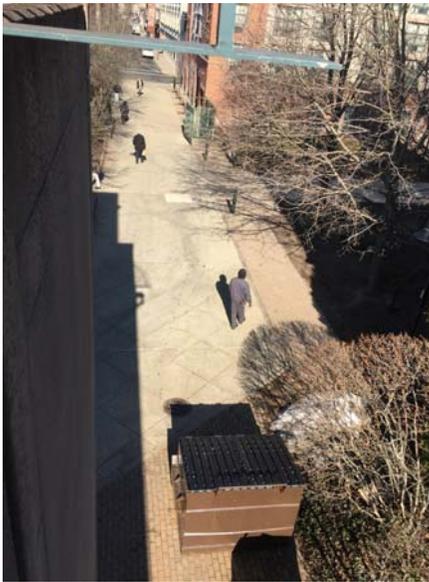
Photo #102

In conjunction with enhancements to be considered for the rear stair and elevator tower, the adjacent Courtyard also could benefit from updates and enhancements (**Photo #102**).

Enhancements, such as replacement of portions of the existing concrete walk with stamped and/or decorative concrete that is appropriate for a pedestrian pathway, creation of new and/or additional plantings (or a planting zone) and/or screen walls along the border with the adjacent buildings, installation of a free-standing sculptural lighting element (and/or tree sculpture, translucent panels, etc.) along the pedestrian path relating to the history of the City and/or surrounding neighborhood, relocate the existing dumpster and trash receptacles to allow a continuous pedestrian connection to the corridor adjacent to the garage, all could assist in transforming this area and modernizing this Courtyard and patron experience (various concepts as follows).

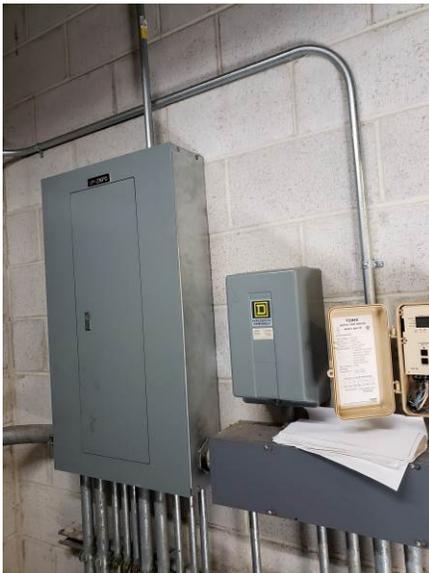
Photo #103

The main electrical service (**Photos #103 & #104**) for the garage is a 208 volt, 3-phase, 400 amp system with a fused main switch and single section main distribution panel. A single 175 amp garage sub-panel is located in the main electrical room near the southeast corner of the garage. This room also has electrical equipment which appears to serve the two tenant spaces (labeled National and 282 State). The 282 State service is UI metered separately from the garage service, but the National panel appears to only have a non-utility customer meter.

While most of the electrical distribution equipment apparently dates from original construction, it apparently has been kept dry and does not appear to be damaged. Interior inspection and infrared testing of the equipment is recommended, however, but the equipment can be assumed to have at least 15 years of useful life remaining.

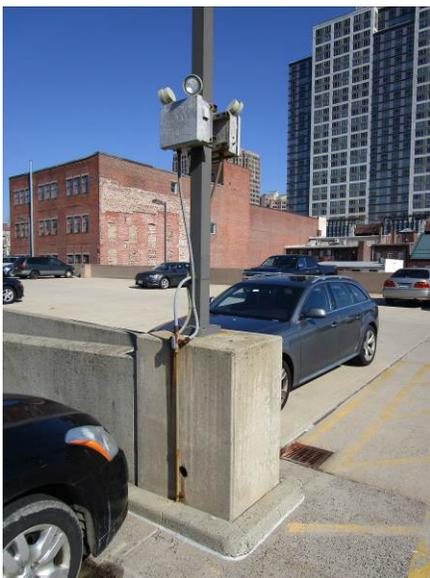
Photo #105

Electrical Distribution: The original electrical conduit installation in the garage was performed with rigid galvanized steel (RGS) using malleable iron straps with clamp backs. Although the majority of the conduit appears to still be in good condition, miscellaneous deterioration does exist throughout and should be replaced. The conduit is primarily surface mounted rather than embedded, except the conduit serving the roof level light poles (**Photos #105 & #106**), and thus is readily accessible for the most part.

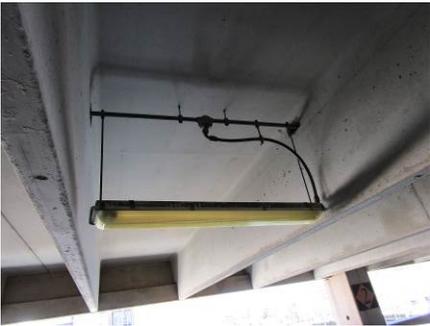
Photo #111

Lighting Replacement with LED: The general garage lighting consists of 4-foot, 3-lamp, vapor-tight fluorescent fixtures with fiberglass housings, and are currently spaced on approximately 30' x 30' centers (**Photo #111**). Although our observation of the garage occurred during the daylight hours and therefore were limited in allowing for meaningful measurements of the current light levels, the fixture type and spacing indicates that these levels would only be marginally acceptable by current IES standards and below the enhanced safety levels expected by NHPA.

The fixture housings, although generally in good condition with only a few outages, many of the acrylic lenses were significantly yellowed due to UV exposure. This yellowing will worsen the already low light level condition of the garage.

There are a reasonable number of good quality LED garage lighting fixtures currently available at this time, and many of these fixtures have a proven track record of reliability and good photometric performance. Use of LED lighting will reduce energy use and maintenance expenses and based on these factors, DESMAN recommends that LED lighting be considered for use when the existing garage fixtures near the end of their useful life.

While replacements for the fluorescent fixture lenses are likely still available and LED replacement lamps could be retrofit into the fixtures, we recommend that full replacement of the fixtures with LED garage fixtures be programmed in the near future; retro-fit solutions are available, but these raise concerns with UL Listing and they do not typically have the same efficiency levels as dedicated LED fixtures. LED garage fixtures can be more easily controlled via occupancy sensors, daylight sensors and dimming controls. Such control enhancements can significantly increase the energy savings realized by use of the fixtures but must be carefully evaluated during design to ensure that they are a proper fit for the facility. Most enhanced control strategies will either require the installation of separate control wiring or local controls on each fixture.

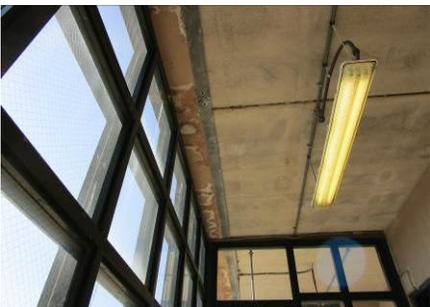
Photo #112

The stairwells are lit with a combination of vapor-tight fluorescent fixtures matching the garage style and wall-mounted high pressure sodium fixtures (**Photos #112 & #113**). These should be considered for replacement whenever the garage fixture replacement is done.

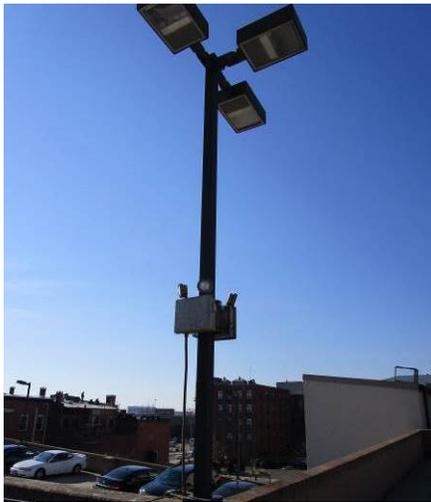
Photo #114

The roof is lit using four twin-head high pressure sodium pole lights (**Photo #114**). The fixtures are shoebox style with a slight up-tilt. The poles are approximately 12' high and mounted to the extended interior columns of the garage. Replacement of the fixtures should be considered when the main garage lights are done.

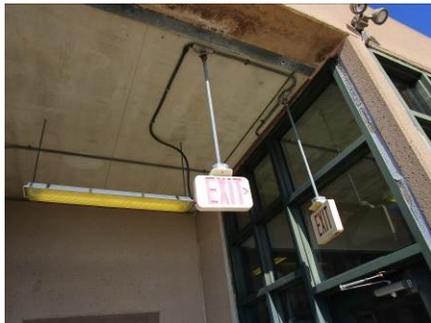
Photo #115

Exit signs (**Photo #115**) are located appropriately in the garage to mark egress paths. The signs are in fair physical condition but testing of the battery function was not performed. The signs utilized are polycarbonate housing style which will not stand up to physical abuse and are more susceptible to moisture issues. A full test of the exit sign emergency function is recommended.

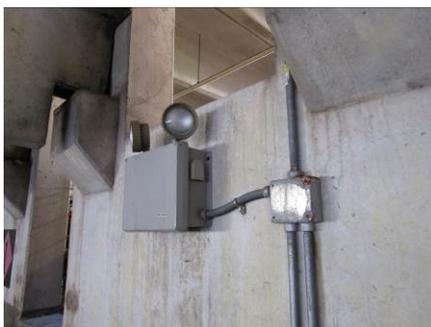
Photo #116

Emergency lighting (**Photos #116 & #117**) is provided throughout the garage and the stairwells with wet location rated twin-head battery units. These units are in fair physical condition, but several that were tested did not function. It is likely that the unit batteries have failed due to lack of maintenance. In the general garage area, these battery units are located along the center column line. This location will prove ineffective at providing a reliable path for pedestrian traffic, especially when vehicles are parked in the center stalls.

Immediate testing and battery or other parts replacement should be considered. Full replacement of the battery units with the addition of remote heads in the drive aisle should be programmed within the next 5 years.

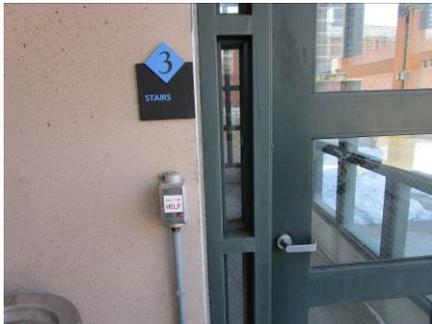
Photo #120

Security Systems: There is an emergency call-for-aid system, as well as audio monitoring devices, located throughout the garage with call stations and speakers located near the stairwells on each level (**Photos #120, #121, #122 & #123**). The system does not appear to be ADA compliant and it was not tested. While this system is not mandatory, proper operation and monitoring of the equipment should be verified. Subsequently however, considering the age of the existing system, replacement of the system should be considered which would result in a new and updated system fully compatible with PNH's operations elsewhere.

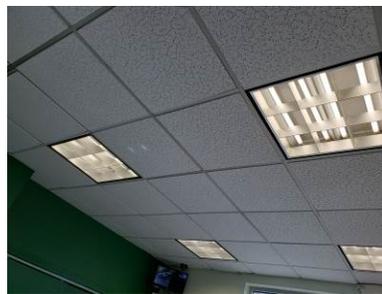
Photo #118

While there may be opportunities to improve and/or enhance the lighting in the tenant spaces (**Photos #118 & #119**), we understand that maintenance/replacement of those light fixtures is a tenant responsibility.

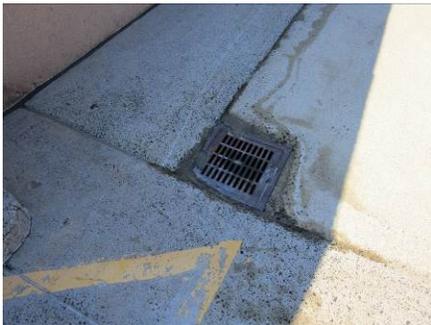
Photo #124

Drainage: The current drainage system consists of floor drains serving the roof and intermediate level drains (**Photos #124, #125 & #126**), all of which are currently combined and piped to the City Storm Sewer. In accordance with current WPCA's requirements for parking garage drainage, intermediate level drains are to be separate from the roof drainage system and subsequently discharge to the City's Sanitary Sewer via a sand/oil interceptor; roof drainage may continue to drain to the storm sewer. DESMAN therefore recommends that a sand/oil interceptor be installed, and roof drainage and intermediate level drainage be separated accordingly.

At that time, due to their deteriorated condition, all floor drains should be replaced. The piping appears to be in serviceable condition however miscellaneous replacement should be anticipated, along with new pipe supports.

This work is currently scheduled to be performed as part of NHPA Project No. 20-005, currently in design.

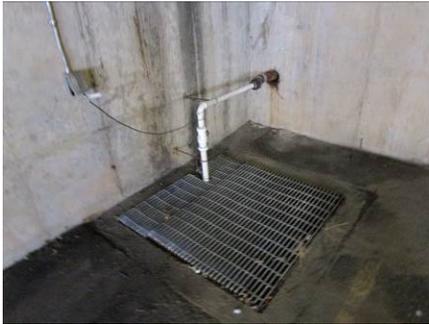
Photo #127

A sump pump (**Photo #127**), installed at the lower parking level below grade, supports drainage from the lower level deck drains. It is not known what the reliable condition of the pump currently is, but due to the water level in the sump observed near the top of the pump, it appears that the pump is not operable. The pump appears to be a common 120v unit connected to a GFI plug-in receptacle; DESMAN therefore recommends that the pump be replaced with a new one. At the time of replacement, in accordance with WPCA's requirements, DESMAN recommends that the pump be disconnected from the storm system and routed to the City's sanitary sewer via the new sand/oil interceptor.

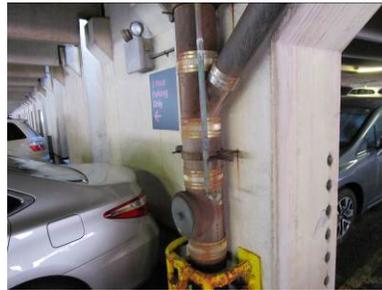
Photo #131

Hose bibbs are located on each level for washdown of the facility (**Photos #128, #129, #130, #131 & #132**). The hose bibbs appear to be in serviceable condition, however there appears to be damage by freezing of the cold water distribution piping. The full extent of the damage is uncertain due to insulation wrapping the piping. DESMAN recommends that the system receive a full-pressure test to confirm its condition and serviceability. However, it is unlikely that the pressure available from the domestic water system is adequate for effective washdown of the parking decks, to fully remove all dirt, oil, residual ice-melt materials, etc.

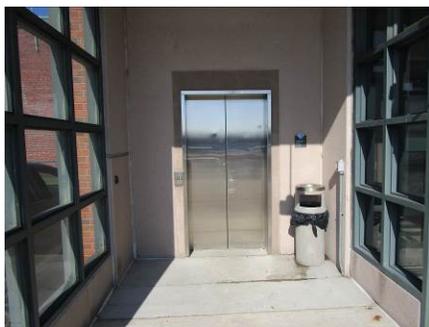
Photo #133

The (2) in-ground hydraulic passenger elevators (**Photos #133, #134, #135, #136 & #137**) were installed in 1993 and appear to be original to the garage's construction, inclusive of mechanicals, controllers, power units, in-ground cylinders and plunger assemblies. Based upon an average useful service life of (25) years from date of installation, the elevators have reached the end of their useful service life, and therefore should be programmed for modernization accordingly.

In conjunction with modernization of the elevators, temperatures are maintained in the Elevator Machine Room by an electric unit heater and an exhaust fan, and are controlled by separate thermostats. The exhaust fan maintains space temperature during periods of high elevator use by exhausting the space with ducted makeup air drawn from outside providing what cooling is available depending on the outside air temperature. Both the exhaust and makeup air ducts are provided with motorized dampers to isolate the space from the outdoors when the fan is not running. Cooling elevator control equipment in this manner is no longer considered acceptable because the space temperature and humidity cannot be maintained within the parameters required for the elevator control equipment, especially

when newer electronic controls have been provided. DESMAN therefore recommends that upgrade of the HVAC system be considered as part of the modernization program. In the meantime, DESMAN recommends that the existing fan heater and motorized dampers be tested for proper operation and repaired/replaced as required.

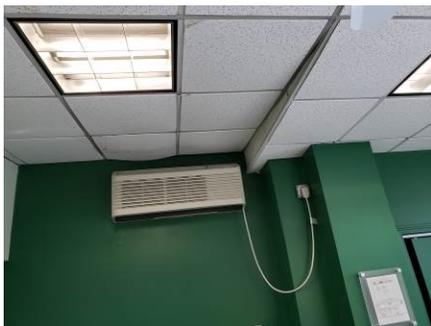
Photo #139

Tenant Space HVAC: HVAC for the Car Rental Office consists of a thru-wall air conditioning unit with electric heat (**Photos #139 & #140**). The age of the unit is unknown, but it appears to have been replaced at least once. A replacement for this type of unit is apparently readily available and so DESMAN recommends that it be replaced accordingly when needed.

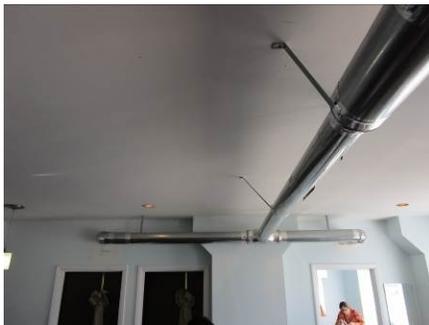
Photo #141

The second tenant space at the front of the facility is currently occupied by a hair salon and is provided with heating and cooling by a split system heat pump with supplemental electric heat, along with a ceiling exhaust fan to exhaust the toilet room to the outdoors (**Photo #141**). The equipment appears to be 5 to 10 years old and apparently is in good condition with approximately 10 years of useful life remaining. The owner of the salon commented however that the unit does not maintain comfortable temperatures in the heating season and that a new supply duct was added to the Heat Pump System to improve air distribution.

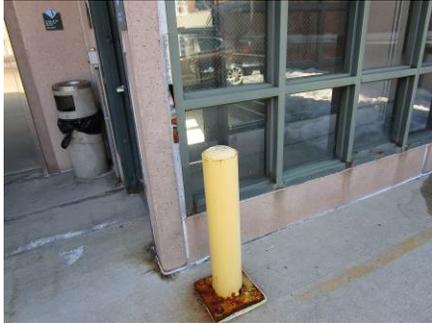
Photo #144

Miscellaneous Metal Surfaces: All miscellaneous metal components should be painted to protect and enhance their useful lives. Metal systems include, but are not limited to, doors & frames, stair systems and railings, bollards, pipeguards, decorative grillwork, etc. **(Photos #144, #145, #146 & #147)**

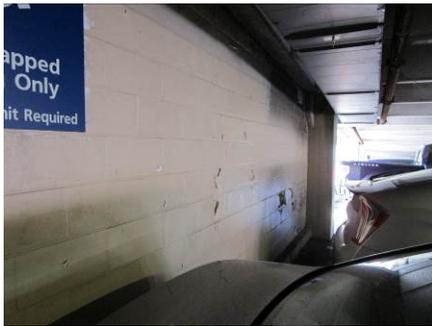
Photo #148

Miscellaneous Concrete & Masonry Surfaces: Various surfaces, essentially consisting of the rear of the tenant spaces, are currently painted **(Photos #148 & #149)**; however, the surfaces are showing indications of failure due to moisture (not unusual in a garage subjected to extensive temperature swings). DESMAN recommends that all currently painted surfaces be programmed for re-painting, but with a paint system appropriate for exterior conditions subjected to significant moisture. At the time of re-painting, DESMAN recommends that objectives be coordinated with applicable architectural enhancements also planned for.

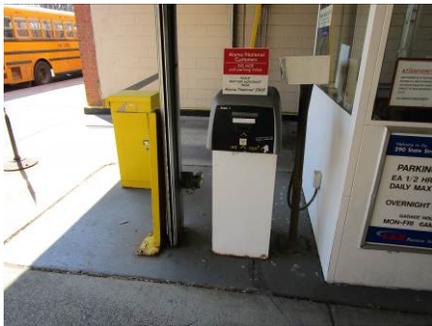
Photo #151

Due to age, improved technology and compatibility with PNH's operations, DESMAN recommends that PNH review the current system for potential enhancements and/or replacement, and plan accordingly (**Photos #150, #151, #152 & #153**).

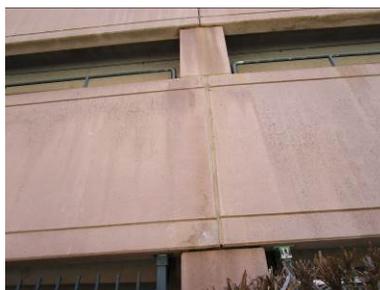
Photo #156

Facade Repairs: The exterior surfaces of the garage appear to be in good condition, however, miscellaneous damage should be repaired, as required; DESMAN recommends that the facade be monitored and the repairs performed on an as-needed basis, including a comprehensive cleaning, replacement of all sealant materials and flashing, removal of excess vegetation (**Photos #154, #155, #156 & #157**).

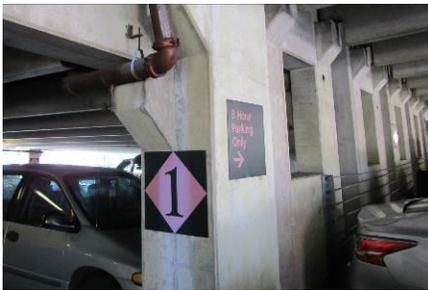
Photo #158

Update of Garage Signage: Although the garage is a simpler type of facility and wayfinding requirements of the garage are comparatively limited, opportunities for updating and modernizing do exist, especially in conjunction with new development occurring within downtown New Haven, designating the facility as a parking garage and directing patrons to park in this facility.

In conjunction with NHPA's branding of the facility as well, the existing exterior identification signage can be refurbished and updated with new sign box materials and new graphic faces to be more in keeping with NHPA's logo and graphic standards.

At the time of signage improvements, DESMAN recommends that objectives be coordinated with applicable architectural enhancements also planned for **(Photos #158, #159, #160, #161, #162, #163 & #164)**
