**CONDITION APPRAISAL
(FY 2020)**

**AIR RIGHTS PARKING GARAGE
NEW HAVEN, CONNECTICUT**

**NEW HAVEN
PARKING
AUTHORITY**

NHPA PROJECT NO. 20-001
DESMAN PROJECT NO. 20-19171.00-2

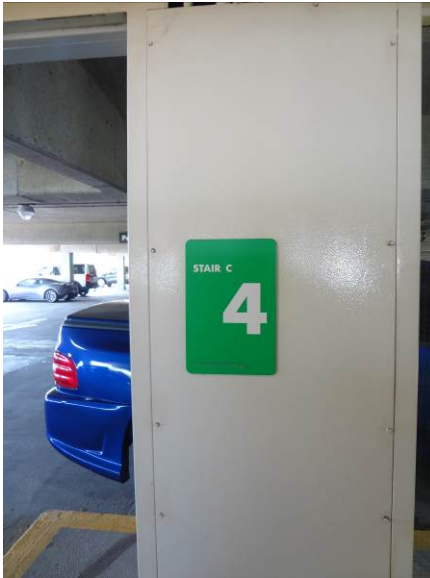
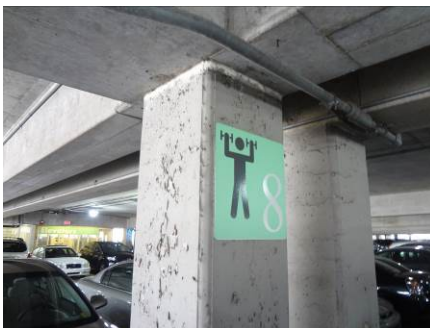
Photo #1

DESMAN makes special note that certain repairs deemed necessary over the next five years are now coming due. Certain significant increases are associated with a full replacement of the signage program (**Photos #1 & #2**) as well as various streetscape improvements along South Frontage Road and Rev. Dr. Martin Luther King Jr. Boulevard to improve the pedestrian experience around the garage. There have also been modifications made to account for changes in the condition of the garage, adjustments in the work envisioned (as requested by NHPA staff), changes in economic climate, and changes in the scope of repairs being recommended by DESMAN which are based on currently observed conditions.

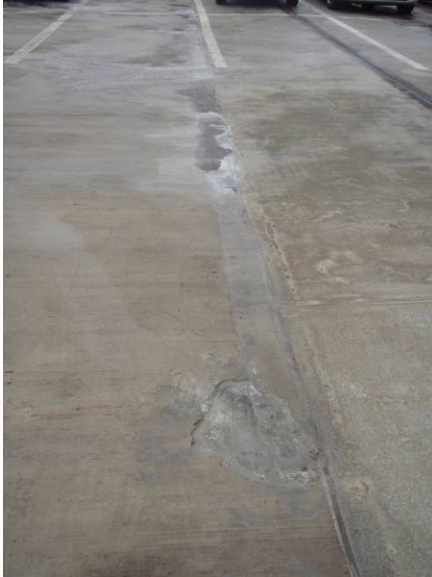
**Photo #3**

While partial depth concrete deck repairs have been performed historically (**Photos #3 & #4**), a designated amount of deck repair was addressed as part of the comprehensive repair program of 2011/2012, with additional work in 2015/2016 and continued again in 2016/2017 as well as season (2017/2018) and (2018/2019), a process which should continue to be expected in the future to keep this structure in good condition. As we have indicated previously, this facility's lack of concrete cover and the extent of chloride contamination will continue to result in ongoing corrosion and concrete deck deterioration, so a program to keep it in check is necessary. NHPA should continue to plan to perform repairs at approximate two year intervals, and monitor the performance of the corrosion inhibitor. The projected five year repair costs have been adjusted accordingly.

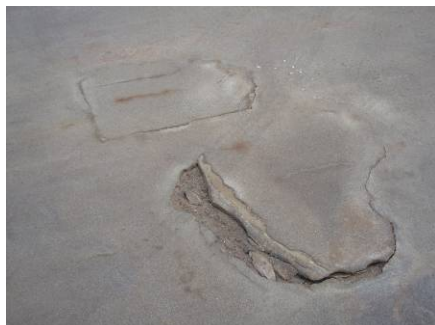
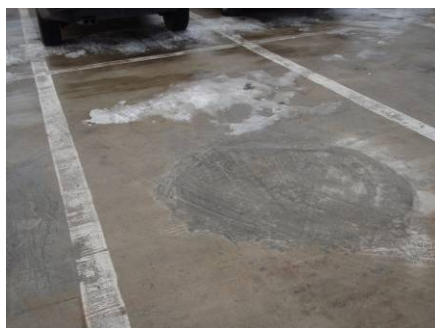
Photo #19

Concrete Deck Repair: Visual observation and sounding of the supported decks shows that previous repairs are performing well, but additional limited areas are showing signs of deterioration. As noted in previous reports, limited amounts of concrete delamination continue to be identified throughout the garage (**Photos #19 & #20**); the majority of this deterioration continues to be found on the facility's roof level, the exposed cantilevered ends of the structure's lower levels, and in high traffic areas such as on the facility's central access ramps between levels.

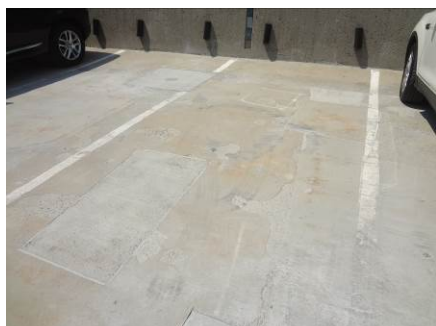
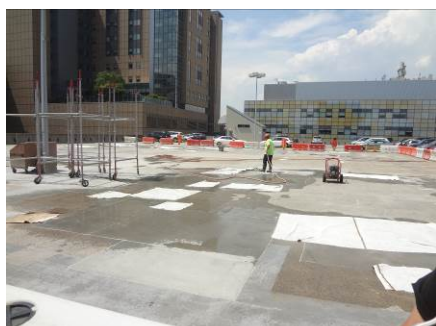
Photo #22

While significant areas of deck delamination were addressed in 2007 and 2008 as well as some additional repairs being performed in 2012, 2015, 2016, 2017 & 2018 (**Photos #22 & #23**), the nature of this deck, with its elevated level of chloride contamination and a demonstrated lack of sufficient concrete cover, will continue to

experience concrete deck deterioration. Since NHPA continues to program the application of a corrosion inhibitor and the installation of supplemental drains to eliminate areas of standing water, DESMAN continues to recommend that NHPA budget for the implementation of structural deck repair over the next 5 years. This item of work should be reviewed each year as part of the condition assessment program to determine how well the decks continue to perform and the repair quantities adjusted accordingly.

Typically, NHPA has planned to perform repairs at approximate two year intervals and DESMAN recommends that NHPA continue to do so. In the interim, though, Desman recommends that NHPA prepare to address minor “potholes” that may appear, thus minimizing the chance that the “potholes” expand to become a larger and more expensive repair. Therefore, DESMAN recommends that “pothole” repair be programmed and NHPA budget accordingly.

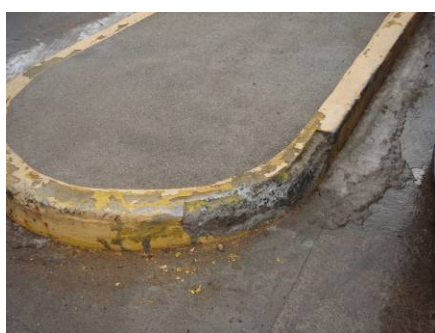
Photo #25

Miscellaneous Concrete Curb Repair: Although minor in nature, DESMAN recommends that miscellaneous curb repair be programmed. With any concrete parking structure, miscellaneous damage by vehicles and snow removal equipment, as well as other conditions exist (**Photo #25**), which are likely to result in the need to implement repairs periodically.

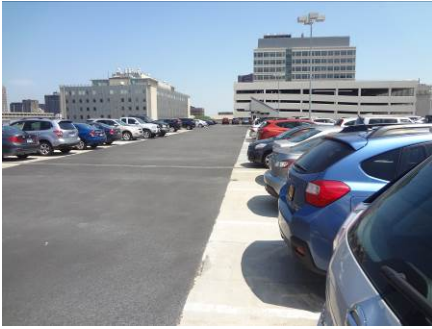
Photo #28

Repairs recently implemented in the current repair program will address additional waterproofing membrane problems identified (**Photo #28**), but the nature of these surface-applied waterproofing membranes dictates that periodic repairs and reapplication will always be required. This work is currently scheduled to be performed as part of NHPA Project No. 20-002, currently in design.

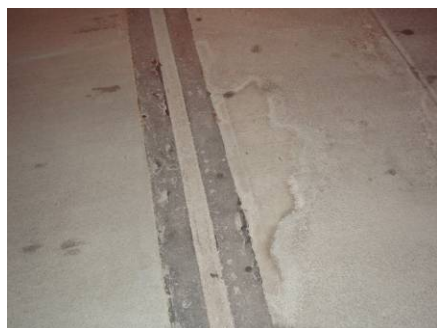
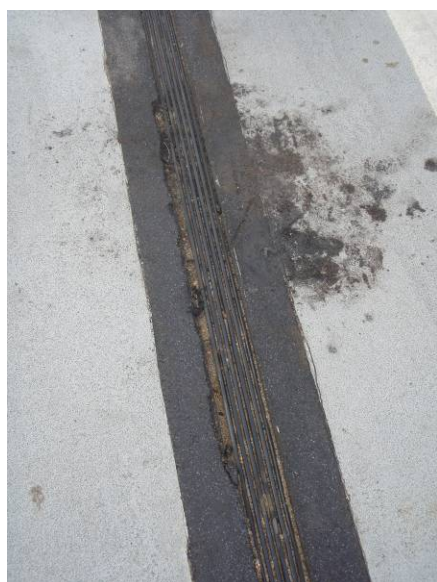
Photo #29

Repair / Replace Expansion Joint: Visual examination of expansion joint seals and expansion joint nosings indicates that the majority of the expansion joints are in relatively fair condition, but they are not being well maintained (**Photos #29 & #30**). The longevity of expansion joint seals requires the periodic removal of accumulated sand, grit and debris which can accumulate within the folds of the joint. This accumulated debris prevents proper joint movement and vehicles traversing across the joints tend to grind debris into seals wearing them prematurely. A limited amount of repairs to expansion joints was performed in 2007 and 2008, and additional programmed repairs to the facility's expansion joints were included as part of the comprehensive repair programs of 2010 and 2012, with subsequent joints replaced in 2018 as part of NHPA Project #13-002. Further replacement is programmed for the future.

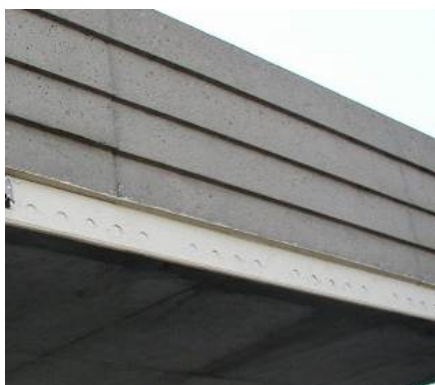
Photo #33

Recoating of P/T Anchorages: The P/T (post-tensioning tendon) anchor points located around the perimeter of the garage were protected with an architectural waterproofing material (Modac®) approximately 15 years ago (**Photos #33 & #34**), and this material has performed extremely well, showing little or no significant deterioration of the coating material or the underlying anchors. Even though no problems have been identified, as a preventative maintenance, DESMAN had included the costs of recoating the concrete along the perimeter strips at the anchorages within our estimated repair and preventative maintenance costs; this work was completed as part of NHPA Project No. 12-002.

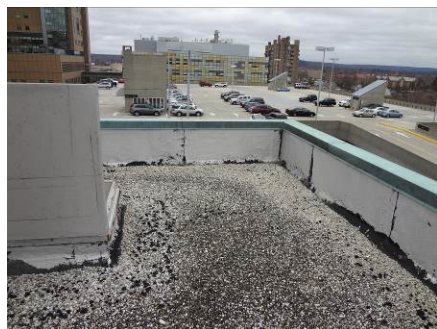
Photo #35

Roofing Repairs at Stairs and Elevator Cores: Although no significant water or moisture infiltration has been identified indicative of a problem with this facility's various roofing, the roofs are all original to the facility, and various components are exhibiting their age (**Photo #35**). Related roofing repairs, such as the replacement of the copper coping materials and re-securement of the batten closures, was recently completed as part of NHPA Project No. 13-002.

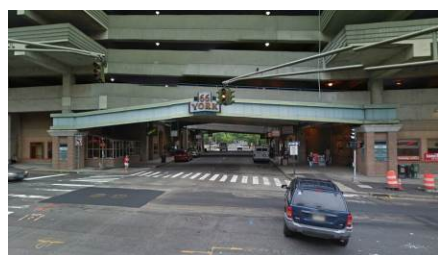
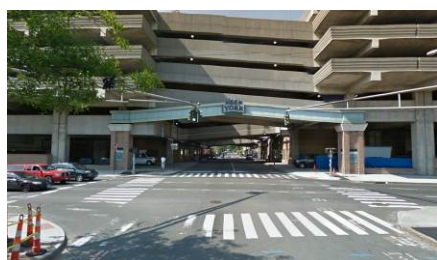
Although the original construction of the Air Rights Garage in 1982 represented a significant milestone and enhancement for the gateway to the City of New Haven at the time, the façade of the garage has become aged (**Photos #36 & #37**). The recent and ongoing development in the immediate area continues to provide a challenge for the garage to stay current; the massive size alone of the garage presents a significant hurdle since any improvement work would have to be large enough to provide an impact but yet be cost-effective.

Recently, with NHPA's re-branding efforts fully underway, additional opportunities have developed that could assist in revitalizing the garage. Enhancements, such as replacing the gateway architectural forms, as well as signage and lighting, combined with rebranding graphics as well as installation of a sculptural screen cladding over the central ramps, could assist in transforming the garage (various concepts as follows).

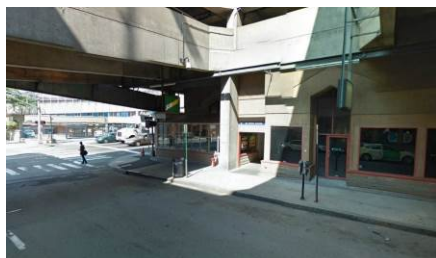
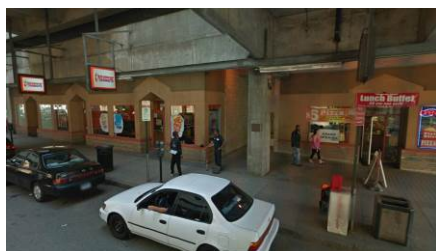
In conjunction with improvements to the lobby entrances to the Air Rights Garage and streetscape improvements to the Rev. Dr. Martin Luther King Jr. Boulevard and South Frontage Road, DESMAN recommends that the lobby entrances along with the sidewalks of York Street be considered for improvement (**Photos #38 & #39**). Although the storefronts and related lighting are the responsibility of the tenant owners, the sidewalks can be enhanced with a decorative stamped/stenciled concrete providing an improved aesthetic appeal, as well as localized updated signage and lighting with new materials that can highlight the entrance, making it more visible from the sidewalk (various concepts as follows).

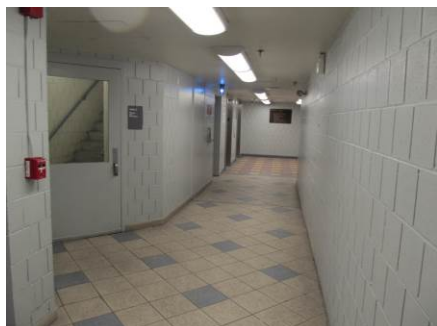
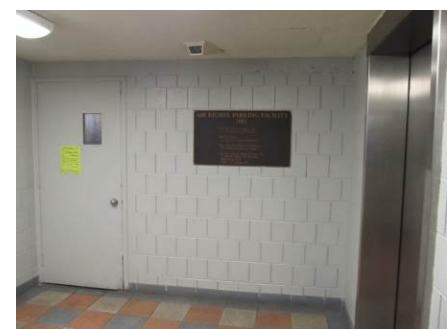
DESMAN does note that the substantial wall surfaces of the lobbies, although painted and bright, appear to be space (**Photos #41 & #42**) that could be enhanced by decorative artwork, paneling, electronic display boards or other related finished system that could further connect the lobbies to the Hospital décor. Additional enhancements, such as accenting with a new material or artwork that draws patrons into the space as well as painting vertical joints in the walls to develop texture and depth, could be programmed accordingly (various concepts as follows); the door at the rear of the Stair G/Elevator 3 & 4 Lobby may be replaced with a more attractive option that is coordinated with the artwork or architectural accent on the wall, as well.

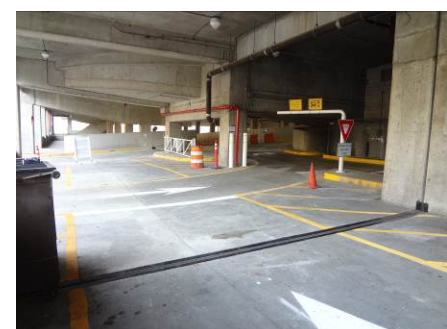
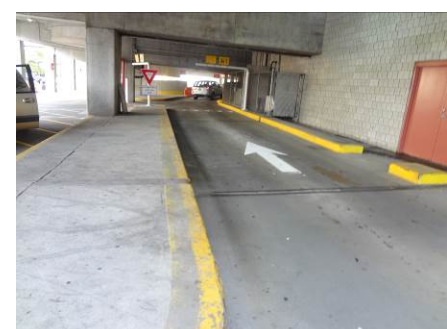
The vehicular entrance from Rev. M.L.K. Jr. Boulevard and York Street has recently been transformed, due to the adjusted entering traffic into the garage from Route 34 (**Photos #43 & #44**). Although the resultant space presents a challenge for significant architectural enhancements due to the busy nature of the space, there may be some opportunity for accented lighting to assist in incorporating the space into the streetscape improvements to York Street.

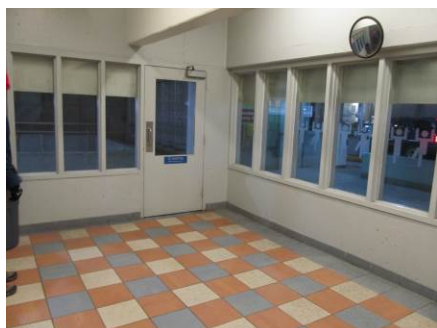
Photo #45

The area surrounding Stair A/Elevator 1 & 2 on the second level provides a larger lobby atmosphere with additional space compared to the other lobby areas, and also presents the patron with the first pedestrian exposure to the Hospital (**Photo #45**). Although a consistent theme has been attempted throughout the lobby spaces, there may be the opportunity to differentiate this space from the others, by refinishing the interior walls with color that contrasts with the ceiling and window mullions/door, as well as updating the visual graphics and provide additional accent lighting.

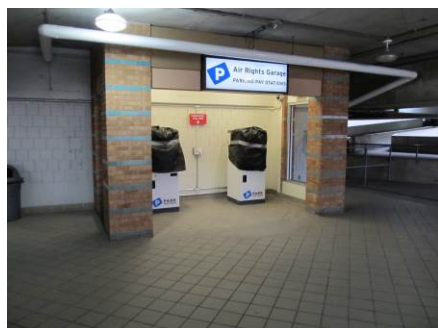
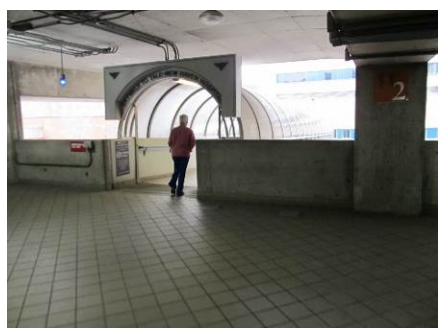
In conjunction with improvements to the second level lobby of Stair A/Elevator 1 & 2, along with the recent creation of a kiosk for new paystations, the space around the kiosk and the connection to the skywalk has become a more substantial gateway to the Hospital (**Photos #46 & #47**), and thus would benefit from certain aesthetic improvements. Enhancements, such as accenting with a new material or artwork as well as updating the connection with new materials that correspond with a new material scheme on street level, could be programmed accordingly (various concepts as follows).

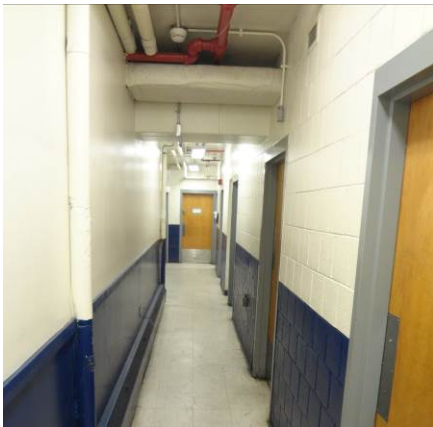
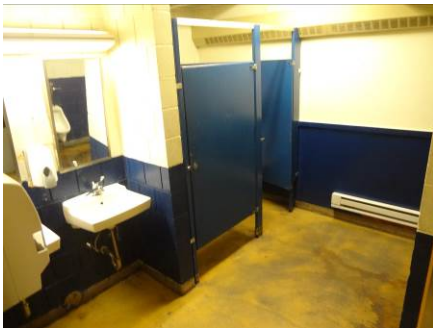
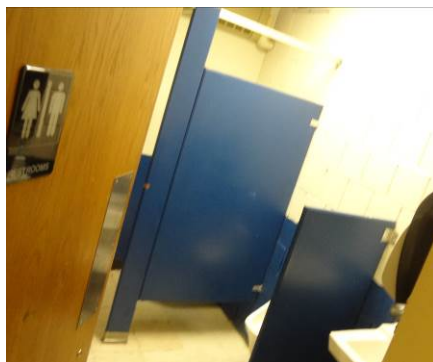
The restrooms, behind the Security Control Room and the Manager's Office would benefit from certain functional and aesthetic improvements, such as new flooring, new lighting, painting, as well as ADA updates as may be required, could be programmed accordingly (**Photos #48 #49 & #50**).

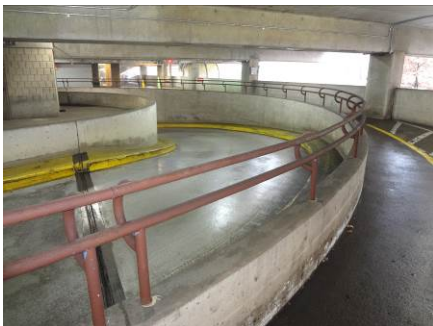
Photo #51

PNH has expressed concern with specific railing systems around the perimeter of the vehicular exit ramps on Levels 1 & 2 (**Photo #51**); due to the height and spacing of the intermediate posts, PNH has requested that modifications be made to minimize the openings accordingly; this work was addressed as part of NHPA Project #12-002.

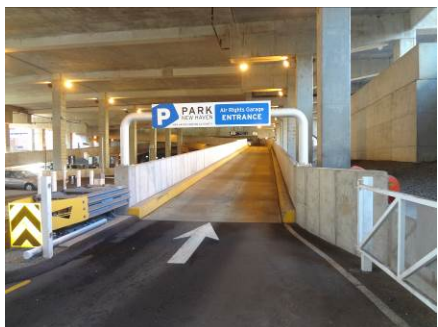
Photo #53

In conjunction with potential improvements to the signage, PNH has observed that incoming vehicles from Route 34 have a potential of damaging the clearance bar assembly at the base of the ramp (**Photo #53**), simply due to their speed and lack of awareness of the posted clearance. PNH therefore has requested that a secondary clearance bar assembly be considered, potentially located at the top of the ramp where vehicles slow down prior to turning into the garage (**Photo #54**), incorporating some form of audio/visual warning as well, such as a horn or blinking light system.

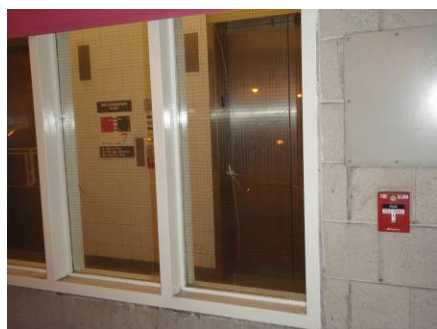
Photo #56

Although designated areas, primarily focusing on the stair towers and elevator lobbies (**Photo #56**), were recently re-painted as part of NHPA Project No. 12-002, additional railings along the street level sidewalks remain (**Photo #57**). DESMAN therefore recommends that these railings be programmed for re-painting accordingly.

Storefront Maintenance/Repair: This work relates to the need to periodically repair damaged or deteriorated sections of metal storefront. The metal storefront can deteriorate due to corrosion and environmental exposure, and can become damaged due to being hit by vehicles, or by vandalism and abuse (**Photo #56**). It should be noted that there were limited repairs performed in 2007 and in 2008 which addressed issues with storefront framing and broken windows (see below).

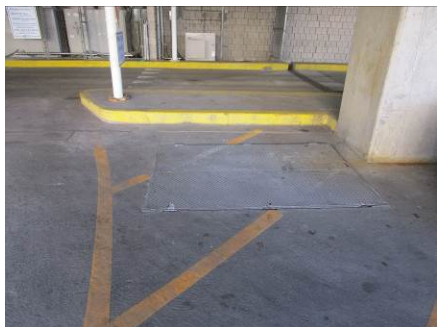
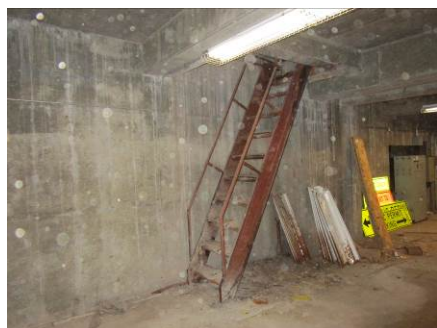
Access Hatches & Metal Stair Replacement (into Mechanical Rooms below): The access hatches on the street level, which allow access into the mechanical rooms below (**Photos #58 & #59**), no longer sit properly into position, thus allowing water and debris, into the spaces below, thus corroding the metal stairs. DESMAN recommends that these stairs be replaced, as well as the hatches also replaced so as to provide full closure and protection.

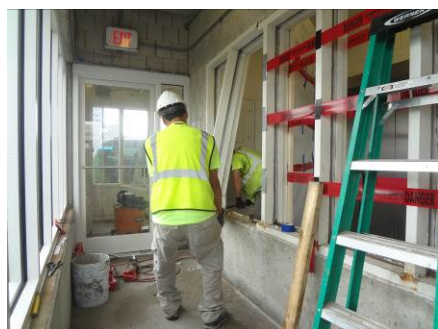
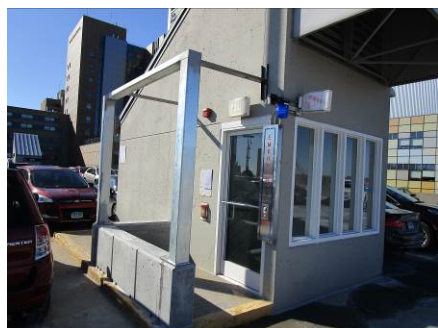
Modifications to Roof Level Storefronts and Installation of Secondary Storefronts at Roof Level Stair Towers: A history of moisture has damaged the lower level storefronts and stairs (reference items above). Therefore, DESMAN had recommended that actions be taken to minimize future moisture penetration into the towers (**Photos #60**

& #61). In order to protect the elevators and minimize moisture into the elevator lobbies, DESMAN noted that the doors, which regularly swing open during high winds (the main culprit of entering water), may be relocated so as to minimize the impact of the wind and rain. In order to protect the stair towers, DESMAN noted that a secondary storefront enclosure may be installed on the curbing, outside the existing doors, to provide a barrier to rain entering the stair. This work was recently completed as part of NHPA Project No. 12-002.

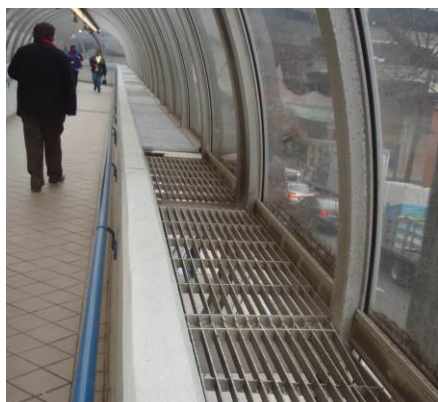
Photo #62

The Skywalk Bridge, spanning South Frontage Road, is demonstrating various stages of wear and tear, such as miscellaneous vertical and overhead concrete spalls, construction and expansion joint deterioration, and miscellaneous cracking (**Photos #62, #63 & #64**). In conjunction with the inspection report performed by CDOT-Bridge Safety, dated November 11, 2011, Desman recommended that all spalled concrete be repaired (**Photo #65**), joints replaced with durable materials suitable to exterior conditions, cracks injected with an epoxy resin to prevent moisture intrusion, cold-galvanizing of exposed metals, followed by the application of a waterproofing coating across the exterior concrete surfaces, which was recently completed as part of NHPA Project No. 13-002.

Other maintenance-related work is associated with the need to periodically repair damaged or deteriorated portions of the pedestrian bridge (**Photo #62**), such as the snow filters installed within the vent openings along the sides of the bridge, hand railings, glazing materials, etc.

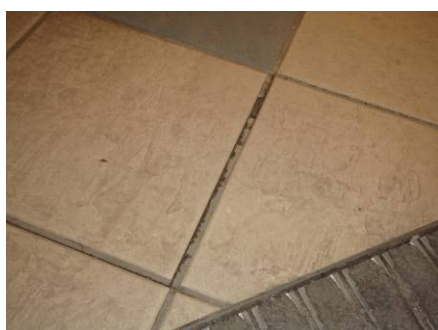
Photo #66

Miscellaneous Flooring Tile Repair: This work relates to the need to periodically repair damaged flooring tile. A limited amount of miscellaneous tile repair was addressed in 2010, but additional repair is anticipated in the future (**Photo #66**).

Although miscellaneous tile repair would typically be considered an operational cost and therefore would not be included as a capital budget item, due to the relation of cracked tile to the apparent electrical conduit embedded in the bridge floor and related magnitude of cost, DESMAN has included the cost in our estimated repair and preventative maintenance costs as a capital budget item. Although certain limited work has recently been addressed as part of NHPA Project No. 13-002 (see photos below), further work was recently completed as part of NHPA Project No. 12-002.

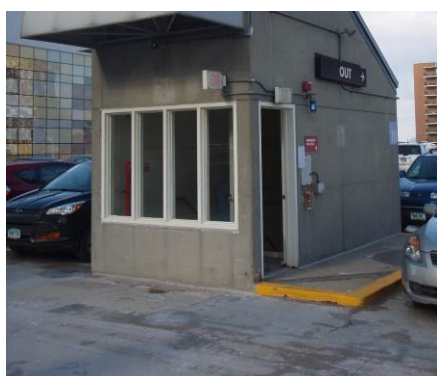
Photo #67

This facility's level of use makes periodic repairs on the remaining doors (essentially limited to the roof level) necessary to address doors which have sprung on their hinges, or to replace missing or damaged door hardware and hydraulic door closers (**Photo #67 & #68**).

It is DESMAN's opinion that door repair is in reality a safety and egress issue and they should be repaired or replaced as an operating expense. DESMAN has, however, included an estimated cost for the periodic repair of damaged doors, some of which may be related to the maintenance and periodic repair of the storefront framing. This work was recently completed as part of NHPA Project No. 12-002.

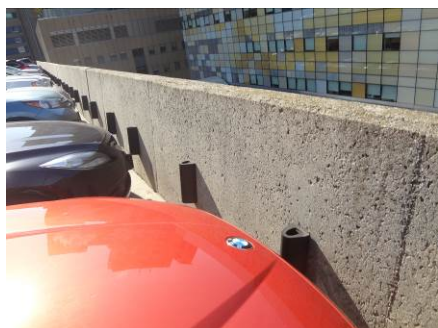
Photo #69

Car Bumper Replacement: The rubber bumpers, installed throughout the perimeter of the garage and at the stair towers acting as vehicle protection, are in various states of disrepair or are lacking completely (**Photos #69 & #70**). In order to continue to provide appropriate vehicle protection, the bumpers should all be replaced.

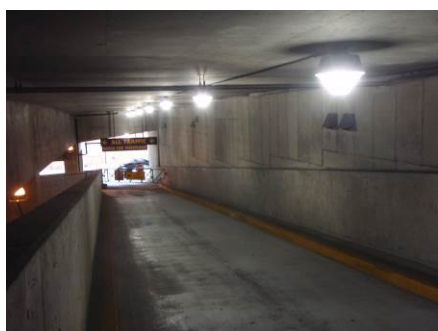
Photo #71

Although the existing metal halide fixtures were installed in 2010 (**Photo #71**), lighting technology continues to improve and thus options for improvements should continually be reviewed and considered. There are now a reasonable number of good quality LED garage lighting fixtures available at this time. Many of these fixtures have a proven track record of reliability and good photometric performance. Use of LED lighting will reduce energy use and maintenance expenses. Based on these factors at this time, LED lighting should be considered for use when the existing garage fixtures near the end of their useful life. While some LED retro-fit solutions are available, these raise concerns with UL Listing and they do not typically have the same efficiency levels as dedicated LED fixtures. LED garage fixtures can be more easily controlled via occupancy sensors, daylight sensors and dimming controls. Such control enhancements can significantly increase the energy savings realized by use of the fixtures but must be carefully evaluated during design to ensure that they are a proper fit for the facility. Most enhanced control strategies will either require the installation of separate control wiring or local controls on each fixture.

Due to the balance between ongoing maintenance costs, related to regular re-lamping and other associated expenses, and the potential savings from an improved technology, such as LED, DESMAN recommends that replacement be considered accordingly, as part of NHPA Project No. 18-003 now in design. While this project had been placed on hold due to funding limitations, funding now allows the project to proceed. This project is now scheduled for bid in 2020.

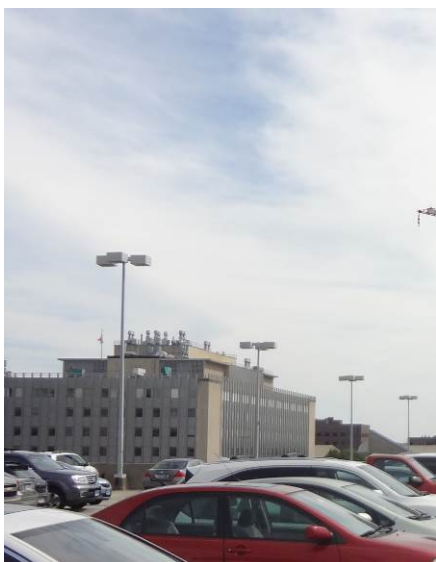
Photo #72

Roof Lighting Replacement: While the roof pole lights are relatively modern, difficulty in maintaining these fixtures would indicate upgrading them to new LED sources sooner than the general garage fixtures. The existing poles, controls and wiring infrastructure can certainly remain (**Photo #72**). The fixtures should be replaced completely since retro-fit solutions for LED lamps in this type of fixture tend to be less efficient and have a generally shorter lifespan. New LED fixtures will have a considerably lower power input and slightly improved lighting performance. This work is being addressed as part of NHPA Project No. 18-003 now in design. While this project had been placed on hold due to funding limitations, funding now allows the project to proceed. This project is now scheduled for bid in 2020.

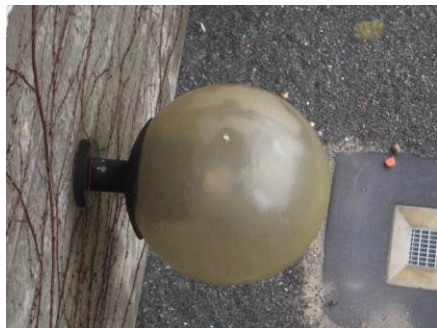
Photo #73

DESMAN recommends that the existing globe light fixtures, mounted on the end parapets of Level 1 and 2 (**Photo #73**), be removed due to previous abandonment and unsightly aesthetics. Removal of the existing parapet-mounted light fixtures, though, is challenging due to limited access and required coordination with adjacent properties. DESMAN recommends that the removal of the fixtures be programmed accordingly but inclusive of associated equipment to achieve access from the levels above (with appropriate fall-arrest equipment) to avoid impacting and/or inconveniencing the adjacent properties. This work is being addressed as part of NHPA Project No. 18-003 now in design. While this project had been placed on hold due to funding limitations, funding now allows the project to proceed. This project is now scheduled for bid in 2020.

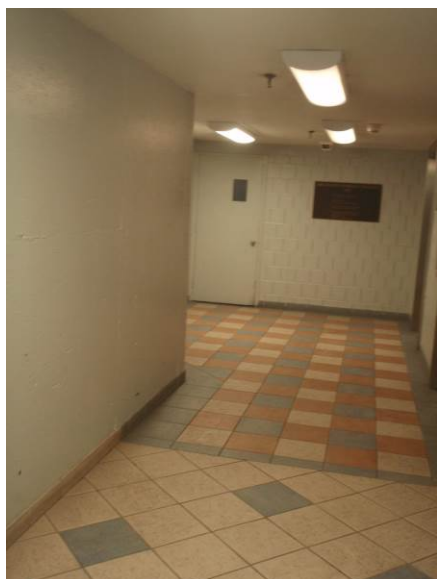
Photo #74

The existing lobby light fixtures appear to be performing well (**Photo #74**), although typical preventative maintenance is recommended to replace failed bulbs. Should NHPA wish to consider the aesthetic enhancements noted previously, DESMAN recommends that the existing fluorescent light fixtures be re-lamped and cleaned.

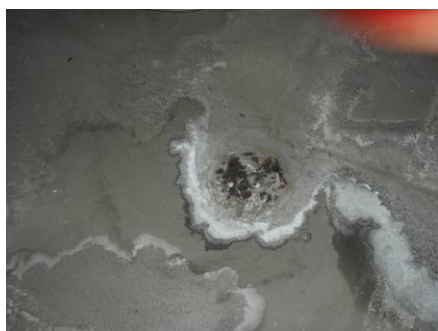
Photo #77

Cleaning Floor Drains & Sand/Oil Separators: Accumulation of sand and debris continues to be noted in and around drains (**Photo #77**), or deposited in unused corners of various parking decks, particularly the roof where sand has been used during the winter months to address icing conditions. It is important that accumulated sand be removed from the garage decks each spring as they hold concentration of chloride (road salt) and moisture in direct contact with the concrete deck, causing an increase in the amount of deterioration which could take place. As mentioned in previous reports, all sand, dirt and debris accumulated on supported parking decks should be removed periodically, as this dirt and debris tends to hold moisture and chlorides detrimental to the structure.

NHPA's utilization of the facility's high pressure wash-down system is important in reducing concrete deck deterioration and costly repairs. It is highly recommended that the facility be washed down quarterly or minimally twice a year (spring and fall) to remove accumulated sand and debris and to flush accumulated road salt (chlorides) from the surface of the deck. The facility's wash-down system was designed to provide a sufficient volume of water at high pressure to assist in cleaning the concrete decks, thus greatly reducing the amount of structural deterioration likely to take place.

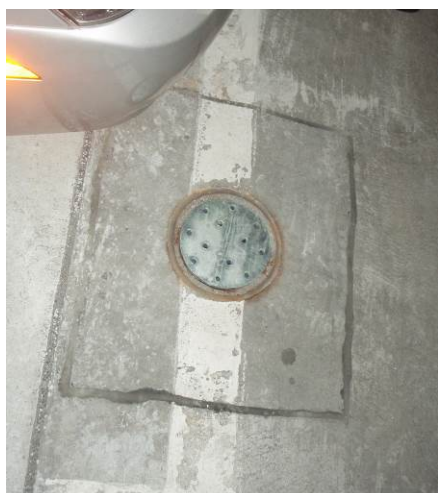
Photo #78

Facility Storm Drainage System: Miscellaneous repairs were performed as part of the repair program in 2012 and also addressed as part of NHPA Project No. 13-002 now completed. **(Photos #78 & 79)**. Due to the age of the system, DESMAN has included the cost for full replacement to be phased over the next five (5) to (10) years; since miscellaneous repairs continue to be performed, Desman recommends that this cost may be reviewed annually and adjusted accordingly.

In the interim, provisions should continue to be made by NHPA for preventive maintenance of the facility's storm drainage system including its periodic inspection and repair as necessary. The cost associated with making these inspections and nominal repairs should be considered an operational cost and are, therefore, not included as a separate and distinct item within projected repair and preventative maintenance costs.

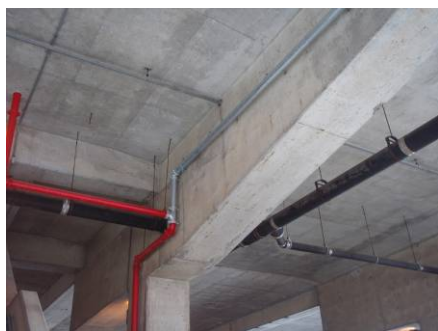
Photo #80

Standpipe System: Repairs to the standpipe system were performed as part of the recent comprehensive repair program (2012), **(Photos #80 & #81)**.

25 – “Standard for the Inspection, Testing and Maintenance of Water Based Fire Protection Systems”. At a minimum, owners’ maintenance personnel should conduct a quarterly visual inspection of piping, fire department connections and hose valves to ensure that systems have not been damaged. A more thorough detailed inspection should be conducted annually to verify that all system piping and components are in proper working order which should include testing and inspection of all valves and components. Flow tests should be conducted every five years at a minimum. Additional requirements for inspection testing and maintenance of Standpipe Systems are outlined in NFPA 25.

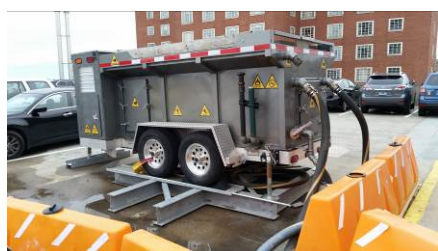
Photo #82

Permanent water supply to the Snow Dragon on the roof: NHPA notes that water is needed to begin operation of the snow melting unit (**Photo #82**) and transport of the water to the roof is problematic. Installation of a permanently piped, insulated and heat traced water line would allow the system to be filled easily at any time. The line will need to be extended from the water service entrance at the Highway level, up to the roof. This line will either need to be drained after each use, or it will need to be insulated and heat traced. This work has been performed as part of NHPA Project No. 13-002.

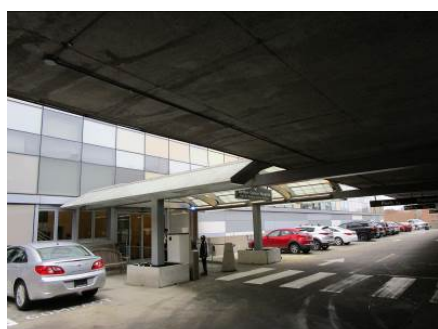
Photo #84

Canopy System Gutter System: When the canopy system was installed at the entrance to the Smilow Cancer Center, on level 4, a dedicated drainage system was not installed (**Photos #84 & #85**). Therefore, when it rains, water pours off of the canopy onto the floor below. This becomes problematic specifically in the winter when the water may freeze. DESMAN recommends that a gutter system be installed that routes the piping directly into the drainage system so as to avoid any possible slip hazards.

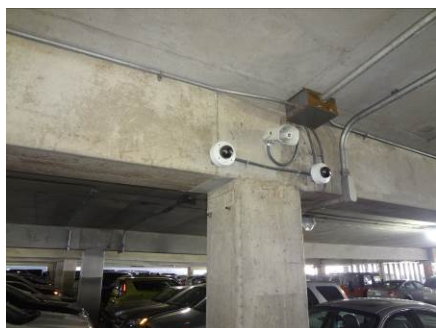
Photo #86

Security System Repairs and Preventative Maintenance: A comprehensive replacement program has recently been completed, addressing replacement and upgrading of the video surveillance system, as well as the access control and audio communication systems (**Photos #86, #87, #88 & #89**). Renovations to the Control Room and Rack Room, along with door replacement and hardware improvements, were also addressed.

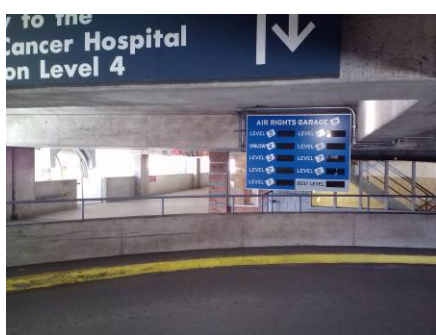
Photo #90

The existing revenue control and parking access equipment was replaced in 2013, along with installation of a parking guidance system (**Photo #90**) and cashier booths. However, due to new and improved technology, the equipment is nearing the end of its economic life. DESMAN therefore recommends that PNH review and study the current system for potential enhancements and/or replacement, and plan accordingly.

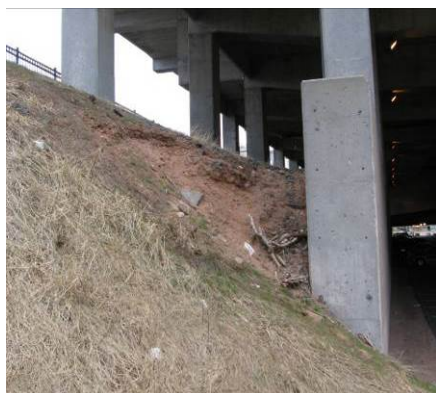
Photo #91

On the north and south sides of the parking garage, at street level, are sloped embankments down to the surface parking below the Air Rights Parking Garage. The northern embankment has been finished with shotcrete while the southern embankment remains as gravel (**Photo #91**); DESMAN recommends that the south side be similarly finished with shot-crete.

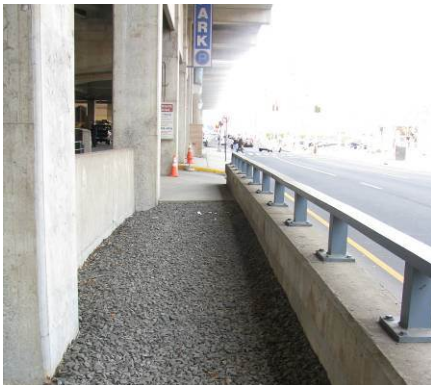
Photo #92

Due to development and construction by the east end of the Air Rights Garage, DESMAN was requested by NHPA to review the sidewalk areas in this location. While the sidewalks are limited, existing surfaces are stone covered and provide an unfinished appearance (**Photos #92 & #93**). The existing sidewalks should be continued to connect to the new development with associated handicap ramps; although the design work was completed as part of NHPA Project No. 17-002 with an approximate opinion of construction cost of \$500,000, the project was placed on hold per directive of YNHH, and later transferred to the City of New Haven for construction.
