**CONDITION APPRAISAL
(FY 2020)**

**CROWN STREET PARKING GARAGE
NEW HAVEN, CONNECTICUT**

**NEW HAVEN
PARKING
AUTHORITY**

APRIL 2020

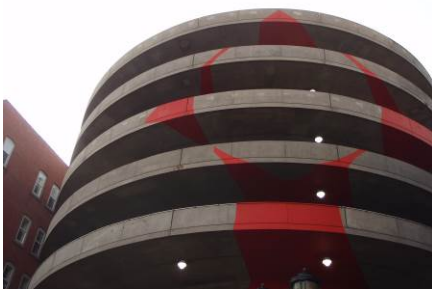
Photo #1

The garage's helical ramp construction is conventionally reinforced cast-in-place concrete (**Photo #1**). The ramp's slabs (entry and exit ramps) cantilever out from an interior concrete ring approximately 15'-0" and the ramp's slab thickness tapers from 11 ½" to 6" thick (from inner ring to outboard end). Cast-in-place concrete parapet walls exist on both the inside and outside circumference of the helical ramps.

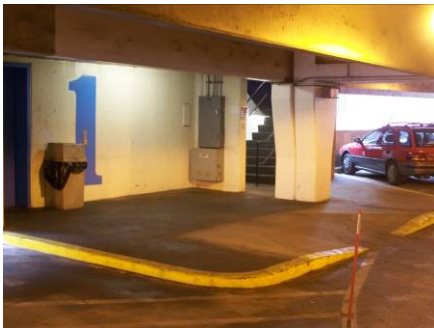
Photo #3

Other work included ADA improvements (i.e., handicap ramps to elevator lobbies) (**Photo #3**) and drainage modifications. Handicapped access modifications were made to all levels of the garage to provide suitable access to the facility's elevators on the east and west ends of the garage.

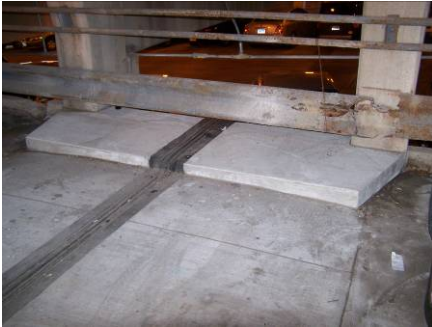
Photo #4

2008: Repairs were implemented to address the five (5) remaining expansion joints of this facility's thirteen (13) expansion joints (**Photo #4**). The repairs implemented were similar to the repairs performed historically, although some minor changes were made to coordinate this work with the future repairs envisioned along the centerline of the garage. Part of this year's scheduled repair work is simply to closely inspect all interior and exterior concrete surfaces for delaminated concrete and to remove the deteriorated concrete in a safe and controlled fashion.

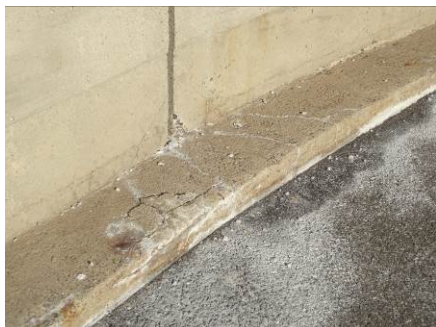
Photo #10

However, the curbing throughout the silo appears to have experienced an increase in deterioration recently, likely due to the joint opening, at these locations, in the silo parapets (**Photo #10**). The joint openings present a challenge due to the movement in the parapets but the curb/beam element around the perimeter of the silo being a fixed element. DESMAN recommends that the curbing be repaired as required and coated with a waterproofing material accordingly. This work is currently scheduled to be performed as part of NHPA Project No. 17-006, currently in design.

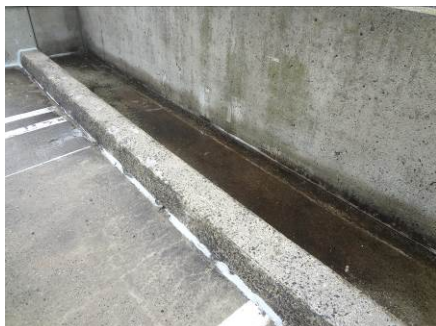
Photo #11

In addition, DESMAN has observed water and debris collecting behind the wheelstop, specifically on the roof level; wheeps through the wheelstops have deteriorated and/or clogged and no longer serve their purpose (**Photo #11**). DESMAN recommends that the void space behind the wheelstops, on the roof level, be filled with concrete, sloping the surface for positive drainage. This work, as well, is currently scheduled to be performed as part of NHPA Project No. 17-006, currently in design.

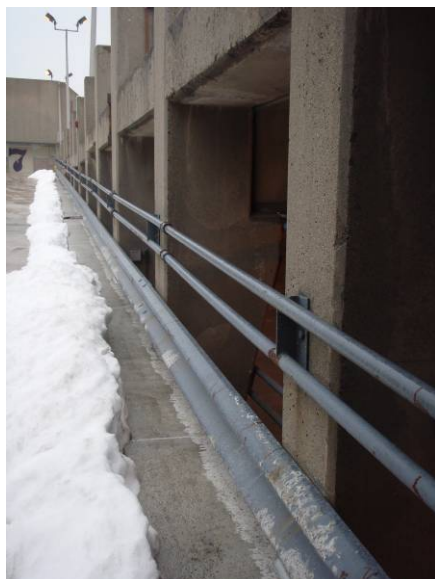
Photo #20

Flashing along the Center-line (Column-line D) and related flashing: Although new curbing was installed along column-line D which is intended to eliminate extensive areas of standing water throughout the garage, redirecting surface run-off into preexisting drains, the slopes of the parking decks are such that a significant opening is provided between the roof level and the immediate level below that allows rain water to intrude onto the lower levels (**Photo #20**).

DESMAN recommends that an aluminum storefront system be installed within this opening to prevent and/or minimize the water intrusion. This work is currently scheduled to be performed as part of NHPA Project No. 17-006, currently in design.

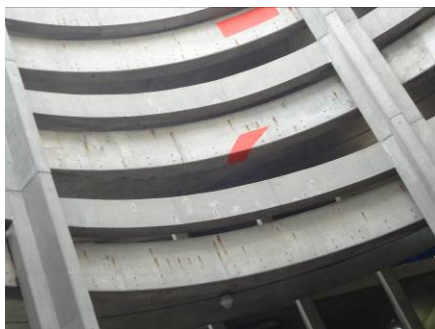
Photo #21

Waterproofing Coating on Interior of Silo: Shallow steel placement and exposure to weather conditions have provided opportunity for moisture contamination and subsequent unsightly corrosion (**Photo #21**). Although the silo surface has not experienced extensive delamination and the surfaces appear intact (significant spalling not yet observed), DESMAN recommends that the surfaces be protected with a waterproofing coating so as to minimize further moisture contamination. This work is currently scheduled to be performed as part of NHPA Project No. 17-006, currently in design.

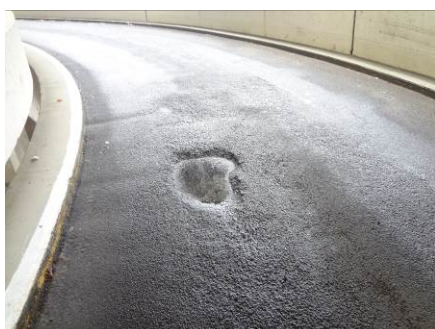
Photo #22

Asphaltic/Protected Membrane System on Silo Ramp Surface: an asphaltic/protected membrane system was installed throughout the Exit Silo approximately 20 years ago (circa 1999). Although generally performing well, miscellaneous deterioration is observed throughout requiring repair to the asphalt (**Photo #22**). DESMAN recommends that these repairs be addressed before damage can be had to the membrane below. This work is currently scheduled to be performed as part of NHPA Project No. 17-006, currently in design.

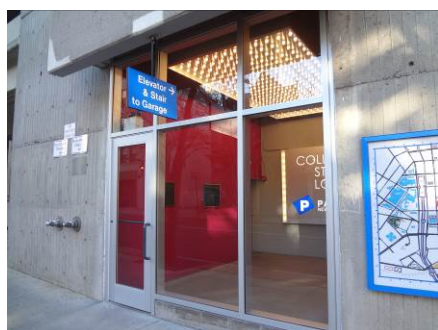
Photo #26

In addition to the architectural enhancements, a storefront system was incorporated to provide a protective vestibule (from the weather) for the elevators [due to the modernization work competed in 2015] (**Photo #26**).

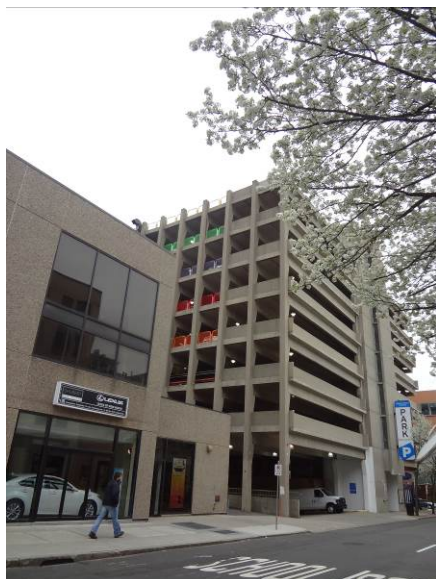
Photo #28

The entrance and façade of the Crown Street Garage along College Street has become aged (**Photo #28**). Although architecturally unique, the recent and ongoing development in the immediate area continues to provide a challenge for the garage to stay current.

Recently, with NHPA's re-branding efforts fully underway, in conjunction with the adjacent Shubert Theater, additional opportunities have developed that could assist in revitalizing the garage. Unlike the entrance on Crown Street, the College Street façade includes the stair/elevator tower which results in an interruption to the façade, thus providing a more immediate opportunity to create an updated impact on the surrounding environment. Enhancements, such as accenting the concrete form to compliment and contrast with the lobby, providing accent cove lighting protruding from the concrete form, as well as providing a band of planters on the façade over the vehicular entrance to soften the face, could assist in transforming the garage (various concepts as follows).

DESMAN understands that this work would be subject to funding, and so DESMAN recommends that NHPA program this work accordingly.

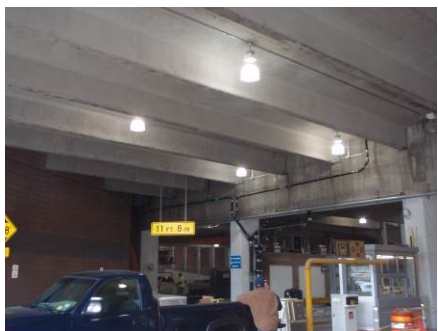
Photo #31

Replacement of all Garage Lighting: The garage lighting was replaced as part of the 2013 comprehensive capital repair project. Work included the stairwell fixtures, as well as the roof level poles/fixtures and helical ramp fixtures (**Photos #31, #32 & #33**).

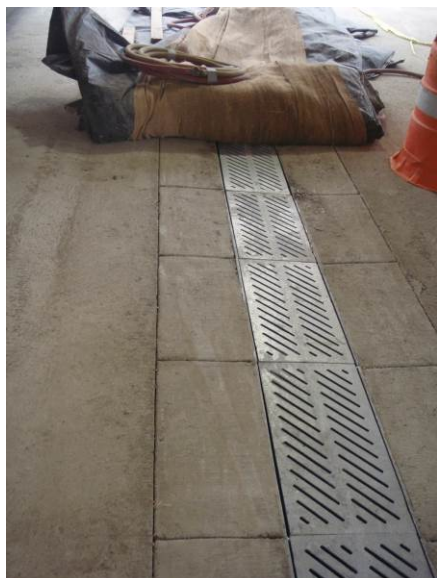
Photo #39

Trench Drain and Storm Drainage Piping Repair: Cleaning of floor drains and trench drains were performed as part of the 2013 comprehensive capital repair program, as well as the installation of a new sand/oil interceptor (to accommodate the separation of the storm and sanitary systems); at the time, all damaged, excessively corroded and/or missing drain gratings were replaced, all of the facility's broken or corroded pipe hangers were repaired or replaced, all broken or leaking pipe and associated pipe fittings were repaired (**Photo #39**).

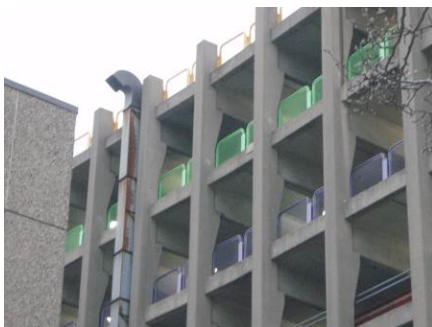
Photo #43

Ductwork serving the Tenant Space: An existing full-height ductwork system (**Photos #43 & #44**) currently runs from the roof down to a unit behind the tenant space which has now become vacated. DESMAN recommends that this system be removed and a new system installed as may be needed when the tenant space is re-fitted out.

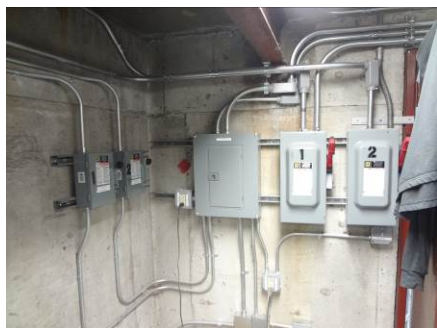
Photo #45

- Office HVAC Equipment including Split System Air Conditioning and Toilet Exhaust Fans
- Electrical Room Ventilating Equipment & Temperature Controls
- Elevator Machine Room HVAC Equipment (**Photo #45**)

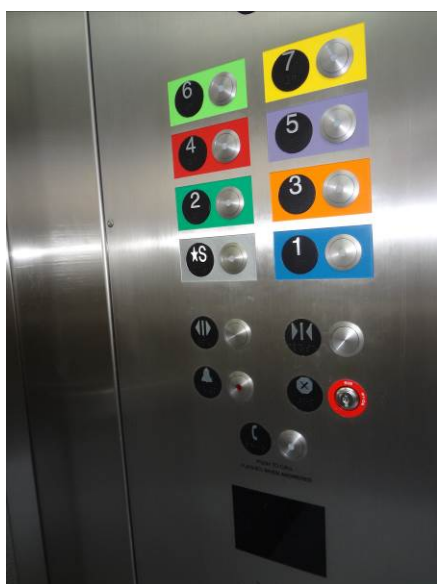
Photo #46

Modernization of Elevator Nos. 1, 2 & 3 was completed in 2015. New controls, hoist-way motors, machine room wiring, switch assemblies, governors with position sensing encoders, new door packages and elevator interior renovations (**Photo #46**), among other improvements, were required in each of the three elevators, as well as the installation of new electronic elevator controls and improvements to the elevator machine room HVAC, inclusive of the installation of an air conditioning system and supplemental heating. To enhance the entrance lobbies, modernization of the elevators also included the replacement of all elevator doors and door frames at the west end and east end elevators on all levels.

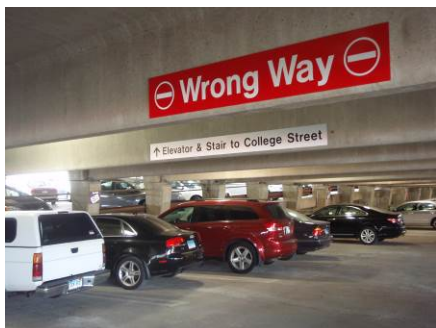
Photo #53

This facility's interior and exterior signage was replaced as part of the 2013 comprehensive capital repair program (**Photos #53, #54, #55 & #56**).

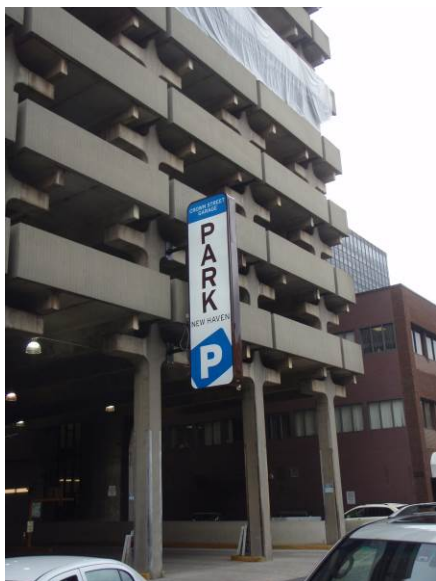
Photo #57

The exterior identification signage was also renovated (**Photo #57**). In conjunction with NHPA's current re-branding program, the signage was refurbished and updated with new sign box materials and new graphic faces to be more in keeping with NHPA's new logo and graphic standards.

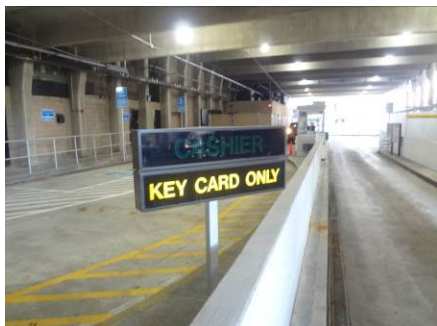
Photo #58

Although new illuminated sign boxes were installed in 2013, improved LED technology now exists that would provide a more appropriate illuminated box suitable for the exterior glare that causes the illuminated sign boxes to be difficult to see (**Photos #58 & #59**). This work is currently scheduled to be performed as part of NHPA Project No. 19-006, currently in design.

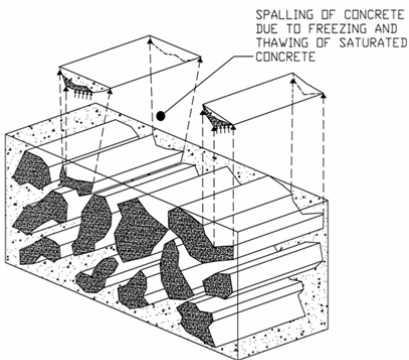
Fig. C

As previously mentioned, these pressures can cause progressive failure of the cement paste and result in scaling of the concrete, and delamination of concrete along subsurface fracture planes (*Fig. C*).

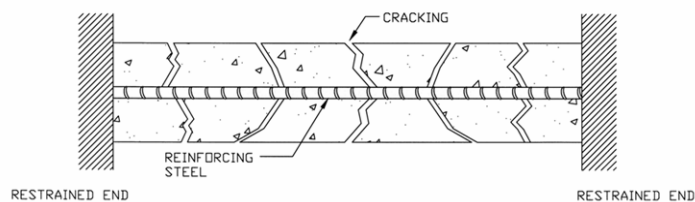
Fig. D

Volume changes due to thermal movement, shrinkage, creep, and loading can also contribute to the deterioration of reinforced concrete. These volume changes will produce stress in restrained members, often resulting in cracking of the member (*Fig. D*). These cracks also provide access to water and other deterioration mechanisms to attack the member.
