**CONDITION APPRAISAL
(FY 2020)**

**TEMPLE MEDICAL PARKING GARAGE
NEW HAVEN, CONNECTICUT**

**NEW HAVEN
PARKING
AUTHORITY**

**NHPA PROJECT No. 20-001
DESMAN PROJECT No. 20-19171.00-2**

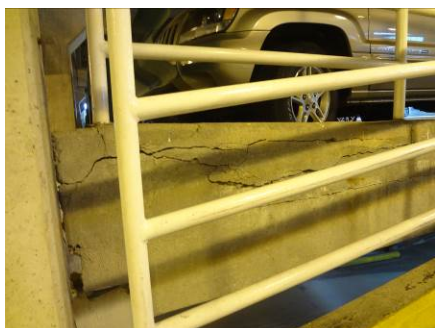
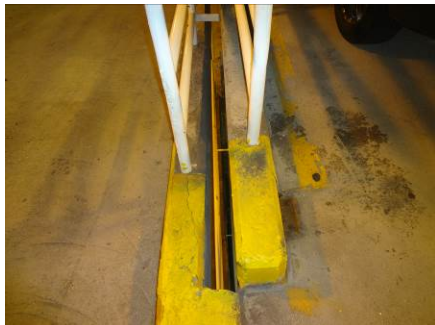
Miscellaneous Concrete Curb Repair: The curbing on either side of the cross-over ramps continues to be sensitive to the stresses provided by the railing systems installed in them, resulting in cracking that expands and becomes greater spalling (**Photos #14 & #15**). DESMAN suggests that this curbing be repaired, perhaps with a more substantial width or depth, although these dimensions would certainly need to consider the turn radius from the vehicles which previously contributed to the curbs being shortened. This work is currently scheduled to be performed as part of NHPA Project No. 18-008, currently in design. Additional repair work should be anticipated in the future and therefore DESMAN recommends that the curbing be monitored and NHPA budget accordingly.

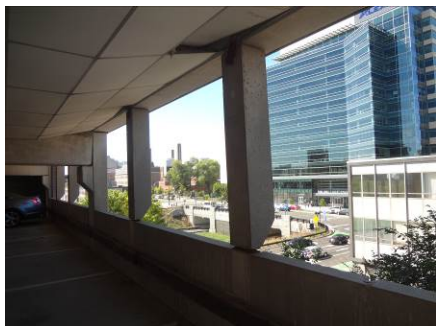
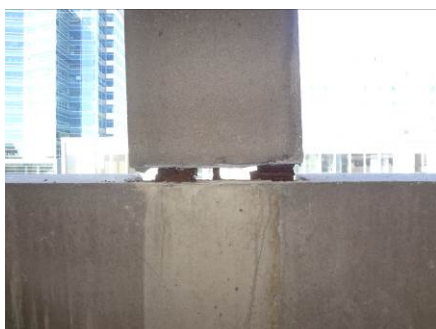
Concrete Rib Repair: Failure of the sealant material at the bases of the architectural ribs, followed by exposure of the metal inserts to the weather, has resulted in corrosion of the inserts and slight leaning of the ribs (**Photos #17 & #18**). Although the ribs appear to be secure, DESMAN recommends that supplemental support plates be installed as well as replacement of the sealant material. This work is currently scheduled to be performed as part of NHPA Project No. 18-008, currently in design.

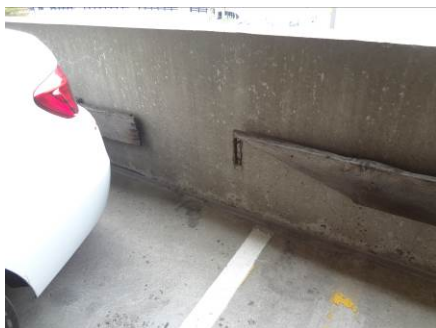
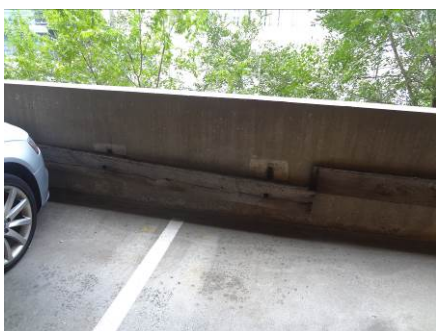
Replacement of Vehicle Wood Bumpers: the wood boards installed throughout the perimeter of the garage, acting as vehicle protection, are in various states of disrepair or are lacking completely (**Photos #25 & #26**). In order to continue to provide appropriate vehicle protection, the wood boards should all be replaced. This work is currently scheduled to be performed as part of NHPA Project No. 18-008, currently in design.

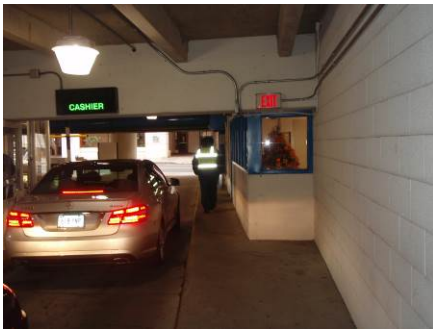
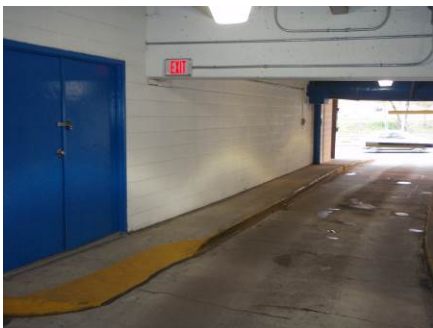
Previously, pedestrian access into the garage from George Street required the patrons to walk along a curb adjacent to the vehicular drive lanes, simultaneously being cautious of beams and other garage elements (**Photos #29, #30 & #31**). As an effort to enhance the visitor's experience upon entering the garage, PNH Project #16-010 was initiated and various improvements were implemented. The adjacent storage areas were removed, glass storefront systems installed for security, a decorative overlay/flooring and murals were installed, and the walls painted, all with improved signage and accent lighting (**Photo #32**).

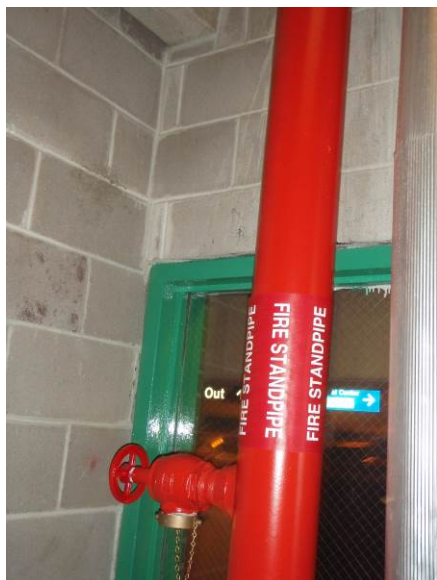
Photo #41

Fire Standpipe Repairs: Although the Fire Standpipe System was reviewed and repaired as part of the 2013 capital project and miscellaneous repairs were performed, multiple standpipes are now missing valve handles; DESMAN recommends that the valve handles be replaced as required on an as-needed basis. **(Photos #41 & #42)**

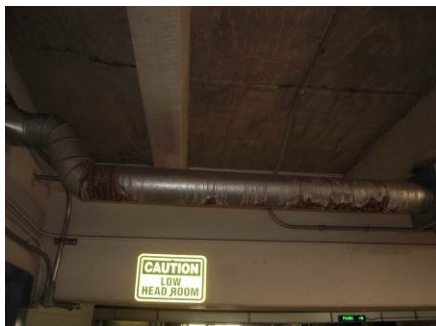
Photo #44

- The supply air duct providing ventilation air to the collection booth is rusting along the bottom (**Photo #44**). DESMAN recommends cleaning, painting and/or replacement of the fan and ductwork.
- It has been reported by the garage security staff that the air conditioning system serving the office area is not working. DESMAN recommends having the air conditioning system serviced by a qualified HVAC service contractor.
- DESMAN recommends inspection of the fire pump by licensed fire protection contractor.

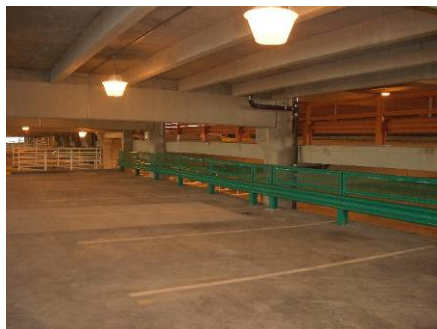
Photo #45

Miscellaneous Metal Surfaces: Due to age and wear, DESMAN recommends that the guardrail systems and handrails throughout the garage be programmed for full re-painting; a warranty should be in place for the coating system, so DESMAN recommends that PNH coordinate with the fabricator and coating manufacturer accordingly (**Photo #45**). Upon re-painting, DESMAN also recommends that all anchors be cold-galvanized as well.

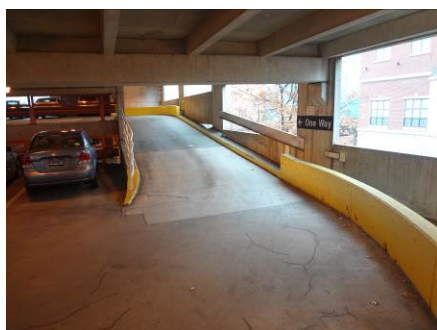
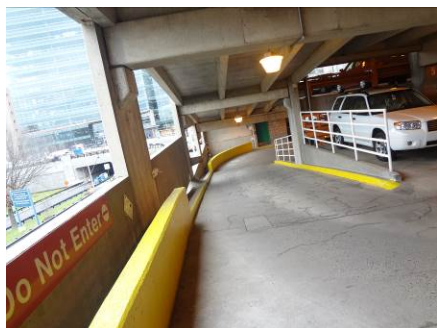
Miscellaneous Concrete & Masonry Surfaces: As with any parking facility, periodic re-painting will be required (**Photos #46 & #47**), the cost of this periodic re-painting has been included within our projected repair costs for this facility.

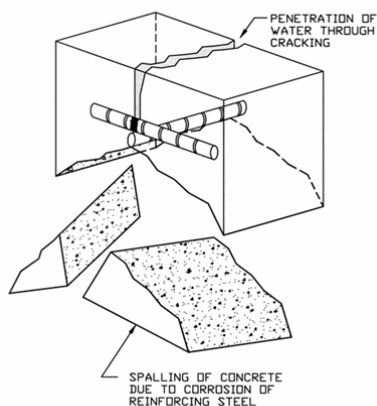
Fig. B

Corrosion of reinforcing steel or other embedded ferrous items such as electrical conduit is a second major factor contributing to deterioration of reinforced concrete (Fig B).

The corrosion process is an electrochemical process, which produces iron oxide (rust) and other by-products. These by-products occupy a minimum of 250% of the volume of the parent metal. This increase in volume produces tensile stresses within the surrounding concrete.

Because concrete has poor tensile strength properties, cracking occurs within the concrete matrix allowing additional moisture and chlorides to reach the reinforcing causing acceleration of the corrosion process. The deterioration caused by this corrosion includes the reduction of cross sectional area of the reinforcing, and the delamination of concrete surrounding the reinforcement.

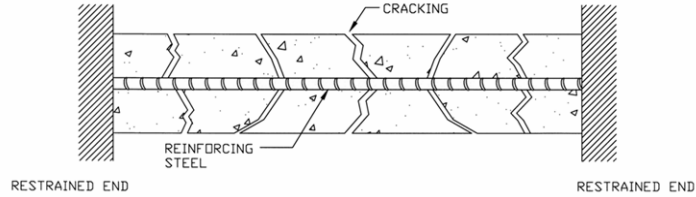
Fig. D

Volume changes due to thermal movement, shrinkage, creep, and loading can also contribute to the deterioration of reinforced concrete. These volume changes will produce stress in restrained members, often resulting in cracking of the member (*Fig. D*). These cracks also provide access to water and other deterioration mechanisms to attack the member.
