**CONDITION APPRAISAL
(FY 2020)**

**TEMPLE STREET PARKING GARAGE
NEW HAVEN, CONNECTICUT**

**NEW HAVEN
PARKING
AUTHORITY**

NHPA PROJECT No. 20-001
DESMAN PROJECT No. 20-19171.00-2

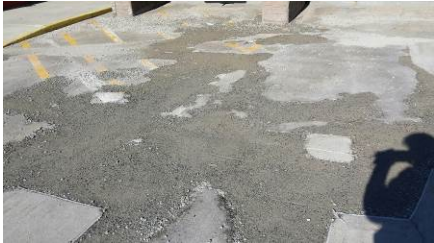
Photo #1

The Temple Street Parking Garage continues to perform well. The top surfaces of the supported decks were observed to be in relatively good condition except for the roof level (Level 9 & 10). Due to significant freeze-thaw conditions, repair work is required on the roof levels. **(Photos #1 & #2).**

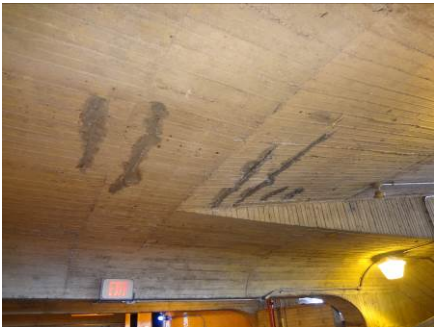
Photo #3

As previously reported in past Condition Assessment Reports, this facility's overhead concrete surfaces are exhibiting increases in overhead deterioration. Continued overhead concrete repairs are anticipated for the future. **(Photo #3 & #4)**

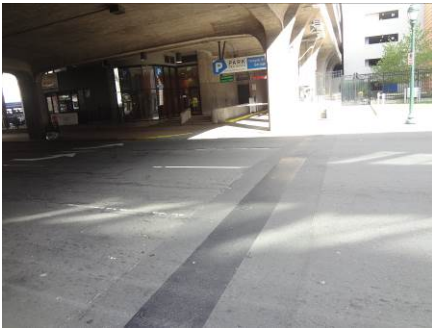
Photo #8

We understand the City Engineering Office had been pursuing a capital program for this work and certain repair work has now been completed, particularly with regard to the tunnel structure to the east and the street expansion joint on the east side of the garage(**Photos #8 & #9**).

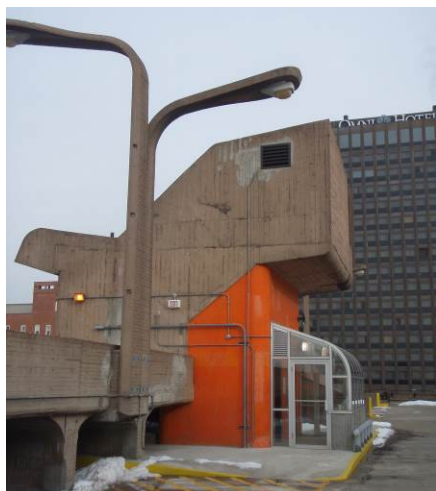
Photo #33

Due to the various repair programs performed at the Garage, in conjunction with the age of the facility, DESMAN has observed varying stages of weathering that have had an impact on the multitude of repair mortars used at the facility (**Photo #33**). Although the majority of the patches continue to remain durable, the patches have presented a patchwork of colors that, depending on the location, can have a negative impact on the facility's aesthetics. Depending on the extent of visibility, DESMAN recommends that select patches be re-addressed or a staining be considered that may improve the blending of colors.

This work is currently scheduled to be performed as part of NHPA Project No. 17-006, currently in design.

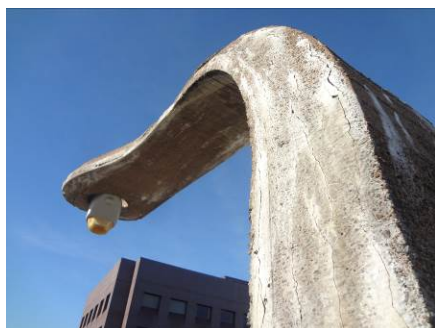
Photo #36

Roof Level Light Poles: Recently, DESMAN observed significant deterioration occurring at the top of one of the "cobrahead" light poles on the Roof Level (**Photo #36**); repairs are currently in progress as part of NHPA Project No. 18-030. DESMAN recommends that the other light poles be monitored and repaired as required, addressing cracking as it occurs.

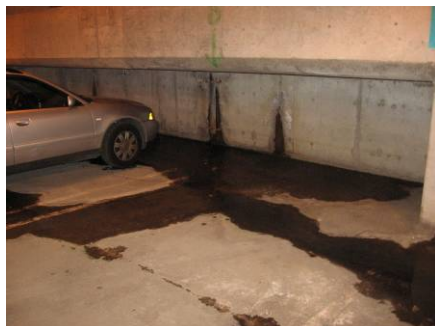
Photo #45

Water Infiltration – Basement Level: Water infiltration through the foundation wall directly adjoining the adjacent Gateway Community College site, and through the southern foundation wall down the center of Level B3 (**Photo #45**) has been addressed as part of the (2013) comprehensive capital project, utilizing chemical grout injection and negative-side waterproofing. Although water infiltration has been greatly reduced, DESMAN recommends that the basement continue to be monitored since water infiltration continues to occur. DESMAN will continue to carry costs associated with additional periodic negative-waterproofing which can be reasonably expected to be recommended over the next five years. This work is currently scheduled to be performed as part of NHPA Project No. 17-006, currently in design.

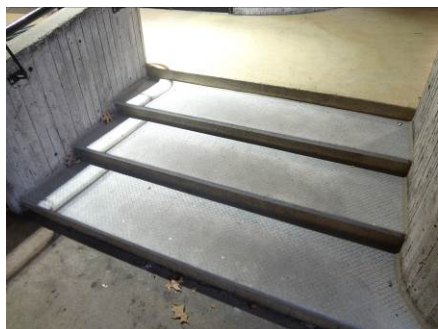
Photo #48

Epoxy Flooring Repairs and Improvements: As part of the comprehensive restoration project of 2000, architectural improvements were implemented to various stair and elevator lobbies, including the installation of an epoxy flooring system within the street level lobby at Elevator 'B,' and as part of NHPA Project No. 15-004A, cast aluminum treads were installed as well. DESMAN recommends that the epoxy flooring system be monitored and repaired as required, as well as the anchors for the new treads be adjusted and/or replaced as required to keep the treads in-place and secured. (**Photo #48**)

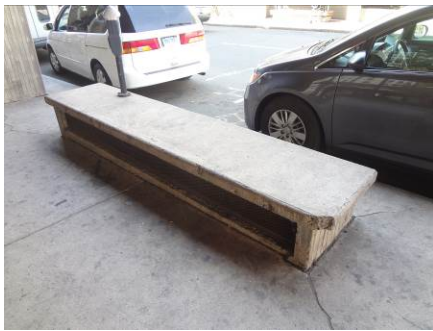
Photo #52

Ventilation Shaft Bench Improvements: Due to loitering atop of the ventilation shafts which have become used as benches, as well as damage due to skateboarding, PNH has requested that DESMAN consider certain aesthetic improvements that would impede the loitering and protect the benches (**Photo #52**). While various concepts were developed, the preferred option incorporates a wood skin over the benches with possible planter configurations, although a simpler concept, such as the steel rods used at nearby benches (**Photo #53**), may be used at certain benches to minimize cost.

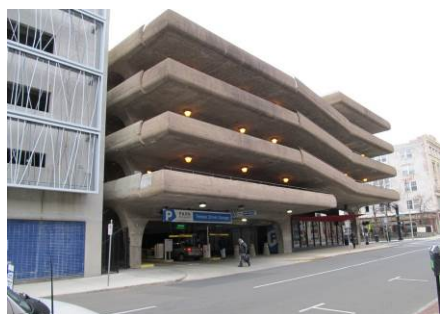
Photo #54

The façade of the Temple Street Garage along Crown Street has become aged with varying colors of past repair mortars (**Photo #54**). Although architecturally unique, the recent and ongoing development in the immediate area, including the construction of the adjacent Gateway Community College, continues to provide a challenge for the garage to stay current.

Recently, with NHPA's re-branding efforts fully underway, additional opportunities have developed that could assist in revitalizing the garage. Enhancements, such as the installation of linear, programmable LED accent lighting to wash the underside of the structure and accentuate the form with similar LED fixtures to up-light the ceiling of the entrance, could assist in transforming the garage (various concepts as follows) (installation of accent lighting along Temple Street is currently scheduled to be performed as part of NHPA Project No. 19-006, currently in design).

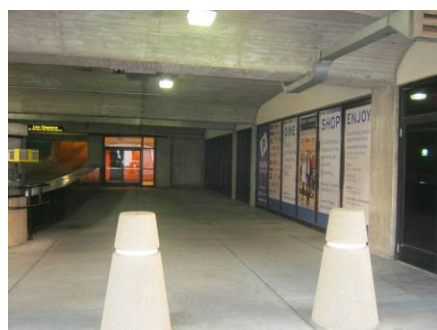
Photo #55

The pedestrian entrance from Crown Street has proven to be a challenge (**Photo #55**). The entrance consists of a substantial open area that has yet to be defined and made unique and welcoming. In conjunction with the resurfacing of the floor slab with a decorative stamped/stenciled concrete, linear, LED, exterior lighting strips may be installed along the structural ribs to up-light the ceiling surface, all providing an aesthetically enhanced pathway highlighting the route to the stair and elevators.

Additional enhancements could include installing an architectural screen element to divide the pedestrian space from the vehicular entrance, applying an accent material to the stairwell wall surface at the rear of the space to attract patrons into the space, incorporate bench seating at the rear of the space, coordinate graphics and the colors/themes of the glazing decals with the design of the space, as well as incorporating bike racks or a sculptural element to further activate the space (various concepts as follows).

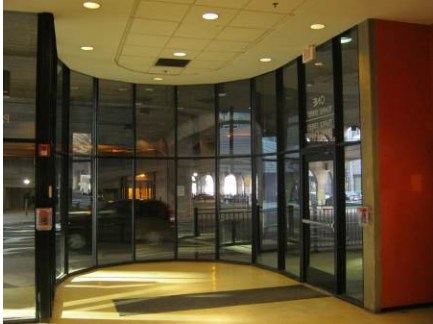
Photo #57

Although the main stair/elevator lobby on George Street (associated with the Parking Office) provides an open and welcoming environment (**Photo #57**), as well as being well-maintained, DESMAN recommends that the lobby could be energized and refreshed to be made more current. Minor enhancements could include installing a unique lighting scheme to separate the bump-out from the rest of the lobby space, such as pendant lights hung at random but balanced elevations, as well as placing a sculptural element/artwork in the glazed bump-out while incorporating stylish seating (various concepts as follows).

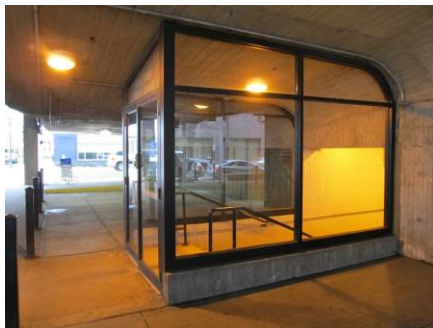
Photo #58

Although the construction of Elevator C and the creation of the open area in 2002 succeeded in greatly improving the environment at this location (**Photo #58**), it has since become aged; the open nature of the space provides an opportunity for refreshing the space as well as coordinating it with the adjacent Gateway Community College. Minor enhancements could include installing thin linear LED accent lighting to up-light the ceiling, as well as activating the space with bike racks or a sculptural element (various concepts as follows).

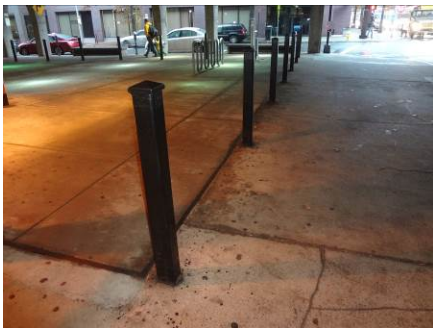
Photo #59

Upon undertaking improvements to the area, replacement of the bollards should be considered (**Photo #59**), and possibly replaced with a system more aesthetically aligned with the other enhancements. The existing bollard mounts have aged and certain

bollards are extensively corroded; regardless, the bollards should be monitored and replaced as required to maintain the desired protection to the area.

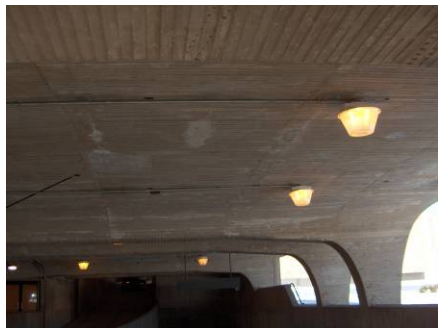
Photo #61

Lighting Maintenance: NHPA should implement a planned lighting maintenance schedule for the facility's lighting; whereby lamps and ballasts are replaced throughout the facility at the same time in lieu of the current practice of intermittent replacement on an as-needed basis (**Photo #61**). No doubt there is a need to periodically replace a limited number of lamps or individual ballasts due to premature failure, but programmed replacement is typically more cost effective.

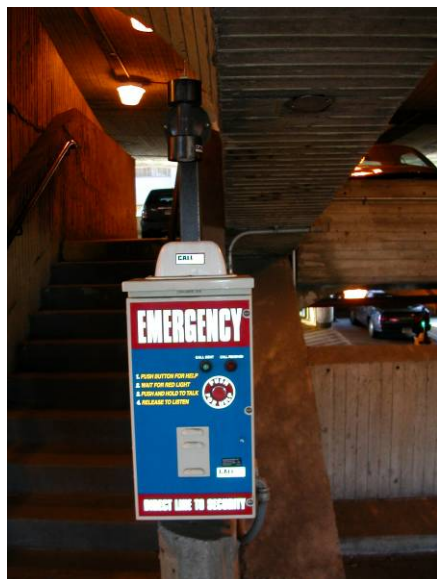
Photo #62

Emergency Intercom Station & Blue Light Repair: The operation of each individual intercom station was not specifically reviewed as part of the assessment of this facility. Testing of each station was not performed as it is understood that operation of this critical safety equipment is verified periodically by NHPA maintenance and operations staff or security (**Photo #62**).

Originally, this emergency intercom system was installed as an independent system; DESMAN recommends that should significant repairs or upgrading be planned, though, that incorporation of the intercom system into a larger and more comprehensive security system be considered; additional security improvements are discussed later in this report.

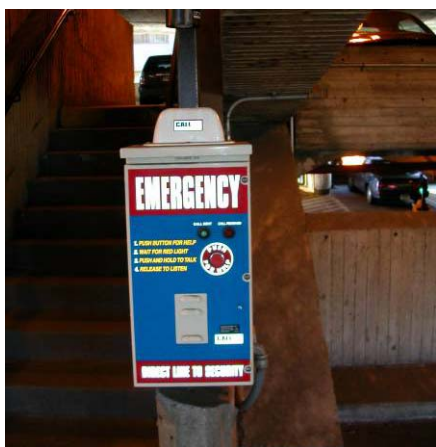
Photo #67

Although an emergency intercom system currently exists at the Temple Street Garage (**Photo #67**), the aged technology may not be appropriate or compatible for combining or incorporating it into a new security system, and thus may require full replacement.

DESMAN recommends that a study be performed first to review NHPA's needs and subsequently to provide appropriate recommendations; design and installation of the security system would follow and be programmed for implementation accordingly, as per the study in NHPA Project No. 15-002.

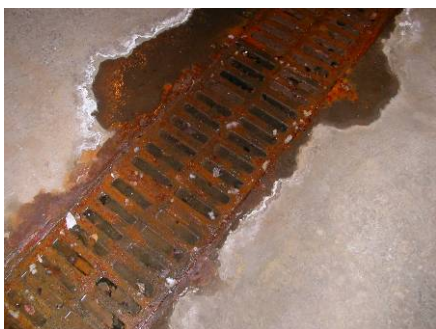
Photo #68

Sand carried into the storm drains can clog drains and associated drain lines (**Photo #68**). In combination with periodic garage wash down, it is imperative that the facility's drainage system be kept clean and operational. A sand/oil interceptor was recently installed as part of the (2013) comprehensive repair project which will require periodic cleaning as well. (**Photo #69**)

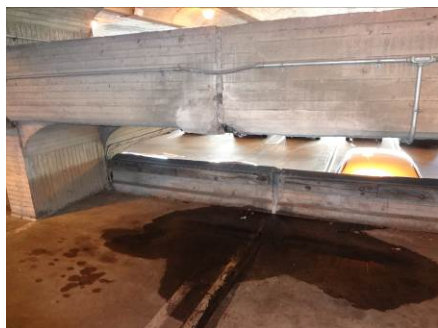
Photo #70

DESMAN has been informed that ponding has been observed to occur on either side of various expansion joints, thus contributing to premature failure (**Photo #70**), as well as adjacent to the door to the elevator machine room (roof level). DESMAN recommends that this situation be monitored, but supplemental drains may be installed if needed to address the ponding should it continue to be a concern. This work is currently scheduled to be further reviewed and addressed as part of NHPA Project No. 17-006, currently in design.

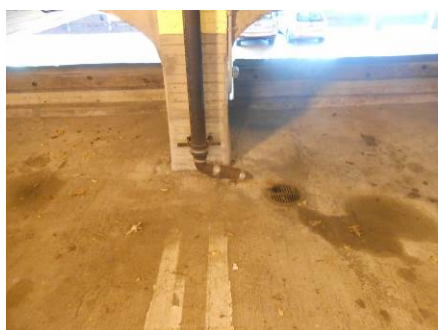
Photo #71

Drainage System Repairs: DESMAN recommends that all damaged drainage components be repaired and/or replaced as required; the system should be monitored and NHPA budget accordingly (**Photo #71**).

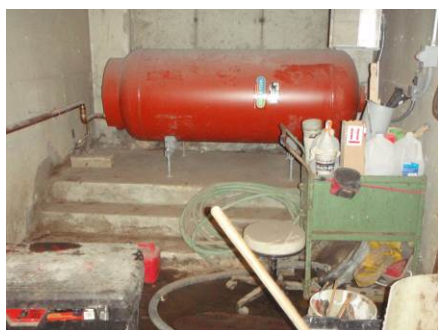
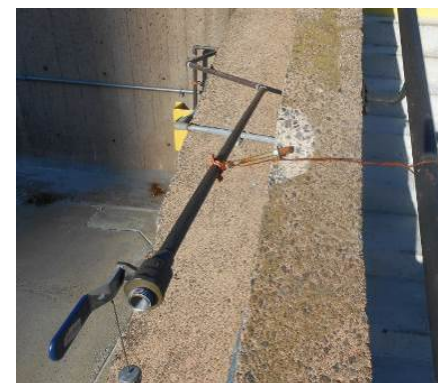
Pressurized Garage Wash-Down System: The installation of a pressurized garage wash-down system was performed as part of the current (2013) comprehensive capital project. **(Photos #72 & #73)**

DESMAN recommends that the washdown system be monitored for damage and repaired as may be required on an as-needed basis.

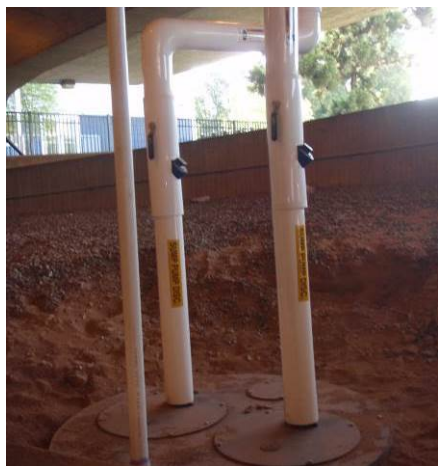
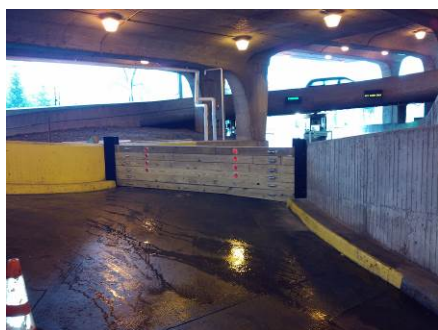
Mitigation of Rev. Dr. Martin Luther King Jr. Boulevard Vehicle Exit Flooding: Storm water is unable to drain from this area of the facility during heavy rains due to the City's storm sewer system being overburdened. As a result, there is a problem with flooding at a low area near the collection booths at the Rev. Dr. Martin Luther King Jr. Boulevard exit. Flooding has resulted in damage to the revenue control equipment and prevents cars from exiting the garage during such events. While there is no ideal solution to this problem as long as the public storm system is incapable of handling the storm flow, a partial remedy has been provided and is in-place. A new sump pump near the collection booths discharges into the city sewer at a nearby location, as well as construction of a wooden barrier to serve as a protective dam. This work was performed as part of comprehensive

(2013) repair program. **(Photos #74 & #75)** Additionally, with the closure of the exit as part of the City's Downtown Crossing Phase 3 project, the ramp will be removed and walls installed, eliminating this flooding situation.

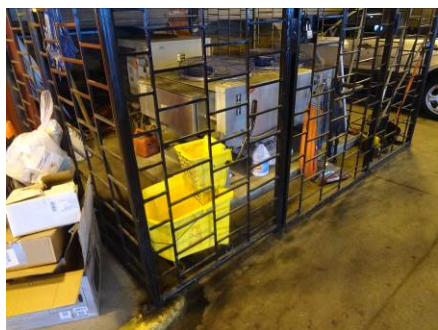
Photo #82

Installation of a Sink for Cleaning: The maintenance mop and bucket for cleaning is stored within the fenced space on Level 3 (**Photo #82**). Whenever NHPA performs its cleaning, staff needs to bring the bucket down to the office in order to clean and fill the bucket, to then bring it back out to the garage. Therefore, NHPA has requested that a sink be installed so that it is closer to where the mop may be needed. However, prior to the sink being installed, DESMAN recommends that proper winterizing and pipe insulation requirements be reviewed to confirm appropriateness.

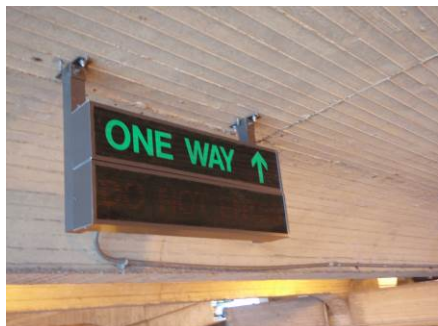
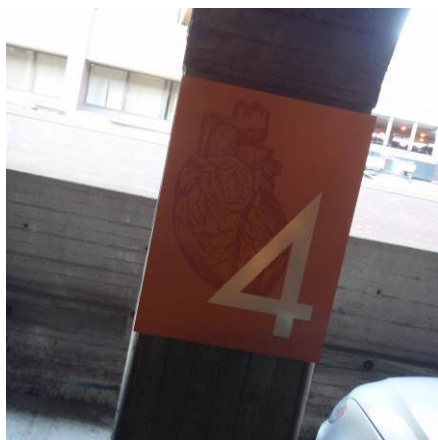
Miscellaneous Signage Repair: This garage has a multitude of traffic and pedestrian way-finding signage installed throughout the facility. Over time, depending on environmental exposure, vandalism and abuse, and normal wear, some of this signage needs to be repaired or replaced (**Photos #83 & #84**). Depending on the type and location of this signage should dictate when it should be repaired; some

signage, particularly some of the illuminated signage with changeable computer controlled messages are critical to garage operation and traffic control and should be replaced immediately after the damage is identified. Some of this work was implemented as part of the (2013) comprehensive capital project although continued repairs should be monitored and address as required.

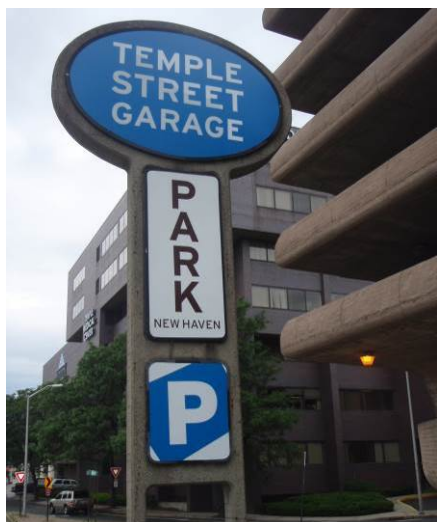
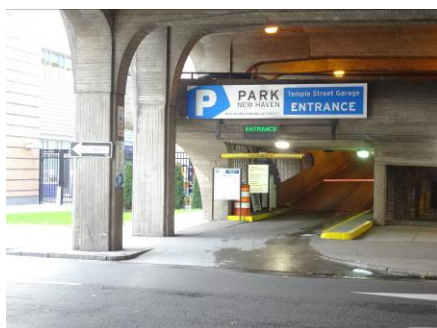
In conjunction with NHPA's re-branding program, the exterior identification signage was replaced (**Photos #85 & #86**). Interior and/or pedestrian signage which incorporates NHPA's logo should also be programmed for replacement. The signage can be updated with new sign box materials and new graphic faces to be more in keeping with NHPA's new logo and graphic standards.

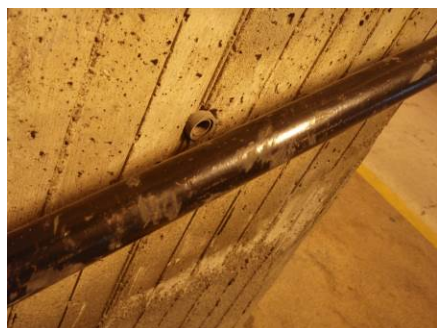
Photo #87

Railings and Miscellaneous Metalwork: This item of work includes painting of facility handrails as well as other ferrous materials (**Photos #87, #88 & #89**), such as the guardrail in front of the roof level elevator vestibules. Painting offers corrosion protection and is an aesthetic enhancement as well. Normal wear and tear due to continued use of the facility stairs necessitates periodic repainting of stair hand railings.

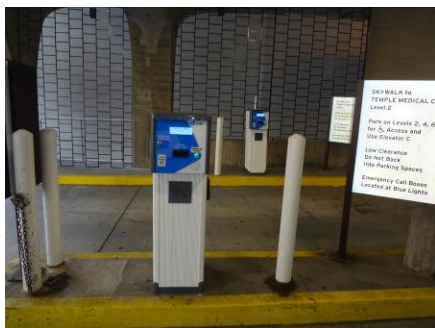
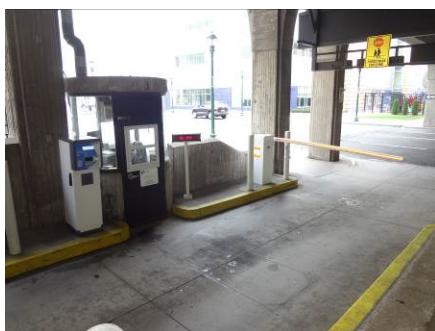
The existing revenue control and parking access equipment was replaced in 2013. However, due to new and improved technology, DESMAN recommends that PNH review the current system for potential enhancements and/or replacement, and plan accordingly. (**Photos #90 & #91**)

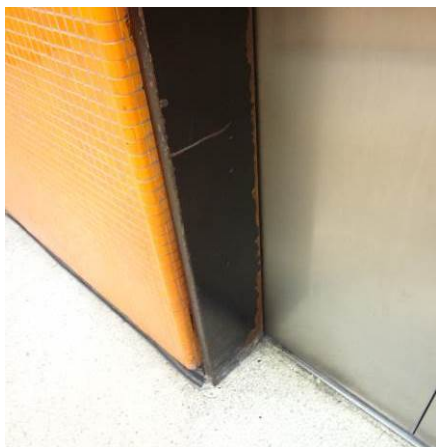
Photo #92

DESMAN did observe miscellaneous corrosion at various framing (**Photo #92**); DESMAN recommends that PNH monitor these conditions as required.

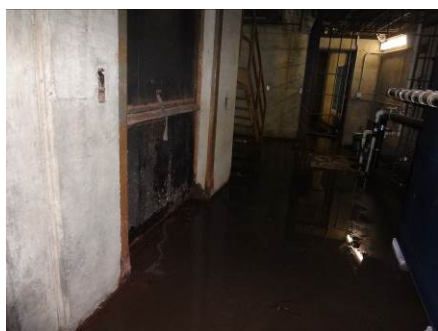
Photo #93

As part of the construction of the adjacent Gateway Community College property, one of the abandoned elevators within the eastern corridor was permanently filled, leaving the second one still open (**Photo #93**). Since various improvements to the George Street area above are still in progress, water infiltration coming from the adjacent property may or may not continue to be a concern. DESMAN recommends that this abandoned elevator be monitored and if appropriate, formally filled.

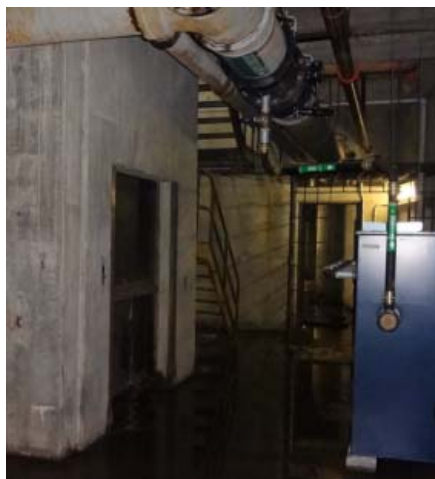
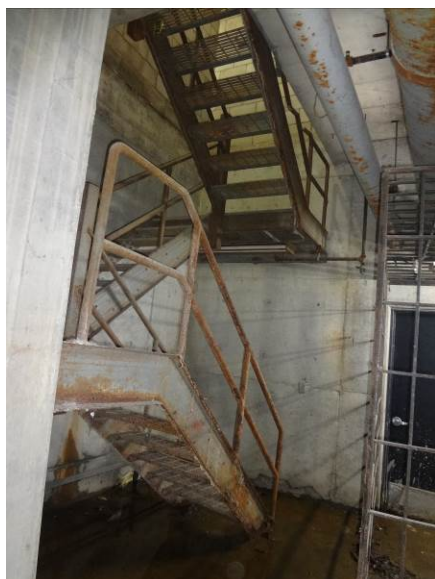
Replacement of Metal Stair: the existing metal stair, leading from the valet parking area (on street level) to the rear corridor on Level B3, is corroded beyond repair (**Photos #94 & #95**). DESMAN recommends that this metal stair be removed and replaced with a new hot-dipped galvanized metal stair system, fully compliant with current Code. However, either prior to or in conjunction with the replacement work, DESMAN recommends that the continued water intrusion into this corridor be addressed so as to avoid further corrosion to the stair system. This work is currently scheduled to be performed as part of NHPA Project No. 20-006, currently in design.

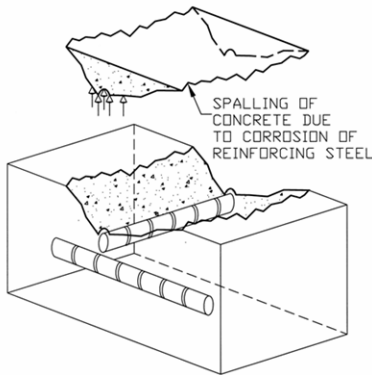
Fig. A

Concrete is a porous material, susceptible to water penetration which can result in increased potential for deterioration. Corrosion of reinforcing steel is an electrochemical process accelerated by the presence of water acting as an electrolyte. In addition, water penetrating into concrete (*Fig. A*) can carry water-soluble chlorides (de-icing salts) to the reinforcing. The combination of chlorides and water further accelerates this corrosion process.

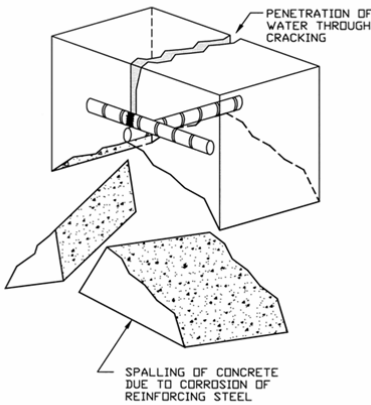
Fig. B

Corrosion of reinforcing steel or other embedded ferrous items such as electrical conduit is a second major factor contributing to deterioration of reinforced concrete (*Fig B*).

The corrosion process is an electrochemical process, which produces iron oxide (rust) and other by-products. These by-products occupy a minimum of 250% of the volume of the parent metal. This increase in volume produces tensile stresses within the surrounding concrete.

Because concrete has poor tensile strength properties, cracking occurs within the concrete matrix allowing additional moisture and chlorides to reach the reinforcing causing acceleration of the corrosion process. The deterioration caused by this corrosion includes the reduction of cross sectional area of the reinforcing, and the delamination of concrete surrounding the reinforcement.

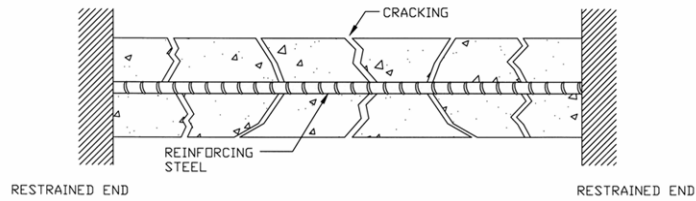
Fig. D

Volume changes due to thermal movement, shrinkage, creep, and loading can also contribute to the deterioration of reinforced concrete. These volume changes will produce stress in restrained members, often resulting in cracking of the member (*Fig. D*). These cracks also provide access to water and other deterioration mechanisms to attack the member.
