**CONDITION APPRAISAL  
(FY 2020)**

**UNION STATION BUILDING  
NEW HAVEN, CONNECTICUT**

**NEW HAVEN  
PARKING  
AUTHORITY**

**APRIL 2020**

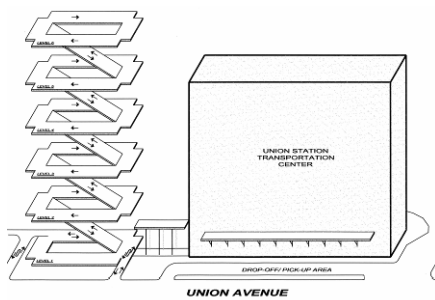
**Isometric #1**

The main pedestrian entries are located off of Union Avenue on the north side of the Station, and pedestrian egress to an adjoining parking garage is provided to at the eastern end of the building (**Isometric #1, Photos #5 & #6**). At the western end of the facility there is a bus station/depot and car rental area. The station has an underground pedestrian tunnel, accessible by stairs, escalators and an elevator from the first level which leads to the railroad platforms located to the south of the Station.

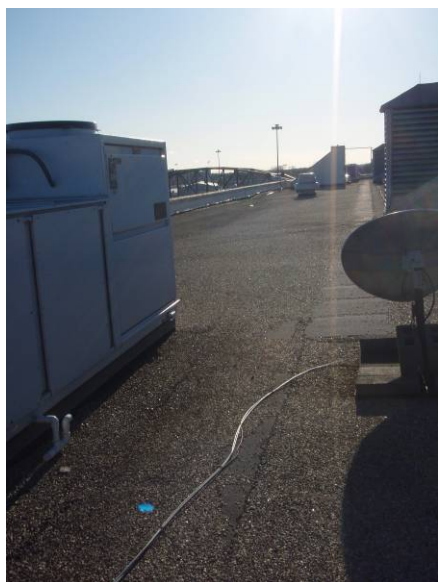
**Photo #7**

- 1997 The pre-existing roofing system was removed and a new four-ply built-up roof, with a 20-year warranty by Johns Manville, was installed (**Photo #7**).
- 1998 A project was implemented to upgrade the Station to comply with the Americans with Disabilities Act (ADA). The scope of work included improvements to public spaces, train platforms, restrooms and tenant entries and new signage.

In 1997, a new four-ply, built-up roof was installed with a 20-year NDL warranty. DESMAN notes that miscellaneous leaking has been observed by NHPA and repairs have been addressd where a leak could be located. DESMAN recommends and has included an allowance to budget for costs associated with miscellaneous water testing to identify leaking in obscure locations.

DESMAN also recommends that the condition of the roof system be monitored, including the various secondary canopy roofs as well (**Photo #43**). Even though the warranty expired in 2017, Desman does not necessarily recommend that NHPA plan to replace the roof in the immediate future. However, miscellaneous repairs are now a maintenance cost, and eventually, the miscellaneous maintenance costs would outweigh the cost of installing a new roof system and obtaining a new 20-year warranty. That said, a study of system options is currently in progress as part of Project No. 19-014.

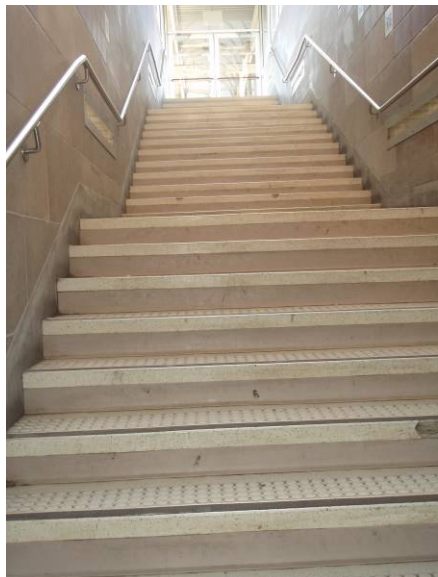
Photo #9

- Addressing various concerns to the facility's southwest stairwell, inclusive of the application of an architectural waterproof coating on the exterior surfaces of the penthouse, repair to the plaster finishes of the upper reaches of the interior of the stairwell, the replacement of the access door and its associated framing.
- Installation of rubber treads, risers, and landings on the stairs leading to the train platforms (**Photo #9**).
- Repair of the lightning arrestor system (**Photo #10**).

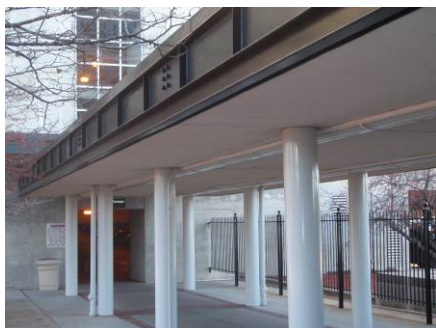
**Photo #11**

- The canopy between the Station and the parking garage was renovated to be more in keeping with the style and historic nature of the Station. A new plaster ceiling was installed, along with new architectural lighting (**Photo #11**).

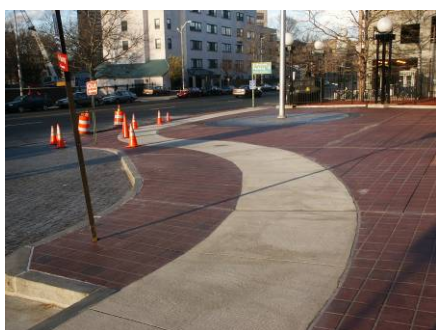
**Photo #12**

- The front passenger drop-off area and sidewalks were replaced. The previous construction of the sidewalk areas consisted of brick pavers set in sand beds, and over time the pavers settled due to moisture and cyclical freeze-thaw. Additionally, because the driveway area was originally constructed of bituminous concrete pavement in combination with brick and granite cross-walk and sidewalk areas, the pavement had become increasingly deteriorated due to contamination with motor oil from the taxis and other vehicles. The front passenger drop-off area now consists of a combination of stenciled and stamped concrete, providing an aesthetic treatment, as well as a more forgiving surface considerate to the level of usage this area receives (**Photo #12**).

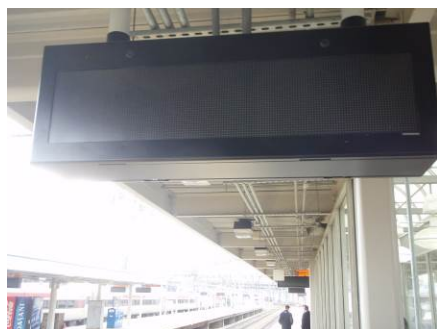
**Photo #14**

- Elevator Modernization and Improvements
- Installation of a new emergency generator.
- Replacement of the fire alarm system with new fire suppression components
- Installation of a New Public Address and Video Message System. **(Photo #14)**
- Installation of a New Security System **(Photo #15)**
- Installation of a New Sand/Oil Separator **(Photo #16)**
- Improvements to the Basement Level Corridors and Spaces **(Photo #17)**
- Various architectural, electrical, and mechanical Improvements to the Pedestrian Tunnel **(Photo #18)**.
- Mechanical, Electrical and Plumbing Improvements: CDOT is currently making various mechanical, electrical, and plumbing improvements within the Union Station Building started in 2010.

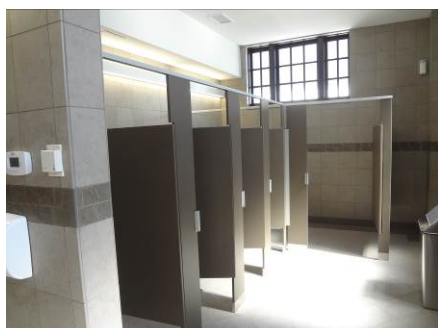
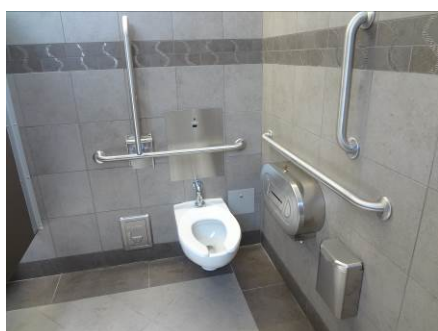
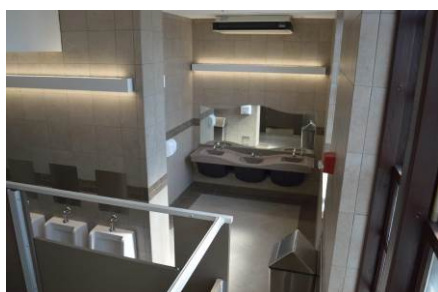
2016 Work related to the Building includes extensive renovation of the facility's public restrooms (**Photos #19, #20 & #21**). The two restrooms were gutted and entirely reworked with new floor and wall tiles. All bathroom fixtures (sinks, toilets, urinals, partitions, etc.) were replaced with new components and all existing plaster finishes were repaired and repainted. New lighting was also installed. Implementation of this work was part of Project No. 08-016 E, now completed.

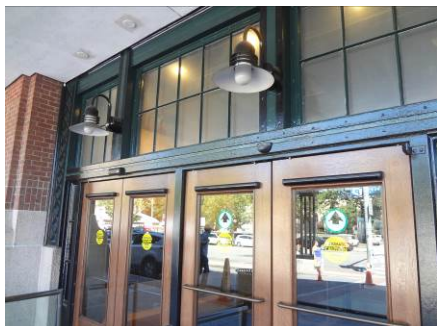
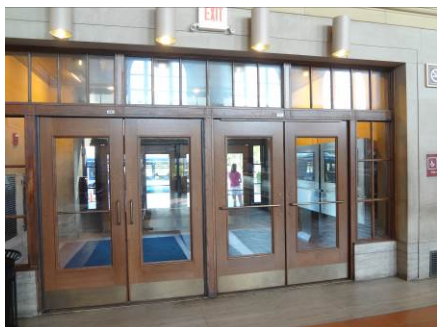
2017 All of the Station's entry/exit doors have been either replaced or repaired, with all hardware and automatic controls (**Photos #22 & #23**). This work was addressed as part of NHPA Project no. 10-005 A.

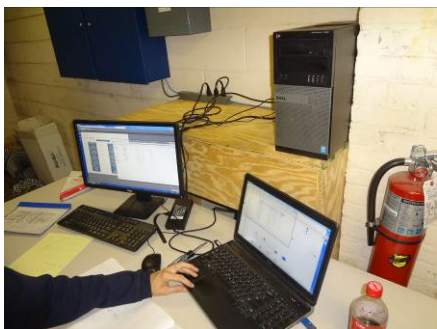
Photo #24

1. Replace Pneumatic HVAC Controls w/ Electronic Controls (**Photo #24**)
2. Replace 3 Packaged Rooftop Units (**Photo #25**)
3. Replace Eight (8) Gate Valves @ Control Valves
4. Replace two (2) Existing Recessed Wall Heaters in Main Entry

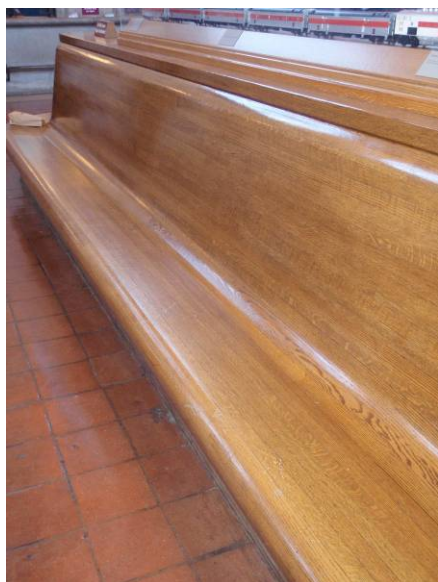
Photo #27

Items to be re-finished include, but are not limited to interior wood trim (i.e. doors and storefront, waiting room benches, stair handrails, etc.), and various brass finishes and components (**Photo #27**). Although this work is currently included as part of NHPA Project no. 15-003 A, now in design, DESMAN recommends that a nominal extent of repair continue to be programmed to address preventative maintenance needs accordingly as they arise.

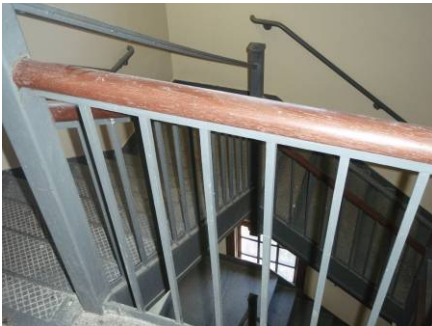
Photo #29

A review of the Station's stairwells indicates that each stair well access door on all levels would benefit from being refinished (**Photo #28**), as well as the handrails throughout the stairwells (**Photo #29**). In combination with this work, each stairwell has been identified as requiring a limited amount of plaster/sheetrock repair in combination with a fresh coat of paint (**Photo #30**).

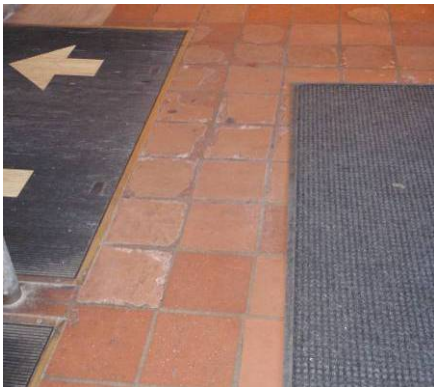
Photo #32

Though the floors are well maintained as evidenced by the high shine, cracked tiles should be maintained in accordance with Historic Preservation Guidelines. Quarry tile repair was identified as being required in the main lobby entry vestibule, the east entry vestibule and in limited areas of the main waiting room (**Photo #32**).

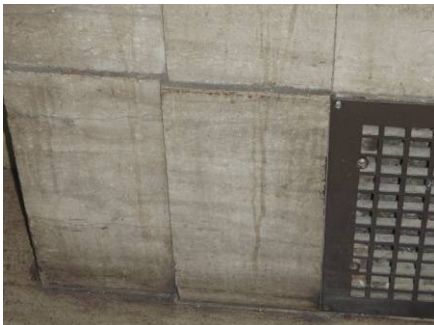
Photo #33

Various components of the building's interior, mainly concentrated to those areas occupied by the general public, need to be periodically maintained; this maintenance will entail periodic cleaning. These items include the cleaning of various limestone and travertine wall finishes within the main lobby, the lobby mezzanine area, the east and west end lobbies and the lower east end lobby at the entry to the pedestrian tunnel (**Photo #33**).

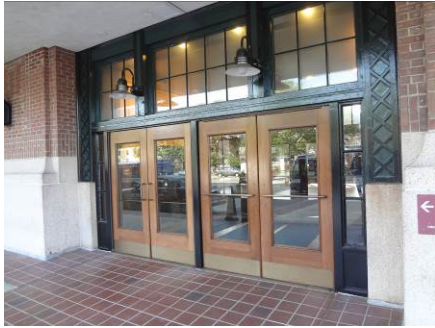
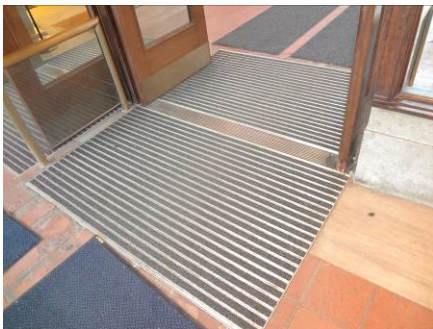
The main waiting room entry doors, west & east end entry doors (**Photos #34 & #35**), as well as the doors along the south side have all either been repaired or replaced as part of NHPA Project No. 10-005.

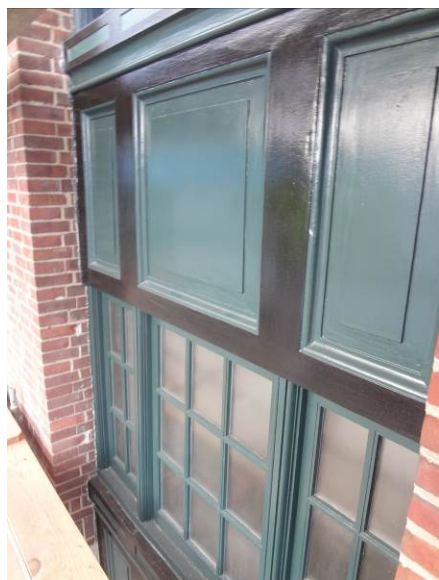
Photo #37

The exterior painted finishes on wood and metal trim located around the perimeter of the Station's windows, have been repainted as part of NHPA Project no. 08-016 B. (**Photo #37**).

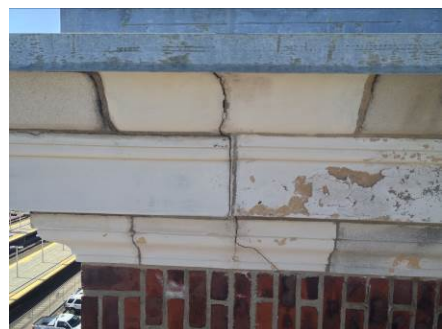
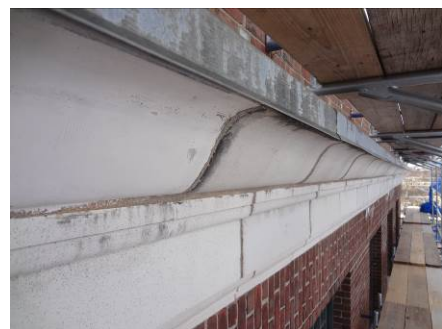
The terra cotta cornice is exhibiting its age (**Photos #41 & #42**). Although NHPA and DESMAN have been hesitant to program extensive repairs to this cornice due to the historic nature of the building, the time is approaching that repairs should be considered more inevitably due to concerns of waterproofing and maintain the building envelop. Acknowledging that respecting the historic nature of the building is critical, there are various options for coatings that may be applied and faux terra cotta that may be installed that would be minimally visible. DESMAN recommends that NHPA continue to monitor the condition of the cornice and program repairs accordingly. That said, an assessment and initial investigation is currently in progress as part of Project No. 19-013.

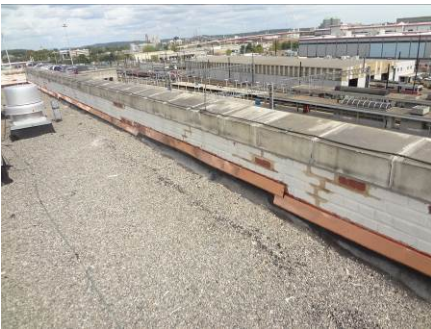
**Photo #44**

- a. Existing caulking was nearing the end of its useful life. The caulking has all been replaced as part of NHPA Project no. 08-016 B.
- b. Cracking in the coping stones, as a result of miscellaneous distress and the mounting of the lightening arrestor system air terminals was also contributing to water penetration. The coping stones have been coated with an elastomeric coating to waterproof and span the cracking as part of NHPA Project no. 08-016 B (**Photo #44**).

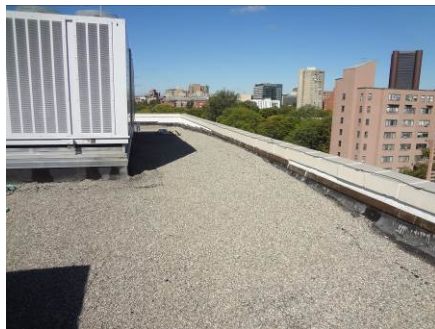
**Photo #45**

- c. Miscellaneous brick removal and re-pointing, on the interior face of the parapet, has been addressed as required, to maintain the waterproofing integrity and prevent leaking (**Photo #45**). Following the masonry repairs, the architectural waterproofing coating has been repaired and re-coated as part of NHPA Project no. 08-016 B.

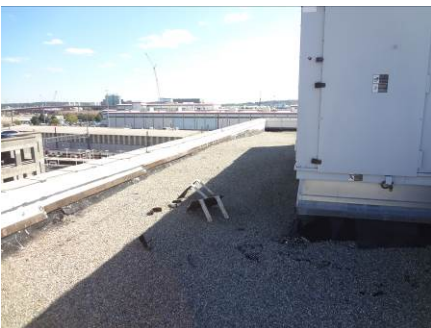
**Photo #46**

- d. Miscellaneous flashing has been repaired or replaced as required as part of NHPA Project no. 08-016 B (**Photo #46**).

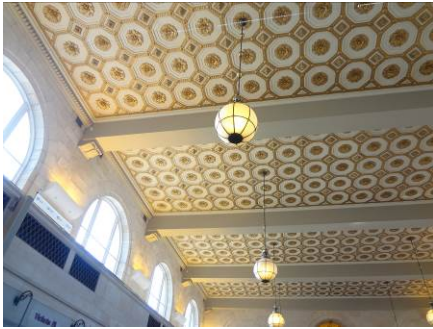
Photo #48

Cleaning of the globe lights in the main waiting area should enhance the aesthetics of the lobby area (**Photo #48**). The wall sconces above the galleries in the main waiting room require a fresh coat of paint. This work is currently included as part of NHPA Project no. 15-003 A, now entering design.

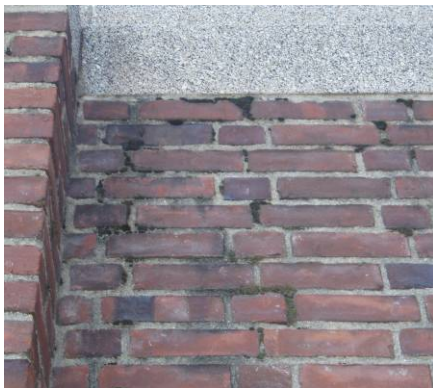
Photo #49

Miscellaneous re-pointing of the brick enclosure was recommended to remove organic growth (**Photo #49**), and repair of miscellaneous units was recommended throughout.

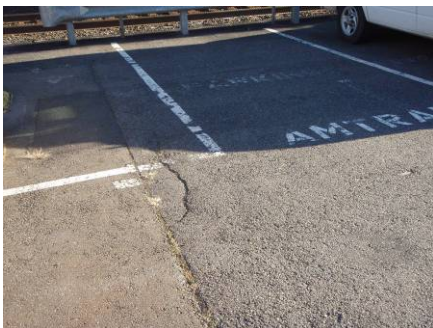
Photo #50

- Cracking has been observed in the bituminous concrete pavement throughout the west lot. These cracks should be properly cleaned and sealed to prevent further deterioration of the pavement.
- Miscellaneous pavement repair is required within the west surface parking lot (**Photo #50**) to address differential settlement issues. This is especially important for those defects that are several inches deep and present a potential trip hazard.

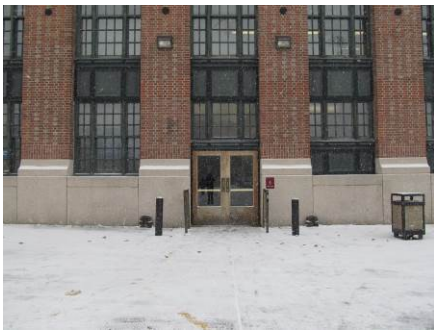
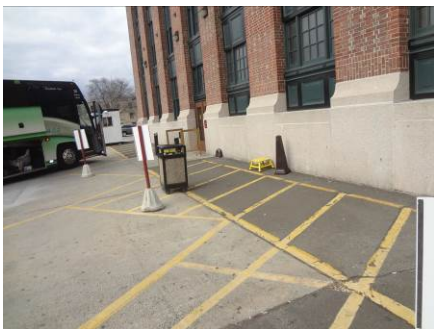
Originally, a canopy structure was intended to be installed at the West Entrance (**Photos #51 & #52**) as part of the comprehensive renovation project of the early 1980s; however, it was never installed. Since then, this entrance has become a challenge since it serves patrons waiting for buses as well as other related needs.

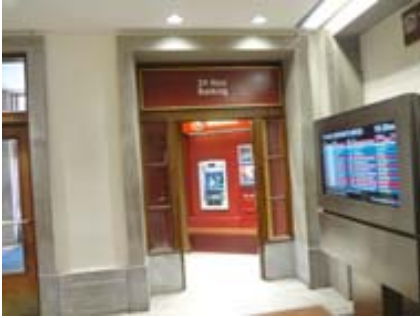
Photo #56

Pursuant to recent discussions, **DESMAN** understands that **PNH** desires to review and study various issues that may be involved in the construction of a potential family restroom (**Photo #56**), in addition to the existing restrooms currently located at the Union Station Building. This study has been in progress as part of NHPA Project No. 18-022; plans however for a single toilet family restroom have been deferred and instead will be considered as part of a comprehensive plan to increase public restrooms.

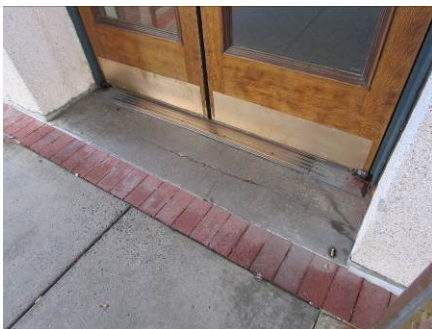
Photo #57

Cracking in the stone thresholds has apparently allowed moisture through, and so nominal leaking has been observed into the tunnel below (**Photo #57**). **DESMAN** recommends that these thresholds be properly sealed and any cracking be repaired.

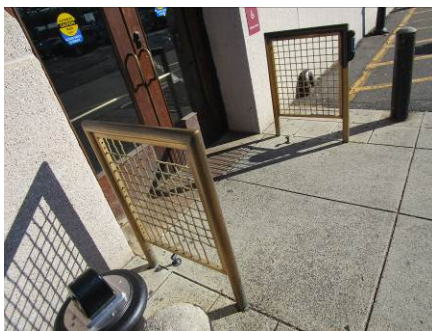
Photo #58

The brass railings by the exterior doors have been susceptible to moisture and thus have corroded, becoming loose (**Photo #58**). **DESMAN** recommends that these railing systems be replaced, perhaps mounted onto a raised curb of some form so as to provide further protection.

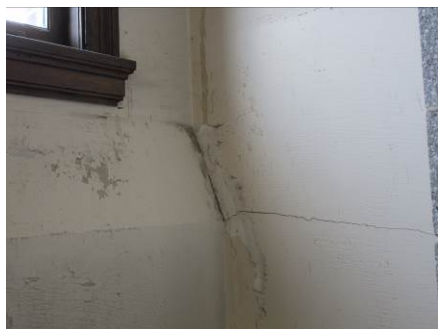
Photo #59

Apparently due to moisture penetrating through the windows or roofing system above, various extents of damage have been observed throughout the now-vacant tenant spaces (**Photo #59**). Since the source of moisture is not exactly confirmed, DESMAN recommends that the envelop be monitored along with other planned improvements, and this wall damage be repaired as required.

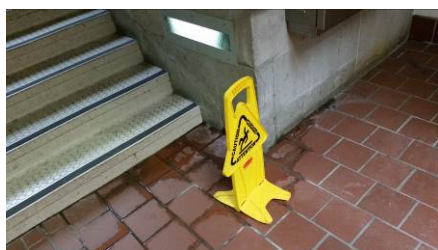
Photo #63

Even though various drainage improvements were undertaken by CDOT as well, additional drainage improvements were undertaken by NHPA in summer/fall 2019 (**Photo #63**) as part of NHPA Project No. 18-013; a limited amount of reserve is recommended to be budgeted each year for additional seepage crack injection which may be required.

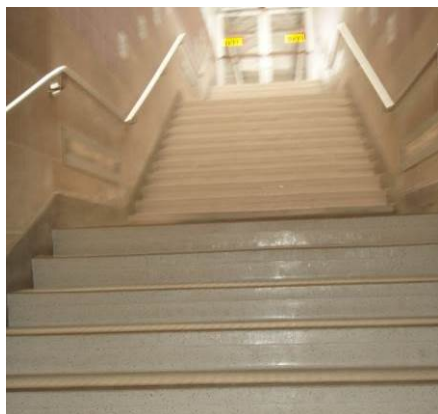
Photo #64

The stair treads and stair landings within the tunnel which access the station's railroad platforms had exhibited some limited wear due to heavy usage and were addressed and replaced in the CDOT project's scope of work (**Photo #64**). NHPA, however, has requested that DESMAN consider a future replacement program in which DESMAN considers other options besides rubber flooring that may be more durable for the long-term, such as supplemental metal treads that may be installed as a retrofit.

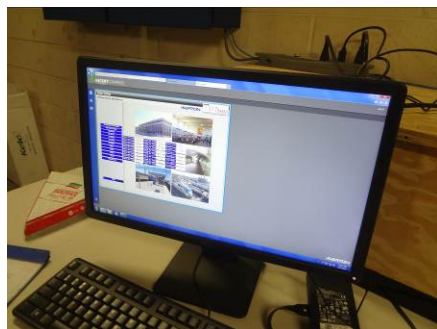
Photo #69

This work has been addressed as part of NHPA Project No. 10-005 B. The upgrades included installation of a new web based Head End Controller for the Building Management System (**Photos #68 & #69**) and replacement of all remaining

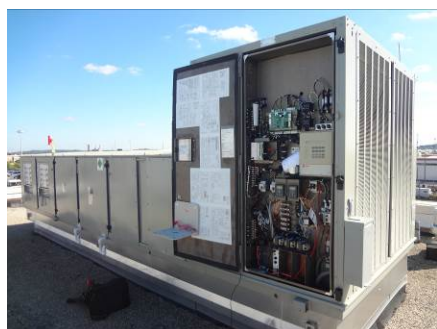
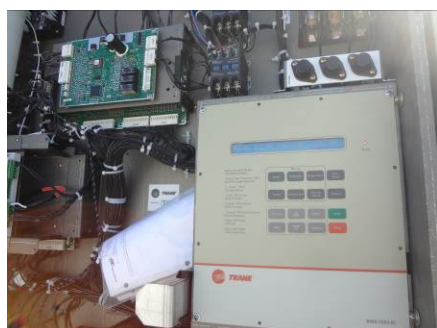
Three of the six packaged rooftop air conditioning units were replaced in 2003, and the second set of three were replaced (**Photos #70 & #71**) as part of NHPA Project No. 10-005 B. However, the time has come again to consider replacement of the initial three, and thus DESMAN recommends that they be monitored and planned for accordingly.

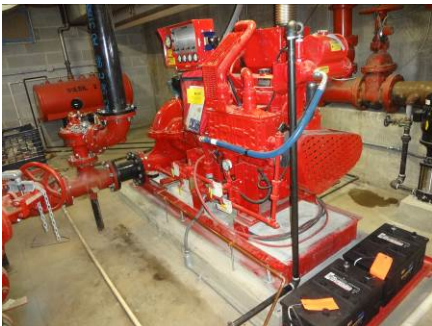
Photo #72

The 30-year old fire pump was replaced (**Photo #72**) as part of NHPA Project No. 10-005 B.

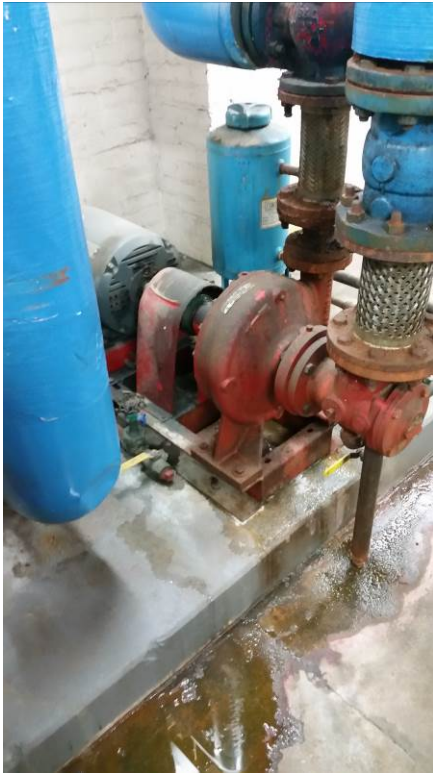
Photo #73

The previous chilled water pump, installed during the 1980's, has now been replaced (**Photo #73**) as part of NHPA Project No. 18-014 now complete.

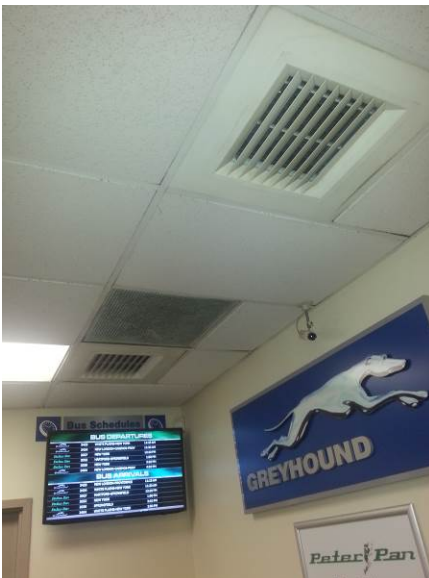
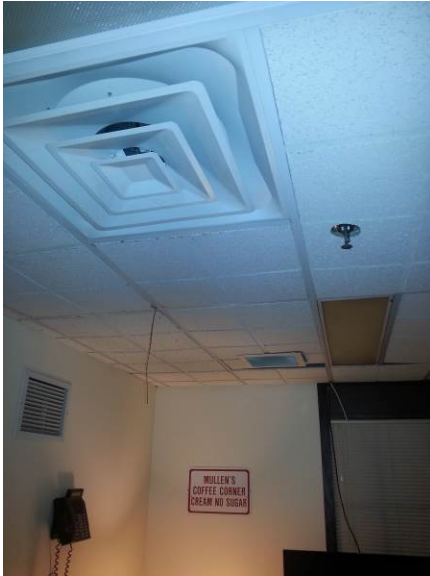
- The Amtrak, Avis & Greyhound spaces (**Photos #74 & #75**), currently served by AHU-6, had been experiencing overheating issues; after review, we found that the unit was originally set up for free economizer cooling but that there was excess restriction in the outside air duct so economizer was ineffective. We addressed the overheating by adding a booster fan in the basement to supply the correct amount of outside air for economizer. Further improvements to AHU-6 controls were included in NHPA Project #10-005B, so additional improvement should be noted. We would subsequently recommend continued monitoring of these spaces to confirm.

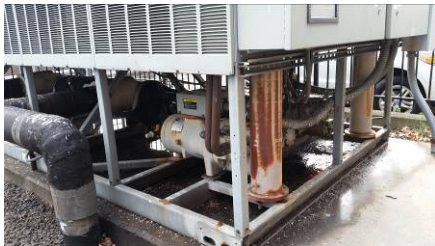
Photo #77

15. The prior 90 ton chilled water plant has been replaced with a new 100 ton chiller in 2019 as part of NHPA Project No. 18-014 (**Photos #77**). DESMAN recommends that regular preventative maintenance be scheduled and provided for every 3 years approximately.

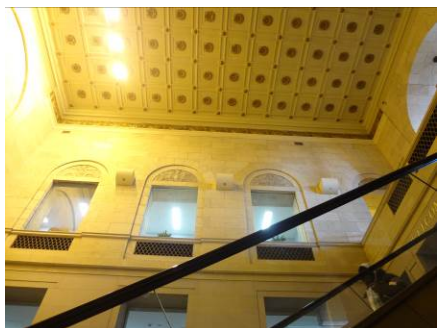
Photo #79

Also, as recommended by DESMAN, modifications were made to the light fixtures over the escalators (**Photos #78 & #78**). Due to their height and positioning over the escalators, access for maintenance was challenging and scaffolding was necessary. This work was accomplished as part of NHPA Project No. 15-003 B in 2019, now substantially complete.

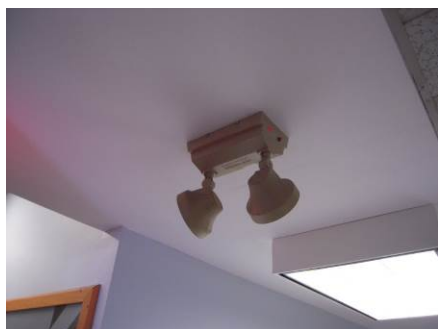
Photo #81

Existing battery-powered twin-head emergency lighting units are installed throughout the second, third and fourth floor corridors (**Photo #81**). DESMAN recommends that PNH Maintenance monitor them and repair/replace them as may be required.

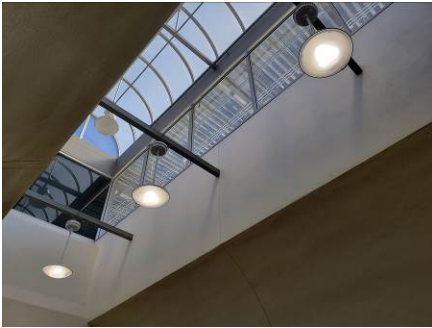
Photo #82

16 foot pendant mounted fixtures in each of two high ceiling areas of the tunnel were replaced in 2019 as part of NHPA Project No. 15-003 B (**Photo #82**).

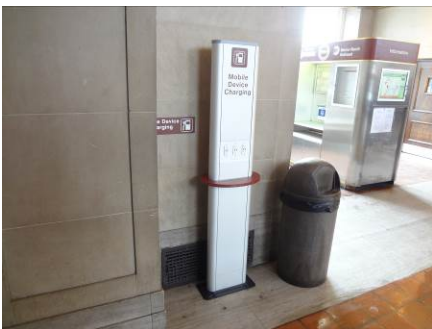
Photo #83

8. Mobile Device Charging Stations have been installed at various locations throughout the Union Station Building (**Photo #83**). DESMAN recommends that PNH monitor the stations for volume of usage and prepare a preventative maintenance program accordingly.

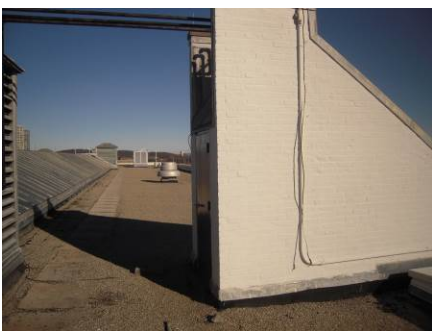
Photo #84

9. PNH had requested that service lights be installed on the roof in designated locations (**Photo #84**) to provide enhanced lighting when performing maintenance on the various roof level mechanical units and equipment. This work was completed in 2019 as part of NHPA Project No. 15-003 B.

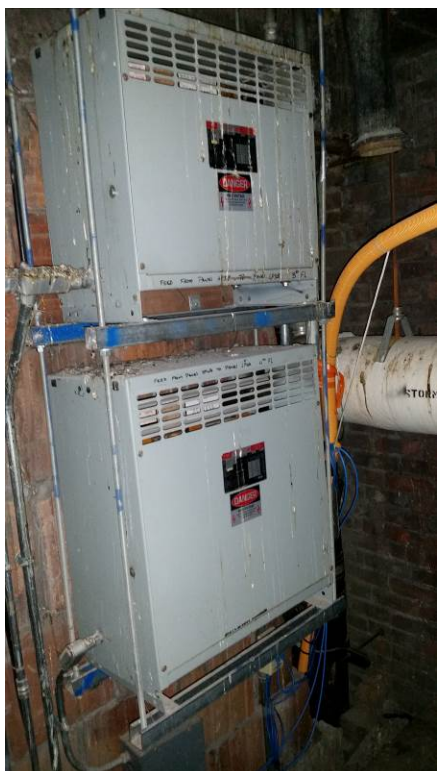
Photo #87

12. Transformer Replacement: The basic cause of transformer noise is magnetostriction: the expansion and contraction of the iron core (laminations) due to the magnetic effect of alternating current flowing through the transformer coils; this produces an audible hum. Magnetostriction may be partially controlled by the transformer design, but it cannot be totally eliminated. Thus all transformers will have some audible noise and will also transfer some vibration into the surfaces they are mounted to. Reducing the noise and vibration could be accomplished by replacing the transformer with one having a more modern construction or providing some form of vibration isolation. Sound deadening materials could also be placed between the transformer and any

location where the noise is problematic. The humming is not typically an indication of impending failure or overloading and unless the noise is creating a disturbance to patrons or employees, DESMAN recommends that it simply be monitored for the time being (**Photo #87**). Various units located in the furred ceiling space are also showing signs of age; DESMAN recommends that these units be monitored and as well, programmed for replacement as may be appropriate.

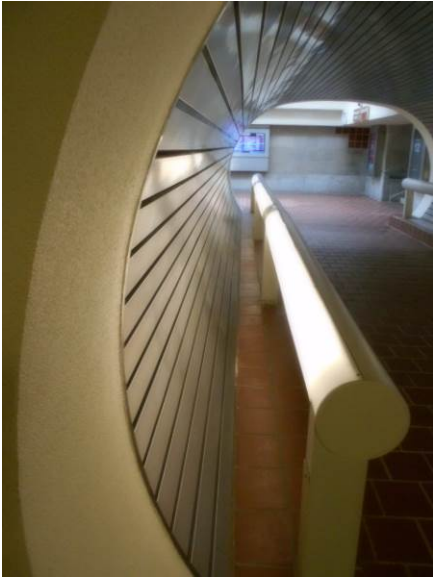
Photo #88

13. Replacement of the Tunnel Light Rail: In order to enhance the tunnel leading to the train platforms, consideration has been made to enhance the rail light on either side of the tunnel (**Photos #88 & #89**). A simple but decorative enhancement may be to retrofit or replace the rail with a color-changing lighting system that may be programmed for additional aesthetics. At that time, DESMAN recommends that the mounting system be modified, as well, so as to avoid the rail system being exposed to moisture and subsequent corrosion.

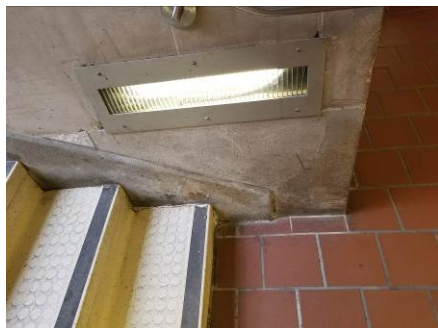
Photo #91

15. The lights within the walls of the stairs leading to the train platforms are aged and difficult to maintain due to their exposure to moisture (**Photo #91**). DESMAN recommends that the photometrics of these lights be reviewed to confirm whether the fixtures are actually necessary; if they are not necessary, DESMAN recommends that the fixtures be removed and plated over, otherwise they be replaced with new fixtures.

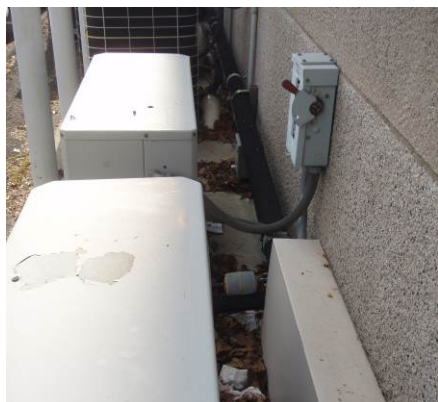
Photo #92

A combination of housekeeping pads also exists, consisting of raised concrete, surface-flush concrete, as well as no pad but for the pre-existing asphalt curbing.

DESMAN recommends that this curbing area be reviewed and the equipment re-organized, appropriate pads be placed or adjusted, and the various piping be enclosed. (**Photos #92, #93 & #94**)

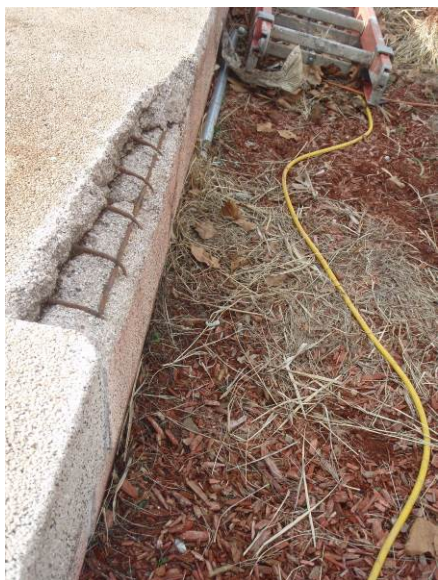
Photo #95

Various site elements have been damaged, such as the precast planter walls in the rear of the Building, as well as moisture damage and corrosion to fencing. All elements and materials should be repaired as may be required. (**Photos #95, #96 & #97**).

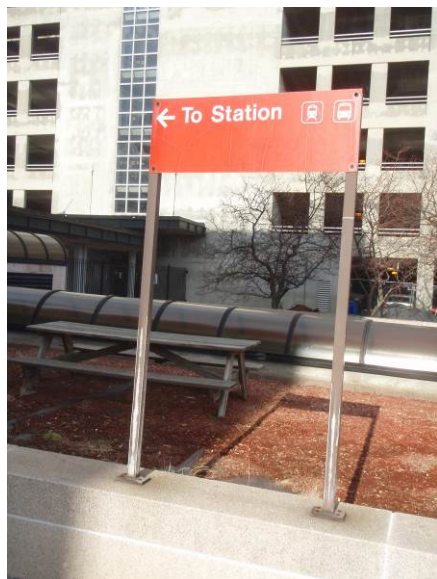
Photo #98

In the meantime, any existing signage which have been damaged should be replaced. DESMAN also recommends that the signage program be reviewed for any potential updating as may be appropriate for patron requirements. (**Photo #98**)

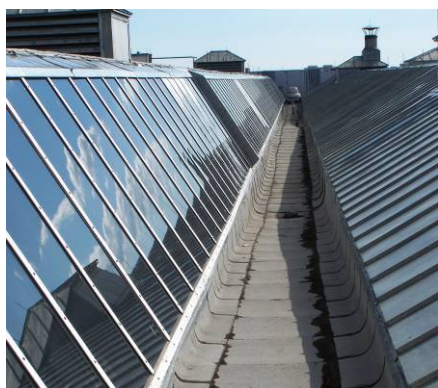
Photo #100

1. Some of the coated skylights on the fourth floor offices are peeling. Should privacy or heat/light protection still be required, a new coating should be applied, or the glass replaced with opaque glass or insulated panels. DESMAN recommends that these be monitored as required. **(Photo #100)**
2. Periodic inspection of the perimeter fencing is recommended to assure this fence remains secure and properly maintained.
