Under Air Rights Garage Surface Parking Lot New Haven, Connecticut

## **CONDITION APPRAISAL**

# UNDER AIR RIGHTS GARAGE SURFACE PARKING LOT

# NEW HAVEN PARKING AUTHORITY FACILITIES New Haven, Connecticut

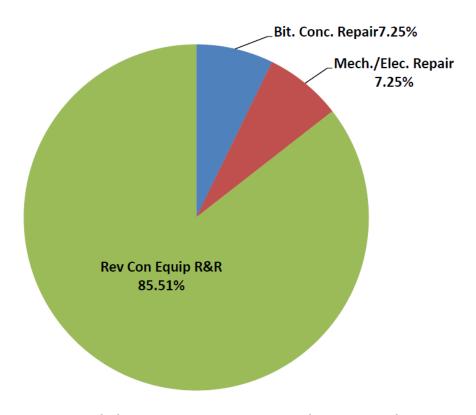
**Recommended Repairs & Improvements split into Disciplines**

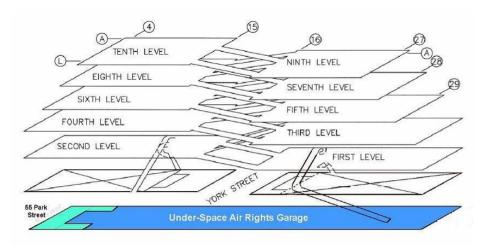
The Under Air Rights Garage (UARG) space is a parking area for approximately 180 cars located directly below Air Rights Parking Garage, and encompasses a section of now abandoned roadway right-of-way which was originally intended as an extension of Route 34 Connector. The total parking capacity of the area was reduced by approximately 40% due to the construction of 55 Park Street Building and its loading dock area (*Photo #3*), as well as the construction of new entrance and exit ramps from Air Rights Garage providing direct access and egress to the service roads at highway level and points east (*Photo #4*). The exit ramp has allowed the elimination of direct exit egress from the Garage to South Frontage Road, although the older exit driveway can still be utilized in emergencies if the Route 34 Connector or the new exit is ever temporarily closed. A garage entry ramp from Highway Level was also constructed as part of the City's Downtown Crossing project.

Vehicular access is provided directly from and to service roads at highway level, which has been constructed as part of the Downtown Crossing and 100 College Street development projects (*Photos #5, #6 & #7*).
